# An experimental study of non-destructive testing on glass fibre reinforced polymer composites after high velocity impact event

**Abstract.** A non-destructive testing method on Glass Fibre Reinforced Polymer (GFRP) after high velocity impact event using single stage gas gun (SSGG) is presented. Specimens of C-type and E-type fibreglass reinforcement, which were fabricated with 6mm, 8mm, 10mm and 12mm thicknesses and size 100 mm x 100 mm, were subjected to a high velocity impact with three types of bullets: conical, hemispherical and blunt at various gas gun pressure levels from 6 bar to 60 bar. Visual observation techniques using a lab microscope were used to determine the infringed damage by looking at the crack zone. Dye penetrants were used to inspect the area of damage, and to evaluate internal and external damages on the specimens after impact. The results from visual analysis of the impacted test laminates were discussed and presented. It was found that the impact damage started with induced delamination, fibre cracking and then failure, simultaneously with matrix cracking and breakage, and finally followed by the fibres pulled out. C-type experienced more damaged areas co

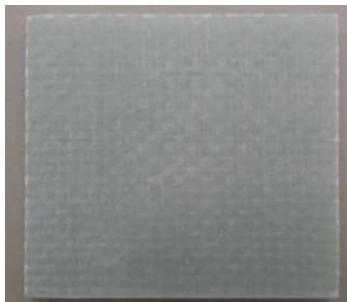
**Figure 2.** GFRP specimens for high velocity impact testing

The GFRP woven cloth was first cut into large panels of 320 mm long and 320 mm wide. After the cutting process, the next step was to perform the lay-up preparation using a heat blanket machine. The laminates were fabricated for the impact tests with different thickness, i.e. 6, 8, 10 and 12 mm. The thickness of each plies of fibre had been measured before the fabrication. The estimation of number of layers had been made after a few sample had been fabricated. All of the fabricated specimens had the same fibre loading and matrix weight fraction. Epoxy resin was used as the matrix by the mixing of epoxy and hardener in 2:1 weight ratio. Both the epoxy and the hardener used were of type Zeepoxy HL002TA and Zeepoxy HL002 TB, respectively. The mixed epoxy-hardener had a low viscosity that allowed easy handling and provided good wetting of the glass reinforcements. The curing process for the high velocity impact test specimens involved the use of heat blanket machine Heatcon HCS9000B and vacuum bagging process. This method accelerated the curing process and also resulted in better strength of the composite material due to the pressure applied by the metallic plate that properly compacted the panel. The material was cured in the vacuum bagging for two hours at 150 °F (65.56°C) to ensure the resin flowed uniformly to the whole glass layers and that the resin fully cured inside the laminates. Each panel then was cut into nine specimens with the required dimensions of 100 × 100 mm as shown in Figure 2 using a CNC router machine.

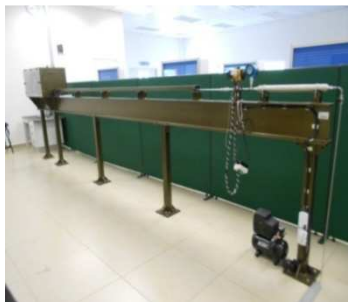
**Figure 3.** Single Stage Gas Gun (SSGG)

The impact tests were carried out using a single stage gas gun as shown in Figure 3. The test machine consists of five main components: catch chamber, ballistic data acquisition system, pressure reservoir unit, firing mechanism unit and the launching unit. The catch chamber provides room for holding the specimen to be tested. The impact tests were performed by clamping the specimens between two steel frames at the catch chamber and striking them at the centre with a bullet.

The ballistic data acquisition system collected the data from the test such as the impact energy and the impact force. The pressure reservoir unit consists of a cylindrical gas tank, pressure regulator, a pressure vessel and a pressure control valves. This unit is used to control the pressure of the gas gun. The pressures were varied from 6 bar to a maximum of 60 bar. Varying the gas pressure in the firing chamber will proportionally vary the bullet velocity. Table 1 shows the details of gas pressures used according to the test panel's thickness. The applied gas pressure was varied due to the fact that thin panel samples were not able to withstand the high velocity impact (given by high gas pressure) and therefore, it was necessary to reduce the gas pressure to avoid complete damage of the panels by the total penetration of the bullets on impact. Initial impact pilot tests established the gas pressure to apply in accordance with the thickness of the test panels.

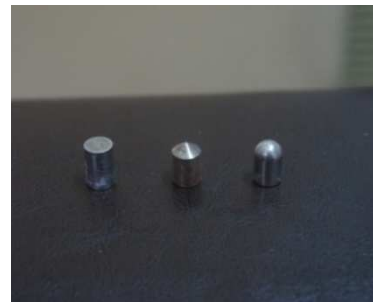
**Figure 4.** Type of bullet

Figure 4 shows three different types of bullets used in this experiment: blunt, hemispherical and conical shape. Each bullet had different cross section area that would affect the impact test result. The bullets that had been used were made from stainless steel. All bullets had the same weight of 5 g. The dimensions of projectile used were 15 mm in length and 10 mm in diameter. The firing mechanism unit influenced the gun's performance by insuring that the bullet slid smoothly along the chamber and shot the target specimen.
