Failures Analysis of E- Glass Fibre reinforced pipes in Oil and Gas Industry: A Review

Abstract: A comprehensive review is conducted on the failures in the field of manufacturing and installation of E-glass fiber reinforced pipes (GFRP). Some of the failures which are mainly encountered after the installation of E-Glass fiber reinforced pipes are the formation of air bubbles in between the polyester resin layer and the surface film, dispersion of moisture in between the tubing outer and inner layers after installation, heat released in between the layers of E-glass fiber reinforced pipes due to exothermic reaction which in turn results in the formation of cracks on the surface of the pipe. The recent findings and challenges performed in conducting research regarding the deterioration caused in glass fiber reinforced pipes are highlighted and each type of failure that was identified was illustrated with an appropriate high resolution photograph. Performing creep resistance and fatigue analysis are new aspects which are still required to be analyzed which have not been stated in the literature which are nominated.

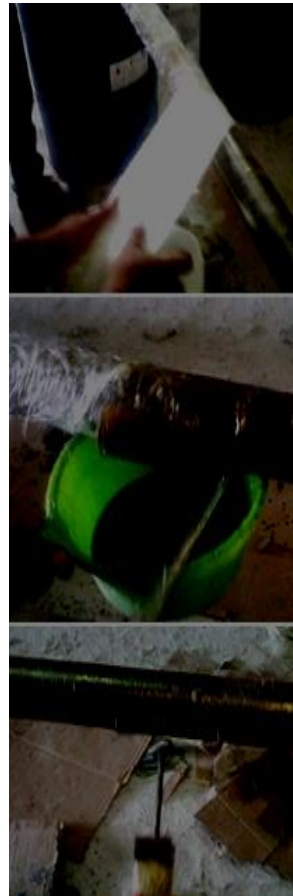
Figure-2: Systematic process of winding and applying resin during the preparation of E-Glass fiber reinforced pipe

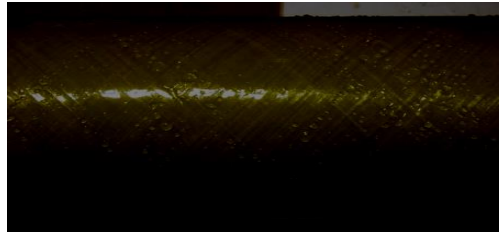
Figure: 3-Failure due the weepage caused by Air bubble formation inside the pipe

As per work done, firstly failures were noticed during the process of Filament winding when a plastic-coated cloth is placed along the longitudinal section of the mandrel, air is vaguely trapped in the reinforcement and resulting in the formation of cells or holes in the wall. So during the forming and curing operations there is a decrease in the strength of the final piping and sometimes making it permeable and so the tubing will not be suitable for all kinds of uses. Also, because when a cloth type reinforcement is applied, it is well oriented into definite layers and is therefore likely to delaminate and also trapping of air in the reinforcement which consequently results in the production of tubing free of passage which promotes leakage and stress concentrations. Water molecules are spread in to fiber-matrix interface and to drifted along the fibers by surface tension reducing fiber-matrix bond. The figure-3 shows the failure caused due to the weepage caused by Air bubble formation inside the pipe.

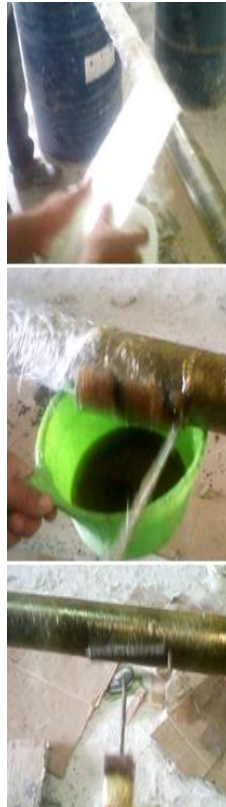
Figure 2:

The correct version of the Figure 2
