Application of infrared camera to bituminous concrete pavements: measuring vehicle

Abstract. Infrared thermography (IR) has been used for decades in certain fields. However, the technological level of advancement of measuring devices has not been sufficient for some applications. Over the recent years, good quality thermal cameras with high resolution and very high thermal sensitivity have started to appear on the market. The development in the field of measuring technologies allowed the use of infrared thermography in new fields and for larger number of users. This article describes the research in progress in Transport Research Centre with a focus on the use of infrared thermography for diagnostics of bituminous road pavements. A measuring vehicle, equipped with a thermal camera, digital camera and GPS sensor, was designed for the diagnostics of pavements. New, highly sensitive, thermal cameras allow to measure very small temperature differences from the moving vehicle. This study shows the potential of a high-speed inspection without lane closures while using IR thermography.

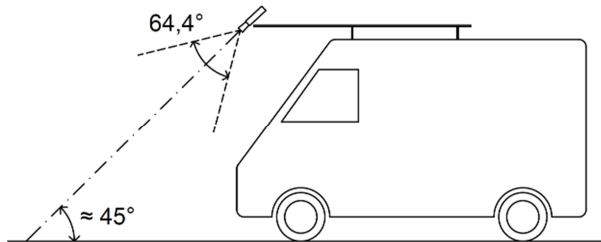
Figure 1. Sketch of measuring vehicle.

During the measurements the thermal camera was fixed to the roof of a vehicle Volkswagen LT35. The dimensions of the vehicle allow to place the camera to a sufficient height, thus the camera view covers the whole traffic lane. The camera was fixed to the roof with the use of roof holders and aluminium profiles. The thermal camera was fixed to the end of an arm by a steel fitting, which allows its turning. The angle of the thermal camera position towards the road plane is recommended to reach at least 45° (Figure 1). In case the angle is too low, undesirable distortion of measured values may

occur. On the other hand, higher angle of the thermal camera position is not detrimental during the measurement, although in such case it is necessary to move the camera further ahead of the vehicle so that its front part would not obstruct its field of view.

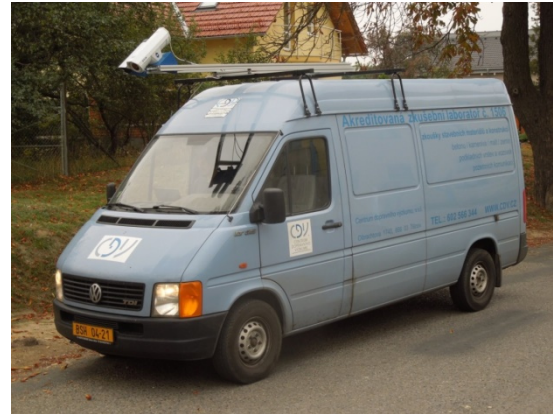
Figure 2. Measuring vehicle with both cameras on roof frame.

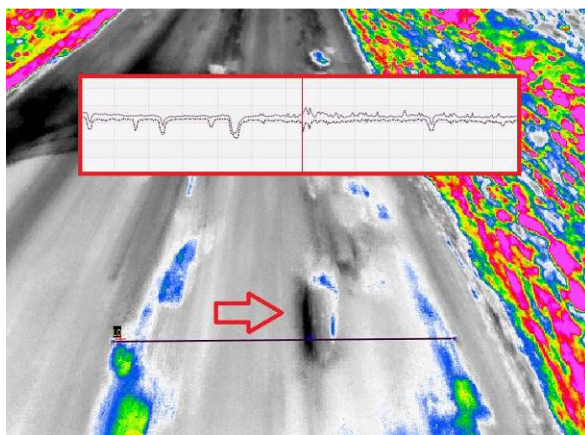
Figure 4. Thermogram of pothole on pavement.

Figure 4 shows a thermogram from the measurement on considerably damaged road pavement. Figure 5 shows a digital camera image from the same spot. The measurement was performed by the measuring vehicle at the speed of 30 km/h. In addition, Figure 4 contains a graph of a temperature course. The upper curve corresponds with maximum temperatures and the lower curve with minimum temperatures in a selected measuring line. The arrow points to a pothole in the road pavement. In that

spot the measured temperature was lower by approx 3 °C (black color). This drop is apparent on the lower temperature curve. The repairs from darker material heat faster on the sun, therefore, they are warmer. They show yellow-green to blue color on the used color palette in the thermogram. The differences on the curve on the left are caused by cooler road surface at the spots which were shaded by roadside trees.

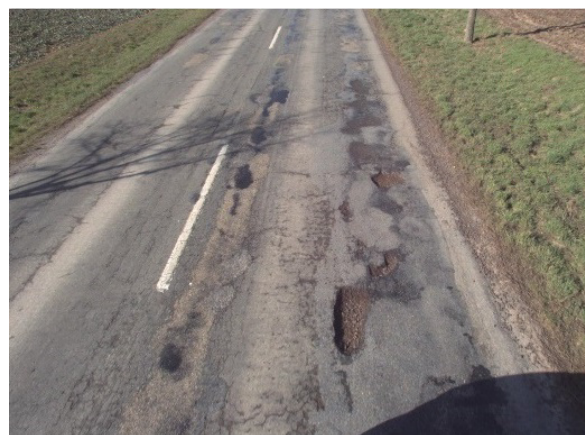
Figure 5. Digital photo of the same pothole on pavement.

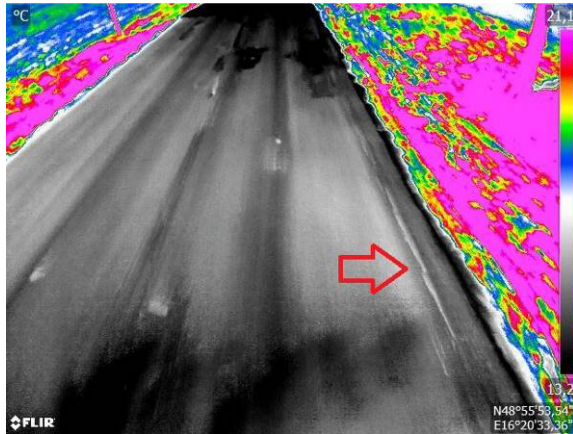
Figure 6. Thermogram of crack on pavement.

The arrow in Figure 6 shows a crack in road pavement recorded by the thermal camera. In comparison with Figure 7 from the digital camera, the thermal camera image makes the crack more apparent.

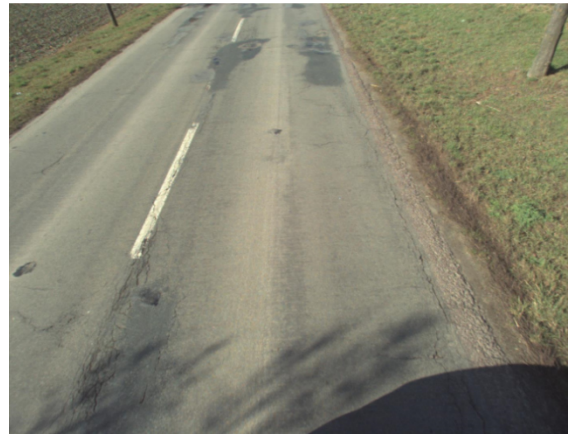
Figure 7. Digital photo of the same crack on pavement.

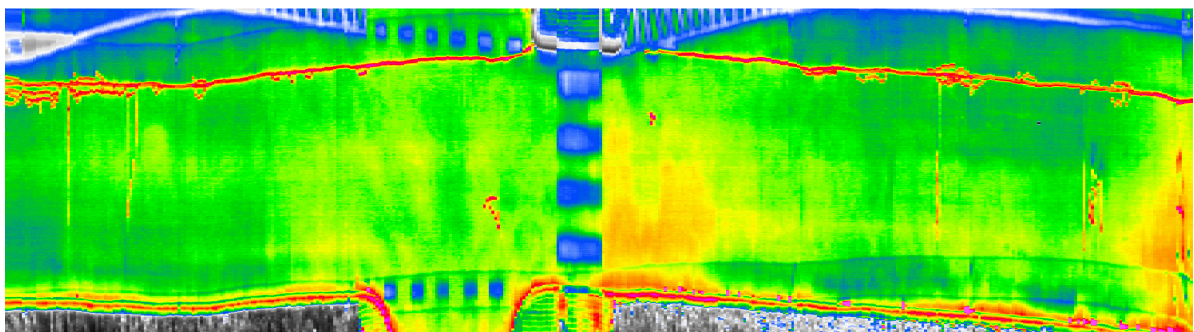
Figure 8. Thermal map of pavement (cross section).

Individual thermograms can be edited and ordered in sequence, which leads to a creation of the temperature map of the measured road pavement. Figure 8 shows an easily distinguishable asphalt filler – irregular red line in the upper part of the image. The filler heats on the sun more than the asphalt road pavement, therefore, it is more apparent thanks to different temperature. Thanks to their white color, road markings reflect heat radiation, thus having lower temperature – it corresponds with blue-white color in the selected color palette in the thermogram.
