A study of tensile residual strength of composite laminates under different patch-repaired series

Abstract. The tensile behavior of composite laminate structures repaired by bonding external patches was studied in the paper. Two different types of patches including wedge patches and inverted wedge patches were used and failure mechanisms, failure load and strength predictions were studied. A convenient and fast method of building 2-D finite element modeling (FEM) of laminate structure repaired was proposed and the strength of repaired laminate structures was calculated by FEM. The results showed that more than 80% tensile strength of the undamaged laminate could be recovered by bonding patch repairs. Moreover, the results indicated that the strength of inverted wedge patches repair were higher than that of wedge patches repair. FEM simulation results indicated that high stress concentration was found along the edges of invert patches and the most weakness part located in the adhesive bondline. FEM analysis results showed that the strength predicted matched well with the test strength.

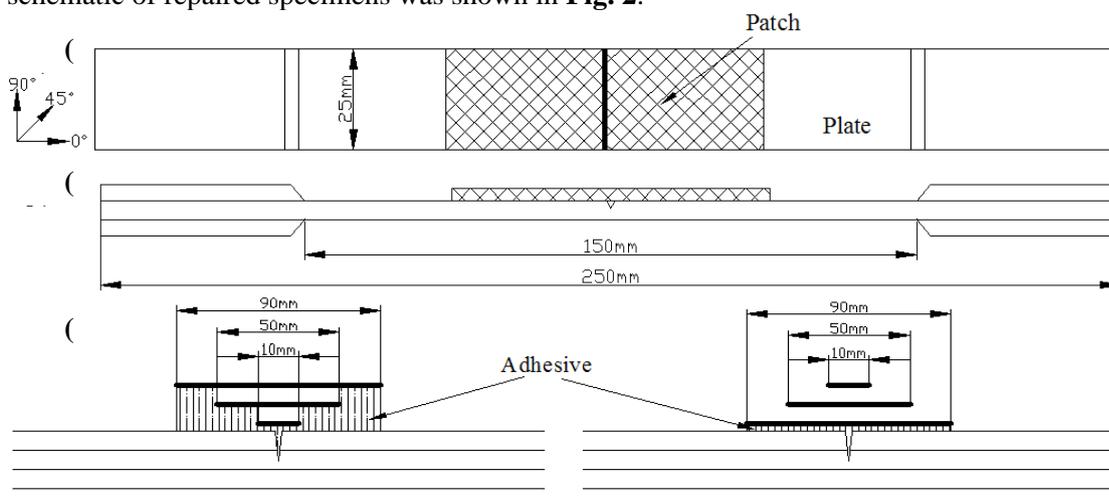
Fig. 2 Test specimens: (a) Front view; (b) Side view; (c) Two different of repaired details

Fig. 2(a) and (b) showed two layers scratch were made in the middle of the specimens ($250 \times 25 \times 0.285n$, n means layers) and then the rectangle patches were used to bond one-sided of the specimen. Beveled Al plates ($25 \times 50 \times 2$ mm) were bonded to each end of the test specimens. All patches for repairing specimens were designed according to following stacking sequence: $[0/0/45]$ and outermost 45° layer increased the impact resistance performance and minimized cracking. After repairing, C-Scans were performed on all of the repaired specimens to evaluate the quality of component repaired. The tensile tests were operated at room temperature on a MTS universal test machine and five specimens were tested for each configuration specimens. The beginning load and the maximum load were set at 0kN and 100kN, respectively. Load speed was 2% of maximum load.

A useful data base on specimens repaired by wedge prepreg patch under tensile loading has been prepared in previous work. [16-19] It showed that the required mechanical performance could be achieved by the repair method of using wedge prepreg patch. This study extended to repair surface damage by inverted wedge prepreg patch and analyze the repairing effect. The stacking sequences of laminates used in this work were followed: [45/0/0/45], [45/0/45/0/45] and [45/0/45/0/45/0/45]. The schematic of repaired specimens was shown in **Fig. 2**.

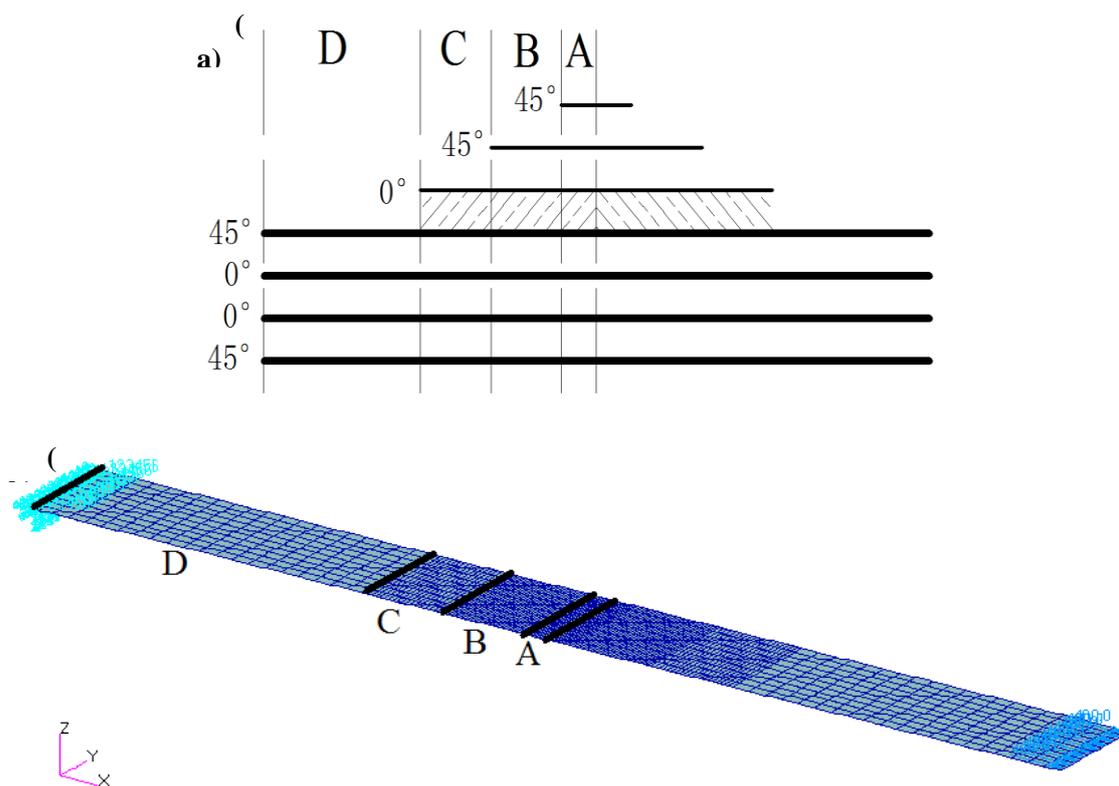
Fig. 3 Finite element model of repaired plate

In this work, a convenient and fast 2-D modeling was built in order to analyze the strength of repaired plates by using MSC.Patran with MSC.Nastran solver. The mesh pattern around the patch was kept very fine in order to capture the high stress and the failure concentration. Boundary conditions were simulated by fixing one end and applying a continuing stage loading in the longitudinal direction at the other. The adhesive bondline was simulated as being isotropic. The patches and the plate were meshed using the Quad-4 node elements. With $[45/0/0/45]$ stacking laminate as example, its symmetrical structure was divided vertically. As shown in Fig. 3(a), A, B, C and D four parts were designed as different stacking layers and the finite element grid connected in turn. The entire model built was shown in Fig. 3(b).

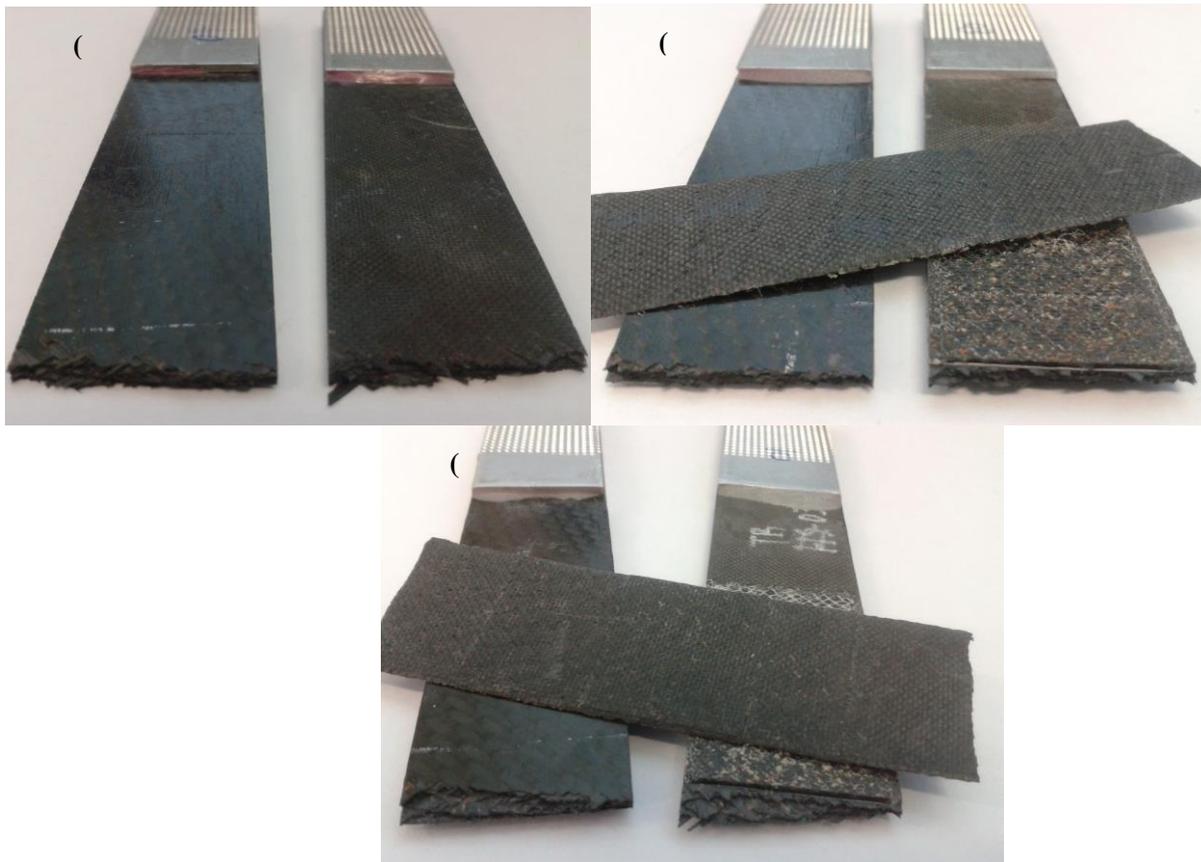
Fig. 4 Photographs of failed specimens: (a) Good specimens; (b) Specimens repaired with Series I; (c) Specimens repaired with Series II

In the experiments, the sound of fiber broken off could be heard. The fracture surfaces were examined by low magnification photography in order to analyze the failure mechanisms of patch repairs. For the undamaged specimens, a large amount of fibre breakage and delamination could be seen near the fracture **Fig. 4(a)**. In addition, it could be observed that fracture located in the weak section of the

plates. The specimens repaired with two different patches were shown in **Fig. 4(b)** and **Fig. 4(c)**. The fibre breakage, delamination and patches separations can be observed in the location of damage plate. Failure process was as follows. ^[10] Firstly, the adhesive was particularly damaged, and then whole patch separated from parent plate under bearing the tensile load which exceeded the maximum shear load of the adhesive. Meanwhile the stress concentrating formed in the location of scratch and scratch extended into deeper section of the laminate, and then final failure occurred.

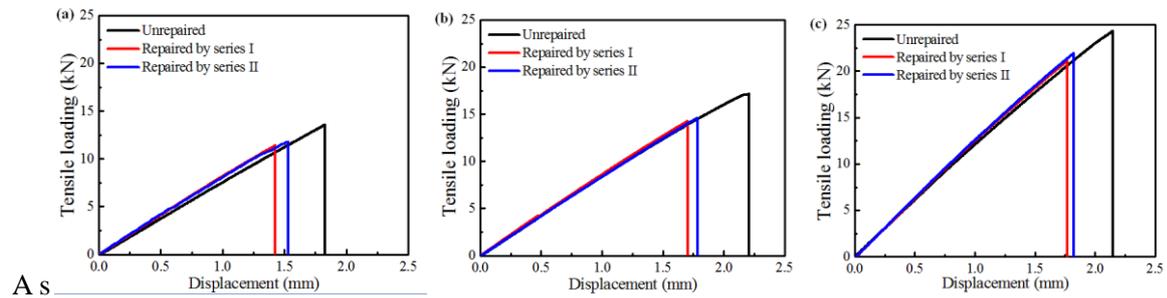
Fig. 5 Load and displacement of specimens: (a) [45/0/0/45]; (b) [45/0/45/0/45]; (c)

Load and displacement curves of specimens with three types of stacking sequences were shown in **Fig. 6** and tensile loads of failure were listed in Table. 2. It could be observed from **Fig. 6** that the strength of unrepaired specimens changed in a linear fashion at different loading and their failure loading were about 13kN, 17kN and 24kN, respectively. For repaired specimens, the similar linear behavior could also be seen before failure. For laminate structure repaired by wedge patch, the upper large patch stacked on the lower small patch, which resulted in the forming of a wedge angle (**Fig. 6**) at the end of pre-patch. When repaired laminate structure bore load, the patch fractured layer by layer, not fractured as a whole, which was fit for bearing large load. However, there was not a wedge angle in invert wedge patch and the loaded repaired laminate structure with invert wedge patch fractured integrally. Thus, the laminate structure repaired by Series II could bear a little higher tensile loading than that of series I. The data listed in **Table. 1** showed the tensile strength of composite laminate repaired by series I and series II methods could recover 80% strength of the undamaged laminate, which indicated that Series I and Series II were used practically in bonding repair.

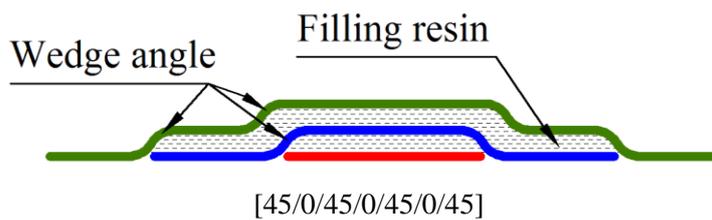
Fig. 6 Wedge angle in wedge patch

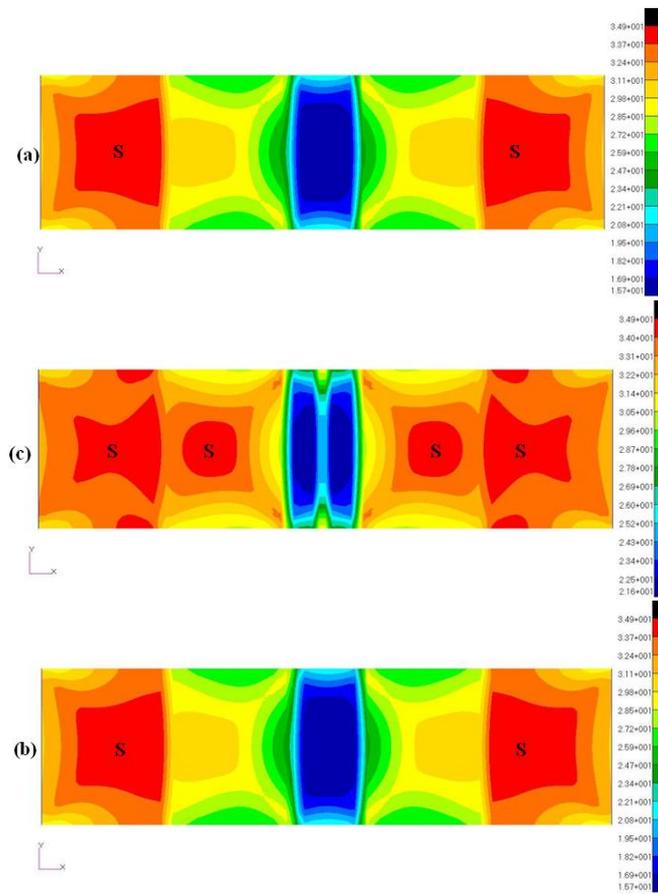
Fig. 7 The maximum stress nephogram of the laminate repaired with wedge patch: (a) 4 layers; (b) 5 layers; (c) 7 layers

The finite element analysis was carried out by applying a 2-D modeling. **Table. 2** gave the prediction of strength value in each modeling. It could be seen that the strength values of repaired modeling were lower than those of the undamaged parent material. According to the phenomenon of the test results, it could be concluded that the adhesive was the weakest part in the repaired structure. For laminate structure repaired, the adhesive strength should be analyzed used the FEM. **Fig. 7** and **Fig. 8** gave the FEM results of the maximum stress of the adhesive bondline.

It could be seen from **Fig. 7** that both ends of adhesive bondline (S area in **Fig. 8**) were the weakest location in the laminate repaired with wedge prepreg patch. The bearing stress extended to the middle part with the increasing in layer thickness and the stress concentration was formed near the damage position. The repaired structure failed when the adhesive bondline reached its maximum bearing stress. It could be seen from **Fig. 8** that the weakest part of the repaired structure with inverted wedge prepreg patch located in the edge of adhesive bondline (P area in **Fig. 8**). The edge stress concentration could be observed in four layers laminate and it decreased with the increasing in layer thickness. The repaired structure failed when the adhesive bondline reached its maximum stress. In a similar study, Liu [20] studied the effects of patch stacking sequences on the fracture process and showed that cohesive damage initiated in the bondline close to the longitudinal patch edges where the stress focused. In addition, patch stacking sequences had a great impact on the strength of laminate. [21]

(2) By analyzing the stress nephogram, patch type affected stress distribution and stress concentration place. The stress focused on the edge of patch by inverted wedge patch repair and it concentrated in the center area along the vertical direction of patch by wedge patch repair.

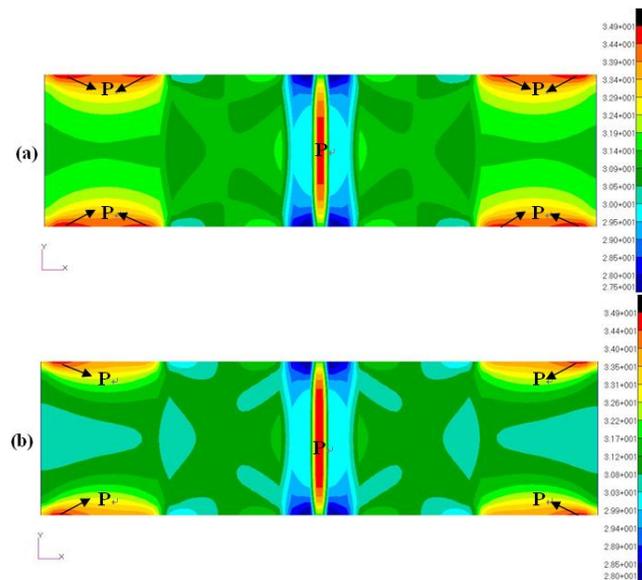
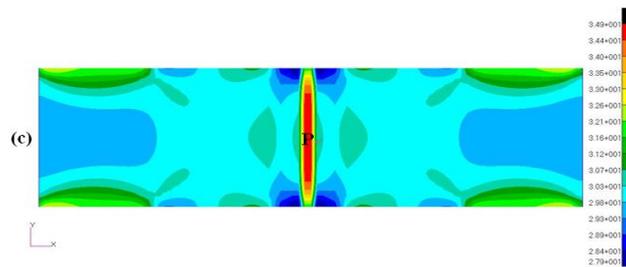
Fig. 8 The maximum stress nephogram of the laminate repaired with inverted wedge patch: (a) 4 layers; (b) 5 layers; (c) 7 layers

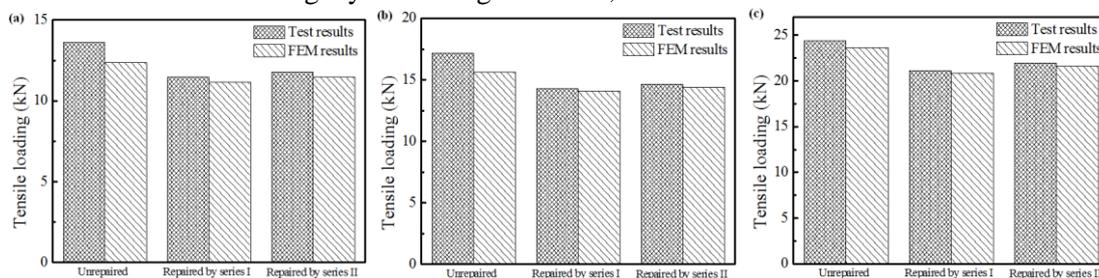
Fig. 9 Compare of the test results with the FEM results: (a) [45/0/0/45]; (b) [45/0/45/0/45]; (c) [45/0/45/0/45/0/45]

The FEM results and the test results are shown in **Fig. 9**. It could be seen that the strength were on the rise with the increasing layer stacking thickness, and the FEM results matched the test results well.
