# Evaluation of Blast Resistance of Fiber Reinforced Composite Specimens under Contact Blast Load

O Janota<sup>1</sup> and M Foglar<sup>1</sup>

<sup>1</sup> Department of Concrete and Masonry Structures, Czech Technical University in Prague, Faculty of Civil Engineering, Thákurova 7/2077, Prague, Czech Republic

**Abstract.** This paper presents results of experimental programme which took place in 2014, 2015 and 2016. Experiments were focused on the resistance of full scale concrete panels subjected to contact blast loading. Specimens were loaded by contact blast by plastic explosive. All specimens were reinforced concrete slabs made of fiber concrete. Basalt mesh and textile sheets were added to some of the experiments for creating more heterogeneous material to achieve better resistance of the specimens. Evaluation of experiments was mainly focused on the damaged area on the contact side and soffit of the specimens. Dependency of the final damage of concrete panels on the weight of explosive and concrete strength was assessed.

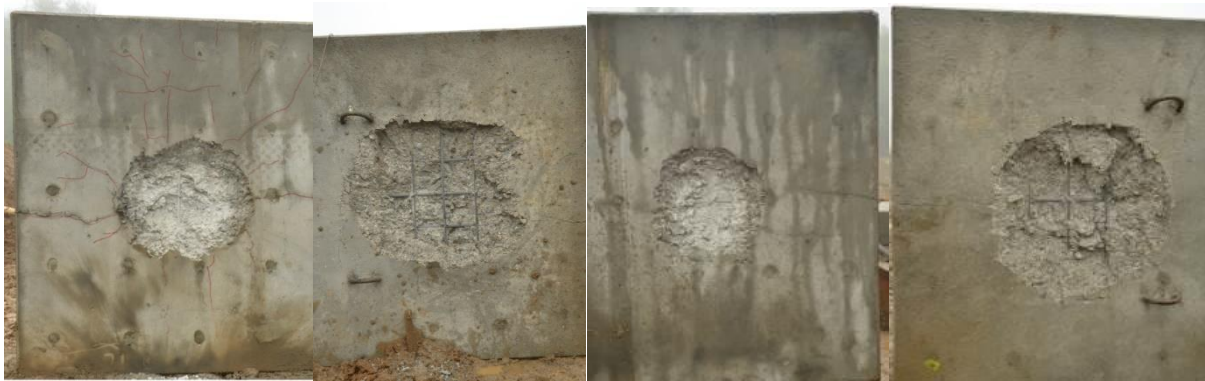
Specimen No. 12 was loaded by explosives of 1.0 kg on the right side and 1.4 kg on the left side. Damage of the specimen on the both sides can be seen in Figure 2. Final damages on the left and right side of the specimen were very similar by its character. Also damaged areas on the contact and soffit of the panel were very similar. The blasts did not achieve puncture of the specimen. On the contact side, the blast damaged area is not deeper than the cover layer. Reinforcement was not damaged by the blast. On the soffit of the specimen, the damage is deeper than the cover layer, but the rebars were not damaged or bent. The damaged area on the soffit was approximately 2.5 times bigger than damage on the contact side. The damaged areas had circular shape on both sides of the panel. Concrete in the perimeter of the damaged area was affected by cracks. Some of the cracks on the left contact side reached edge of the specimen.

**Figure 2.** Specimen No. 12 after contact blast loading, 1.4 kg charge left left contact side, left right soffit, 1.0kg charge right left contact side, right right soffit

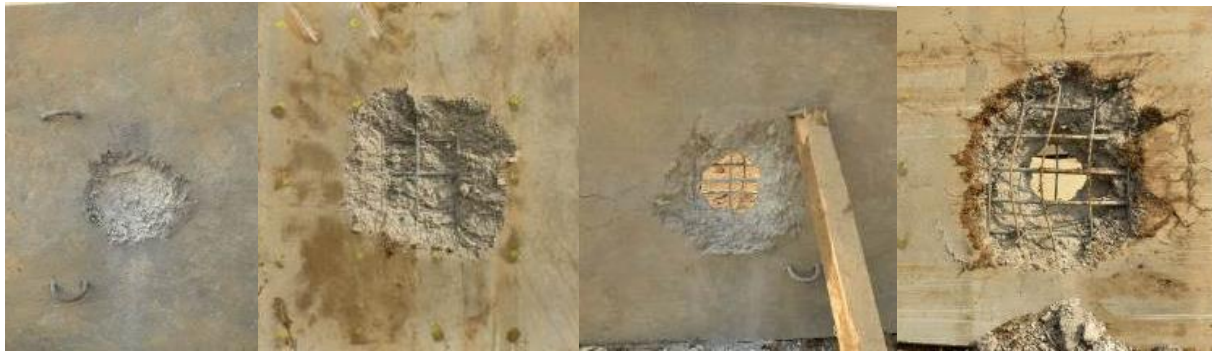
Specimen No. 14 was loaded by explosives with weight 2.8 kg on the right side and 1.4 kg on the left side. Damage of the specimen on the both sides can be seen in the Figure 4. Specimen was punctured through on the right side. Shape of the puncture was circle and was the same as in case of the damaged area of surfaces on both sides of panel. Area of damaged surface on the contact side was approximately 43% of the soffit on the right side and 30% on the left side. There were no cracks on the contact side. The soffit on the right side was strongly disturbed by cracks, left side was not disturbed by cracks. Some of the wide cracks reach edges of the specimen. Cracks were mostly perpendicular to the perimeter of the damaged area.

**Figure 4.** Specimen No. 14 after contact blast loading, 1.4 kg charge left left contact side, left right soffit, 2.8 kg charge right left contact side, right right soffit

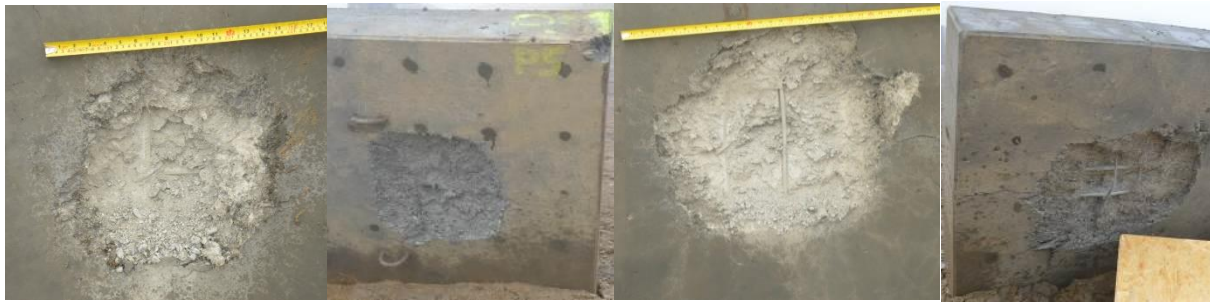
Specimen No. 16 was loaded by explosives with weight 2.8 kg on the right side and 1.4 kg on the left side. Damage of the specimen on the both sides can be seen in Figure 6. Specimen on the both sides was not punctured through. Shape of the damaged area on the contact side was circular, on the soffit it was more similar to the rectangle. Reinforcement on the contact blast was not deformed but the depth of damaged area reach the reinforcement. Steel bars were deformed and bent out of the panel on the right side of soffit, on the left side reinforcement was not damaged. Type of damage was similar to specimen No.15. There was a very dense mesh of microcracks on the contact blast. Cracks on the right side of soffit were wider and some of them reached edges of the specimen.

**Figure 6.** Specimen No. 16 after contact blast loading, 2.8 kg charge left left contact side, left right soffit, 2.0 kg charge right left contact side, right right soffit

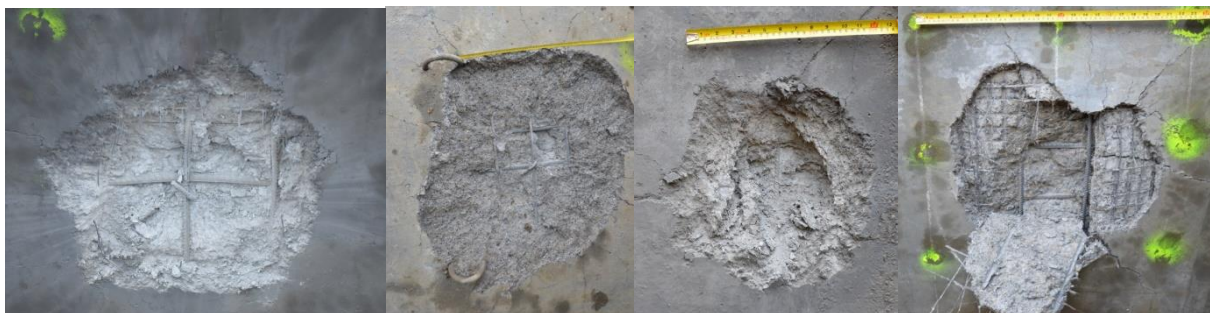
Specimen No. 17 was loaded by explosives with weight 2.0 kg on the right side and 2.8 kg on the left side. One ballast mesh was added into the cover layer. Charge on the left side was placed on the side with basalt mesh in cover layer. Charge on the right side was placed on the opposite side of the specimen. Damage of the specimen on both sides can be seen in Figure 7. Specimen was not punctured on both sides. Damage on the right contact side was similar to the failure due to punching shear but the depth was equal to cover layer. The reinforcement was not damaged. Shape of the damaged area was circular. Area of the damage on the contact side was approximately 65% of the damaged area on the soffit. The soffit was damaged more and the shape of the damaged area was irregular. The type of the failure corresponded with the delamination of the concrete layers. Most of the damaged area was a delaminated layer to the depth of the basalt mesh. Second delaminated layer consists of concrete the depth basalt mesh to the depth of reinforcement bars. Reinforcement on the soffit was practically undamaged. Damage on the left contact side of the specimen was deeper than the cover layer. The reinforcement was unbroken but little bent. Type of the damage was similar to the punching shear failure. Damage area on the soffit was rectangle shape with the depth slightly more than the cover. Reinforcement was only little bent. Soffit side on the left side was not broken into the layers as the right soffit side was.

**Figure 7.** Specimen No.17 after contact blast loading, 2.8 kg charge left left contact side, left right soffit, 4.2 kg charge right left contact side, right right soffit

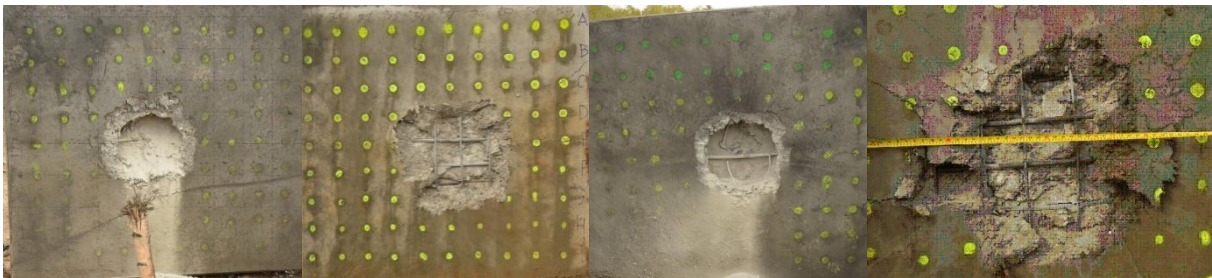
Specimen No. 19 was loaded by explosives with weight 4.2 kg on the right side and 2.8 kg on the left side. Damage of the specimen on the both sides can be seen in the Figure 9. The recycled textile sheets were added to the specimen between reinforcement layers. The specimen was not punctured. Type of the failure on the both sides was similar to the specimen No. 18. On the contact side, it was caused by the punching shear failure, on the soffit by the tension failure. On both sides the depth of the damage was bigger than the cover layer. On the contact side the reinforcement was broken. On the soffit the reinforcement was bent but not broken. Cracks could be seen on the soffit. Cracks are radial to the damaged area. Some of them were reaching edge of the specimen. As well as in the case of No. 17 there was a crack perpendicular to the radial cracks but not continuous.

**Figure 9.** Specimen No. 19 after contact blast loading, 2.8 kg charge left left contact side, left right soffit, 4.2 kg charge right left contact side, right right soffit

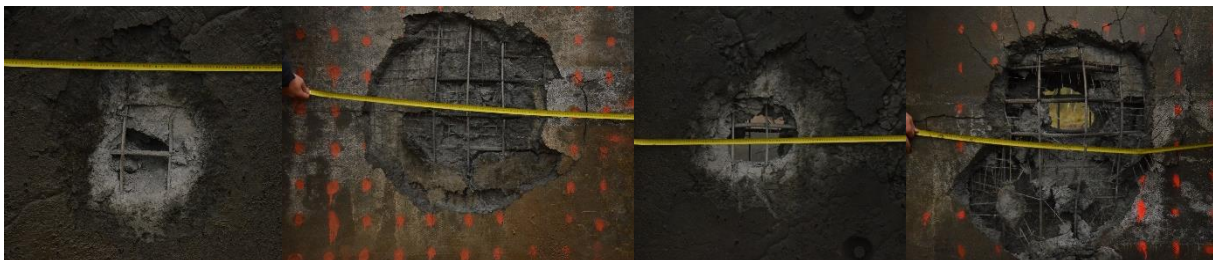
Specimen No. 22 was loaded by explosives with weight 4.2 kg on the right side and 2.8 kg on the left side. Damage of the specimen on both sides can be seen in the Figure 11. Ballast meshes were added into the cover layer in the both sides and between reinforcement. Specimen was punctured through on the right side. Damage on the left and right side was similar in its type. Damage on the contact side and soffit was caused by punching shear failure. Damaged area on the contact side was approximately 55% of the damaged area on the right soffit and 70% on the left side. Reinforcement on the contact side was not deformed. Reinforcement on the soffit is broken and bent out of the panel. On the soffit there was evident delamination caused by adding basalt mesh. As well as in the case of specimen No. 17 the first delaminated layer contains concrete from the surface to the depth of the first basalt mesh. Second delaminated layer was from basalt mesh to the reinforcement. Perimeter of the damaged area was broken by cracks on the soffit.

**Figure 11.** Specimen No. 22 after contact blast loading, 2.8 kg charge left left contact side, left right soffit, 4.2 kg charge right left contact side, right right soffit

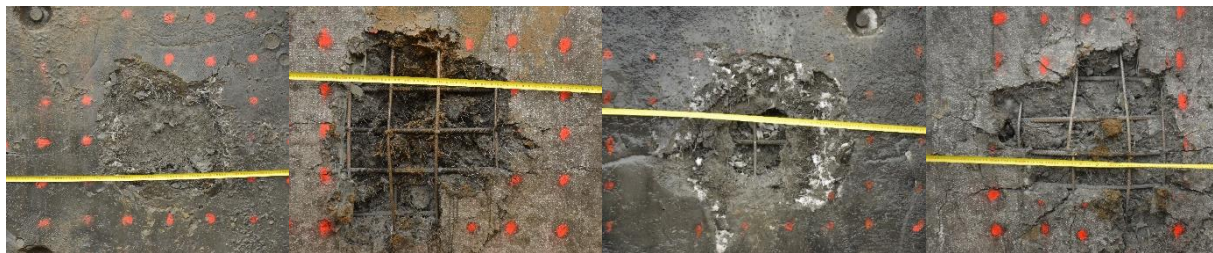
Specimen No. 23 was loaded by explosives with weight 4.2 kg on the right side and 2.8 kg on the left side. Damage of the specimen on the both sides can be seen in the Figure 12. Textile sheets were added to the specimen between reinforcement layers. The specimen was not punctured. On the contact side, it was caused by punching shear failure, on the soffit by the tension failure. On the left contact side damage did not reach the reinforcement. On the rightside damage was deeper than the cover layer. Reinforcement was not damaged. Reinforcement on the soffit was broken on the right and left side. Damaged area on the contact side was approximately 86% of the damaged area on the right soffit and 68% on the left side. Cracks could be seen on the soffit. Cracks are radial to the damaged area. Some of them were reaching edge of the specimen.

**Figure 12.** Specimen No. 23 after contact blast loading, 2.8 kg charge left left contact side, left right soffit, 4.2 kg charge right left contact side, right right soffit
