Ultrasonic examination of concrete with one side access in practice

K. Schabowicz¹, A. Sterniuk², A. Kwiecińska³

Abstract. This paper presents analysis of Ultrasonic tomography as a non-acoustic method for testing concrete. It includes description of theory, measuring equipment, advantages and difficulties which can occur during investigation. The whole content of study part is preceded by a deep survey of the literature. The experimental part consists of description of a study, photos, results and conclusions.

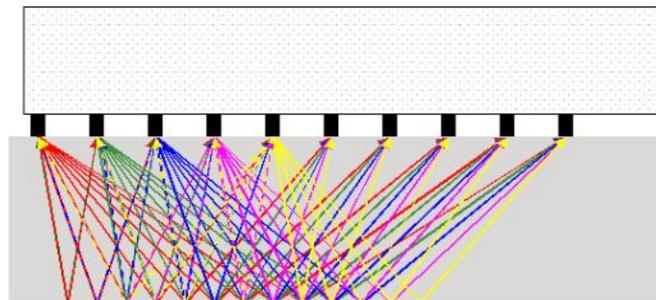
Figure 1. Collecting the data by tomograph A1040 MIRA, [<http://www.acsys.ru/eng/production/detail/a1040-mira/>]

Ultrasonic Tomography is constructed on shear wave pulse-echo technique which is based on exciting an elastic wave in the tested specimen [1, 2]. The excitation source is usually a multi-head antenna (usually a few tens of integrated ultrasonic heads), which is also used for receiving and processing ultrasonic signals as shown in the figure 1.

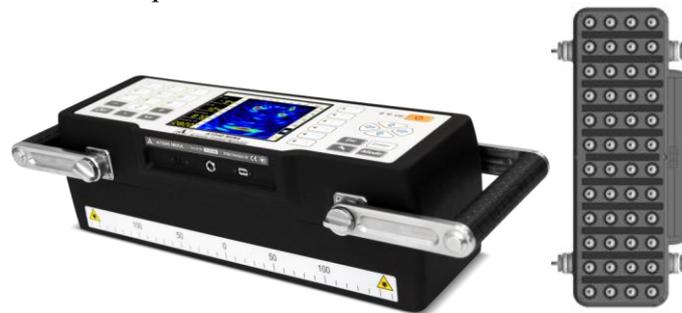
Figure 2. A1040 MIRA Ultrasonic Tomograph: on the left side view, on the right bottom view, [<http://www.acsys.ru/eng/production/detail/a1040-mira/>]

Measuring equipment was invented by Acoustic Control Systems in 2008 and it is called MIRA A1040. It uses automated acquisition of a number of parallel line scans, which allows to build a three-dimensional volume that can be viewed in two-dimensional cross-sections and depth sections with combinational sounding. The device is an autonomous measuring block, which contains a matrix antenna of 48 (12 blocks with 4 elements) low-frequency broadband transverse wave transducers with DPC and ceramic wear-resistant tips.

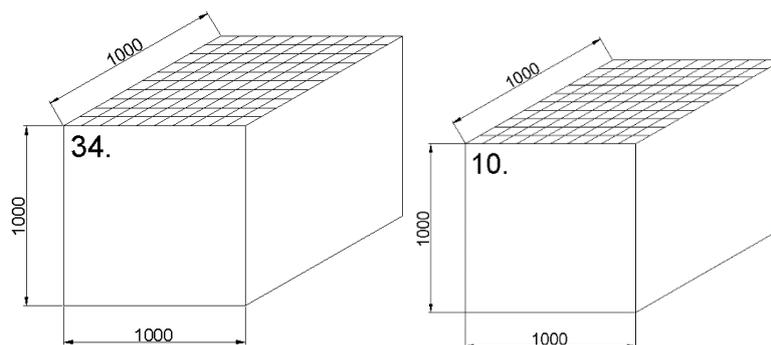
Figure 3. Scheme of probe no. 34 and no. 10 with its dimensions

In experimental part there were tested two probes seen on a figure below. Probe no. 34 and 10 with dimension 1000 x 1000 x 1000 mm are presented in the Fig. 3.

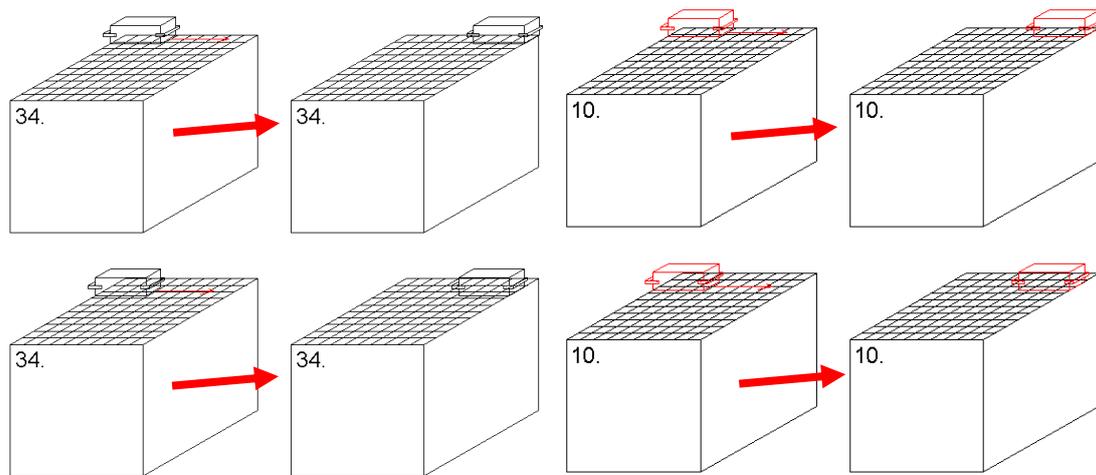
Figure 4. Scheme of testing procedure. Starting with top left image

Probes were tested as in the scheme below. Tomograph with every single scan moved with a distance of a one cell - 100 mm. Starting with top surface of a specimen.

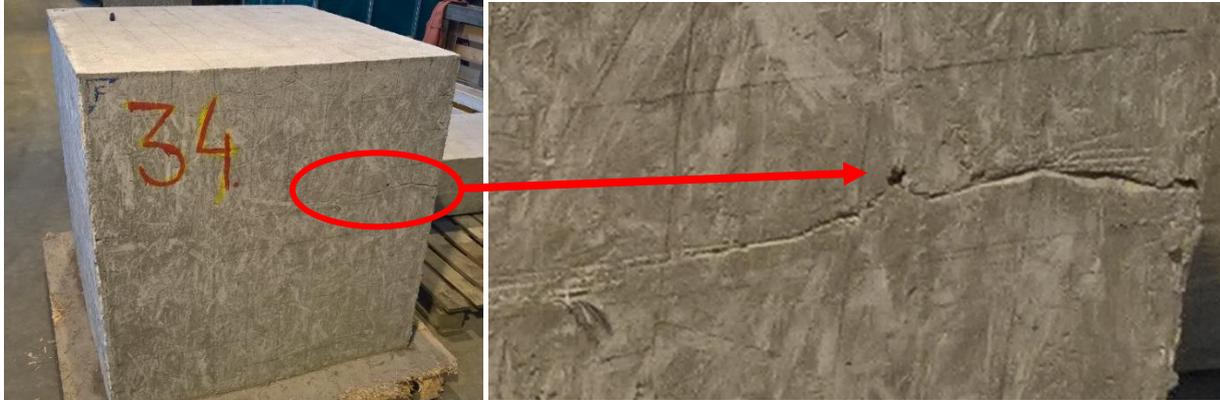
Figure 5. Picture of probe no. 34 and a zoom to longitudinal crack on it

Probe number 34 seen on a figure below in generally has not any deforms or cracks, but on front side of a specimen there is a little longitudinal crack almost in the middle of a height. It may be the signal off inserted supplement into the concrete, however there were no additional information about elements inside the specimen.

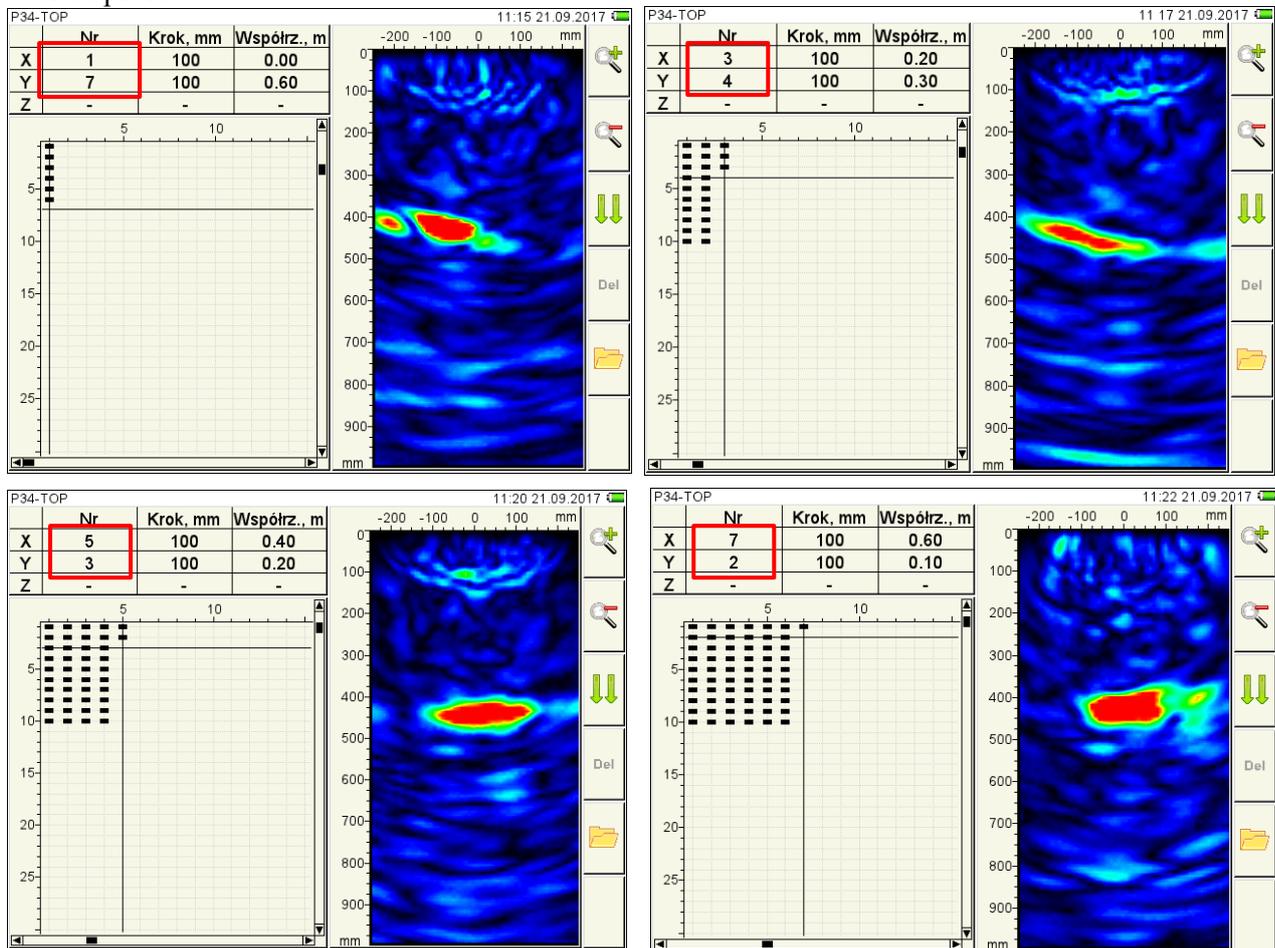
Figure 6. Scanning images obtained from testing top side of a specimen no. 34

From scanning only top side of a specimen we obtain 10 rows – 7 images in one column (1.1; 1.2...1.7 etc.). In all we obtain 70 scanning images. In this example, rows are marked with Y, and columns with X.

In the figure 6. On the image 1-7 which is located in the 1st row at the beginning of tested element we can already noticed reflected wave at the depth of around 420 mm – almost in the middle of specimen's height exactly in the place of a longitudinal crack. The same situation is noticeable in every image for example in the image 3-4; 5-3; 7-2.

At the depth of 5 to 120 mm and 100 to 900 mm there are light spots which might be some kind of air voids, It also can be the effect of badly compacted concrete mix. In exemplary images we can also

noticed air voids marked with a light spots and a reflection at the depth 1000 mm which is the height of a tested probe.

Probe number 34 before testing had visible crack almost in the middle of specimen's height. After scanning top side of a probe there was the same reflection at the comparable depth in every image – from 1st to last row and column. It means that inserted barrier is located at full span and length of a sample. Slightly differences in depth of reflection might mean that inserted block is made with an elastic material, that bends because of a weight of a concrete mix. There are also visible spot lights in different depth of a probe that might be air voids or the cause of badly compacted concrete mix.

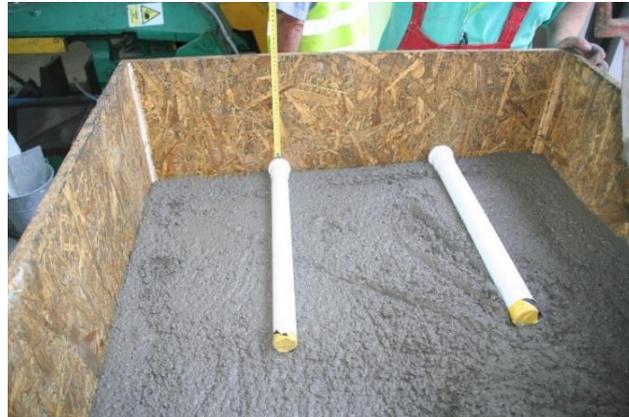
Figure 7. Additional insertions in concrete mix

Picture below presents two pipes located on concrete mix. The length of the tubes reaches almost half of a probe's span. The material they are made of is probably PVC, there are no data if the pipe's

inside is filled with other material. The measuring tape indicates that the top part of a tube is located at depth of around 26 cm. There were no further information about extra supplements in other concrete mix layers.

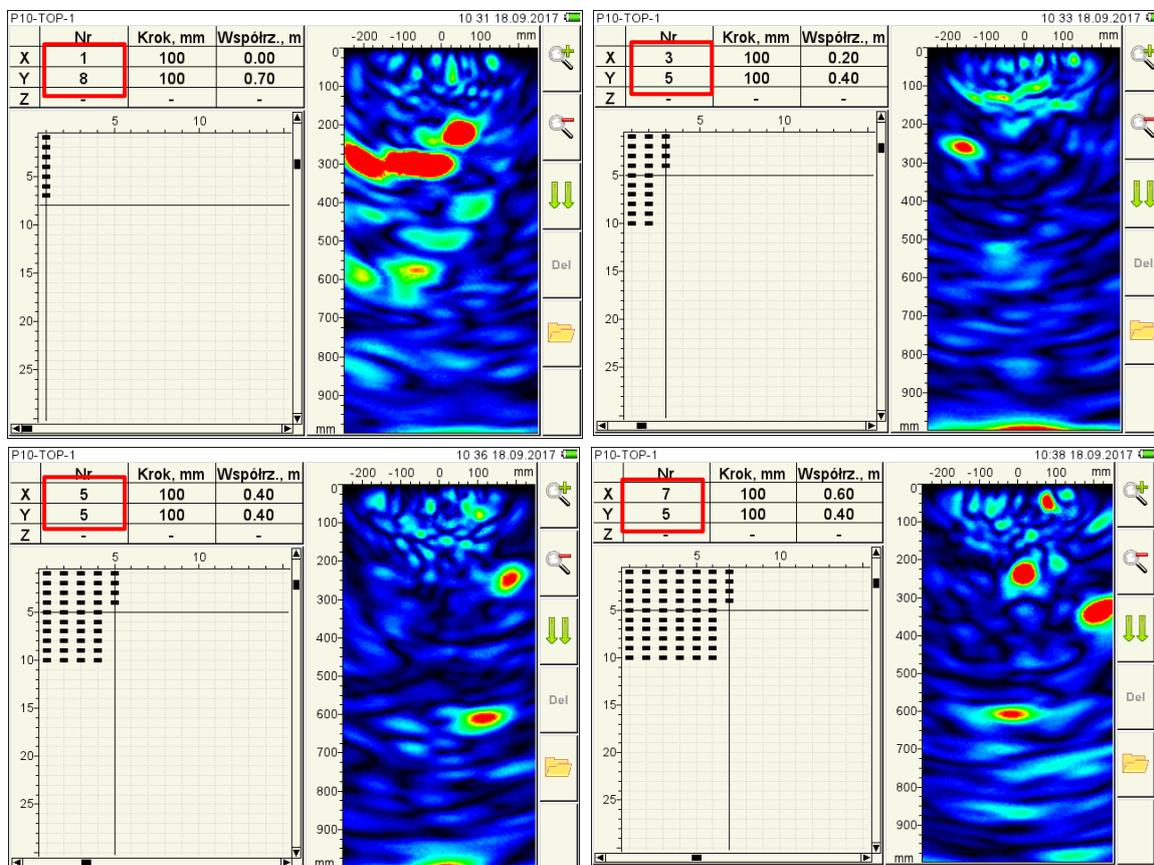
Figure 8. Scanning images obtained from testing top side of a specimen no. 10

Scanning top side gave the amount of 70 images, 10 rows and 7 images in one column (1.1; 1.2...1.7 etc.). In this example, rows are marked with Y, and columns with X.

In obtained images we ought to look at least for two reflections in the upper part of a specimen – around 26 cm from the top edge of concrete block.

In the image 1-8, we can notice many reflections in different places. Knowing the position of two pipes, we can assume that the right part of long and red spot is known inserted element, the left part at the edge of a probe and a red spot above identified pipe is an error reflection. This phenomena occurs when an propagated wave acts on edge of different density element or edge of a probe. Part of a wave reflects [5] on that edge and might be presented in scanning images as a defect, but in a reality it is not existing. This behaviour is called “edge effect”. Presented image 1-8 is located at the beginning of probe’s edge, in the 1st column. In the same image at the depth of around 600 mm there is a light reflection, also in this case the left reflection might be the cause of “edge effect”, but the right reflection at this depth could be the additional insertion. The area of 600 mm depth will be more precisely examine in next scanning images.

In the image 3-5, we can notice the strongest reflection at the depth of 260 mm, it is first inserted pipe, also the light spots at the top of an image might be the effect of a bad compacted concrete mix, some material defects or air voids. Red reflection at the depth of 1000 m indicates the bottom of tested probe.

In the image 5-5 we can see clear echo at the depth of 260 mm it is the second inserted pipe. In this image we can also observe strong reflection at the depth 600 mm, it is possible that there are inserted another two elements under know pipes but in the other layer.

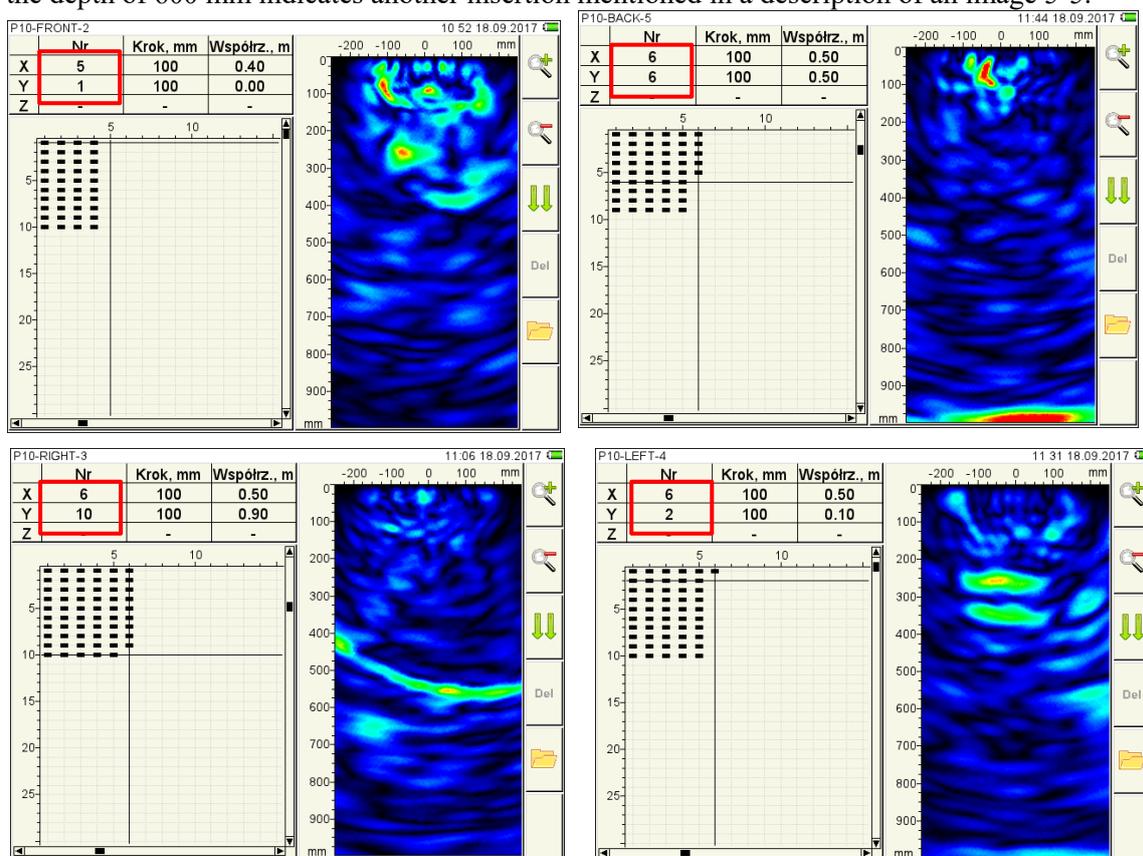
Figure 9. Scanning images obtained from testing a specimen no. 10

In the figure below in the image 7-5, so at the other edge of a specimen we can notice a red spot at the depth of around 210 mm it is seen on an image 5-5 second inserted pipe. The difference in the depth of tube’s localization can be the cause of a diagonal pipe insertion or a tube movement during compacting concrete mix. The red signal on the right might be the effect of “edge effect”, but the echo at the depth of 600 mm indicates another insertion mentioned in a description of an image 5-5.

To conduct more precise testing, probe was scanned in more four directions, which is a front, back, left and right side of a specimen. On each side Tomograph moved exactly in the same way as in the top side. Every side of a specimen was divided into cells, creating a mesh. Tomograph with every single scan was moved with a distance of a one cell - 100 mm. Obtained results are presented in the Fig. 9. Starting with a front side of a specimen, obtained images did not show any interesting reflections, as in the image 5-1, the only light spots occurs in the top part of a concrete block, which might be the effect of a wrongly compacted concrete mix or air voids.
