Monitoring the long-term durability and microstructure of polymer concrete patching materials with high content of secondary raw materials using advanced methods

J Hodul, L Meszarosova and R Drochytka

Institute of Technology of Building Materials and Components, Faculty of Civil Engineering, Brno University of Technology, AdMaS Centre, Veveri 331/95, Brno 602 00, Czech Republic

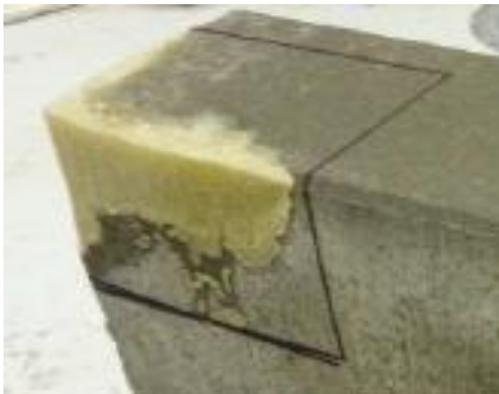
Figure 1. Sample of the PM-E patching mortar for CT Tomography.

3.2.2. CT Tomography. Using special computed tomography (CT) designed for building materials, it was possible not only to observe the microstructure of the test samples, but also to consider the internal structure and distribution of pores and filler. In our case, whether the influence of weathering on the reprofiled part of the concrete curb degraded the polymeric repairing substance was monitored. As a tomographic sample, a cut-off section of the reprofiled corner of the concrete curb was used (see figure 1 and figure 2).

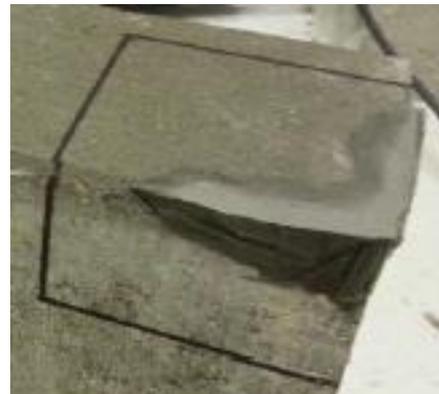
Figure 2. Sample of the PM-P patching mortar for CT Tomography.

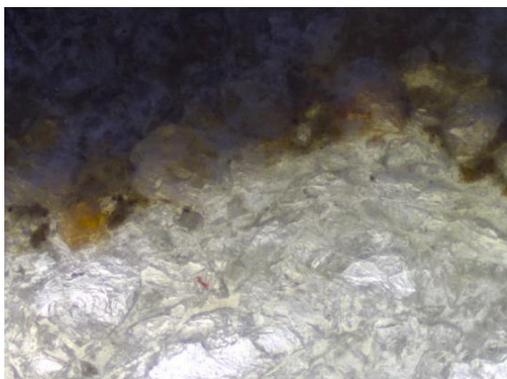
Figure 3. Connection detail of the PM-E reprofiling substance to the concrete base (at the top of the figure) (100x).

4.2.1. *Optical microscope.* From figure 3 and figure 4, it is evident how the epoxy resin, due to its low viscosity, flows into the porous structure of the underlay concrete and thus creates a strong connection at the contact zone. This is very important to ensure good adhesion of the reprofiled mortar to the underlay. The PM-P sample in figure 4 is not sufficiently transparent for viewing in transmitted light, but the interface is visible very well, even in incident reflected light. The figure shows the PM substance in the left lower part, and it is obvious that it is very well grounded in the underlying concrete. In the microscopic observation of the PM-E sample surface (figure 3), it is possible, with transmitted light, to observe in detail the interface of the existing concrete underlay (at the top of the figure), and the polymer concrete patching mortar, due to its high transparency. Furthermore, it is possible to observe the perfect anchoring of the reprofiling substance into the concrete underlay.

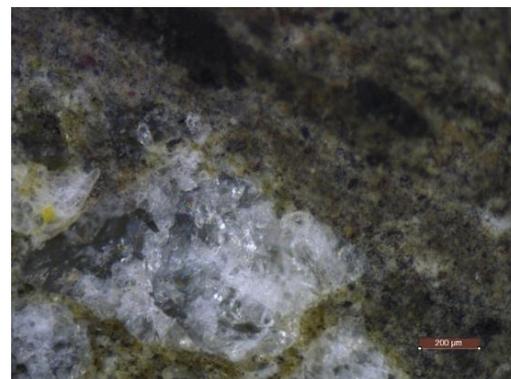
Figure 4. Connection detail of the PM-P reprofiling substance (in the lower left part) to the concrete substrate (100x).

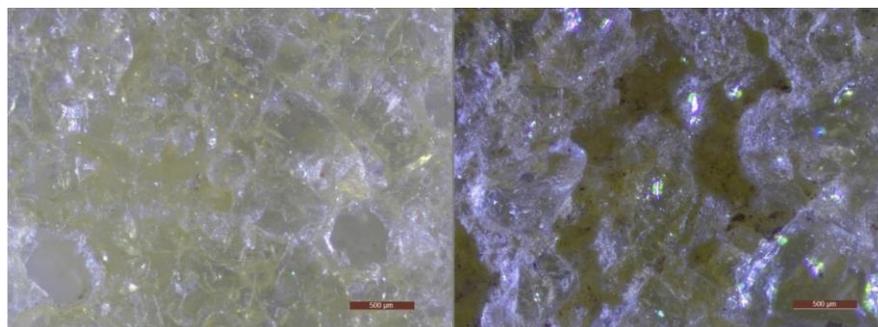
Figure 5. Surface detail of PM-E sample – left sample intact by sunlight (UV rays), UV affected surface can be seen in the right image (50x).

Figure 5 clearly shows the perfect coating of glass shards in an epoxy matrix, which is slightly yellowish. The micrograph in the figure 5 right shows the degradation effect of UV radiation, which affected the applied substance as a result of the exposure of the reprofiled curb to weather effects. Due to the effects of solar radiation, the epoxy matrix decreased slightly as a result of photooxidation (macromolecule breakdown by UV radiation).

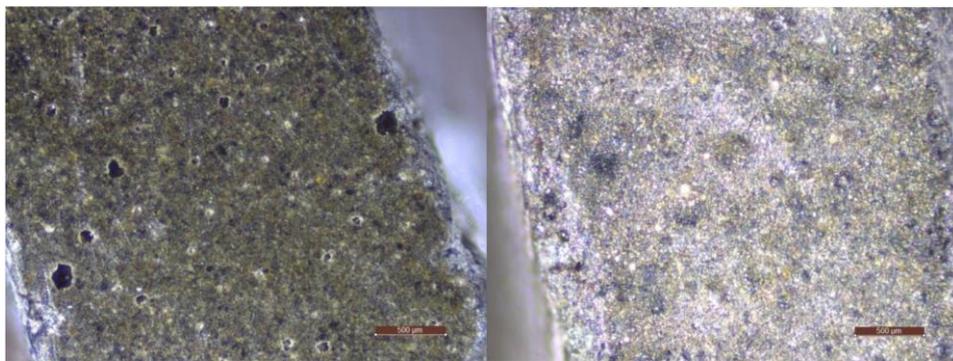
Figure 6. Surface detail of PM-P sample – left sample intact by sunlight (UV rays), UV affected surface by photooxidation can be seen in the right image (50x).

Figure 6 on the left shows the microstructure of the PM-P substance surface, where it is possible to observe the uniform distribution of fly ash grains (cenospheres) in the epoxy matrix. In figure 6 on the right, it is possible to observe the apparent change in the surface of the substance due to photooxidation; this is a sample that has been subjected to weathering for 300 hours. From the microscopic analysis, overall, the results indicate that the effect of atmospheric influences does not produce micro-cracks or the separation of substances from the concrete underlay.

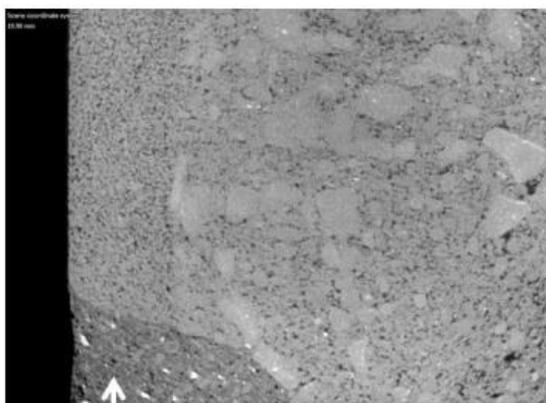
Figure 7. Internal structure of the PM-E substance (indicated by arrow) and detail of connection to the concrete curb.

4.2.2. CT Tomography. From a computer tomography (CT) observation (see figure 7 and figure 8), it can be concluded that the patching mortar is compact in both variants on overall cross-section, shows no cracks, tears or higher porosity or separation of the repairing substance from the underlay, compared to the comparative REF samples. Due to the appropriate viscosity, the substance is firmly anchored to the underlay. Additionally, the PM-P substance had a denser and more compact structure compared to the PM-E substance, which can be said to have higher strength and better long-term durability.

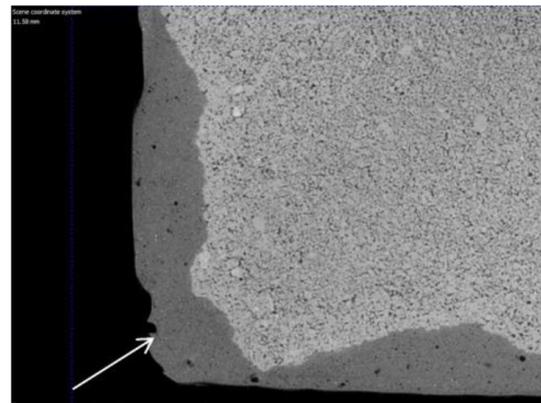
Figure 8. Internal structure of the PM-P substance (indicated by arrow) and detail of connection to the concrete curb.
