Comparative study of assessment the tanker ship behaviour in damage stability situations

C Andrei and R Hanzu-Pazara

Constanta Maritime University, Faculty of Navigation and Naval Transport, 104
Mircea cel Batran Street, Constanta, 900663, Romania

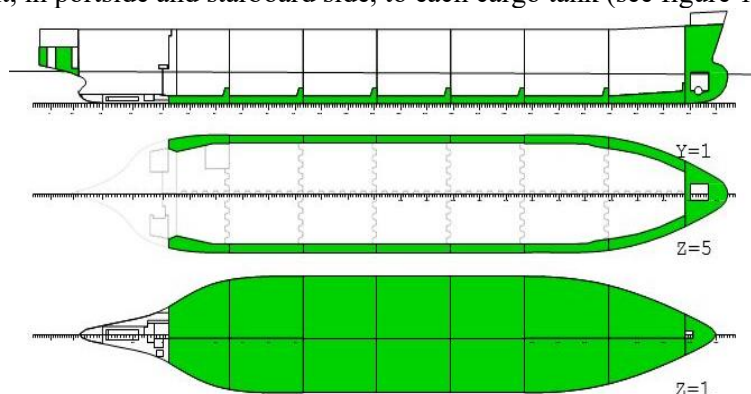
The ship has fifteen cargo tanks comply with the MARPOL 73/78 Annex II requirements for the carriage of pollution category X, Y, Z and OS substances. Water ballast tanks (green colored) are positioned adjacent, in portside and starboard side, to each cargo tank (see figure 1).

Figure 1. Ballast and cargo tanks arrangement.

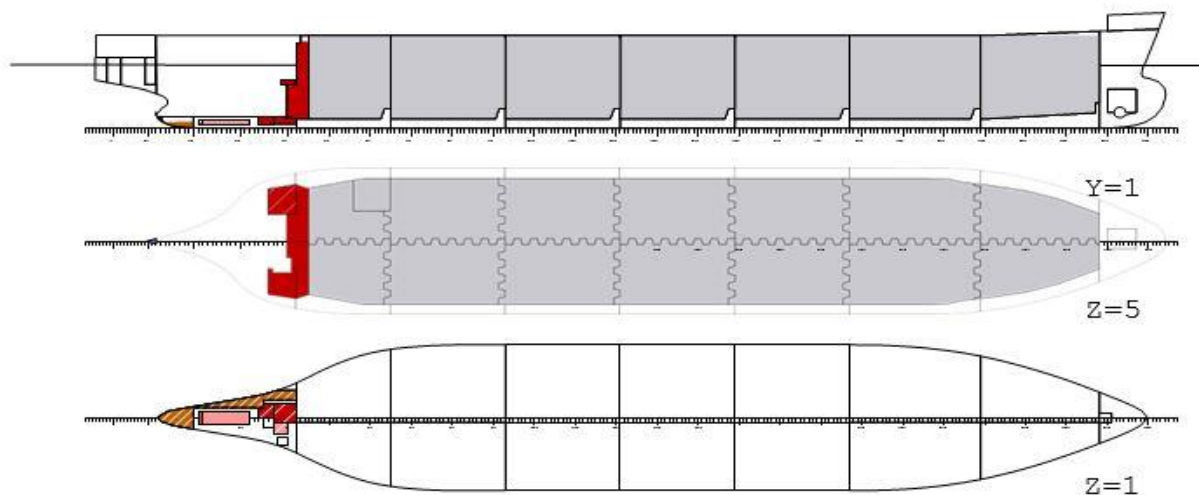
In the above damage situation, the vessel was considered in full loading condition (see figure 2) and the ship's hull was affected in the region of ballast tanks no.1, 2 and 3 portside (see figure 3).

Figure 2. Loading condition of ship in damage situation no.1.

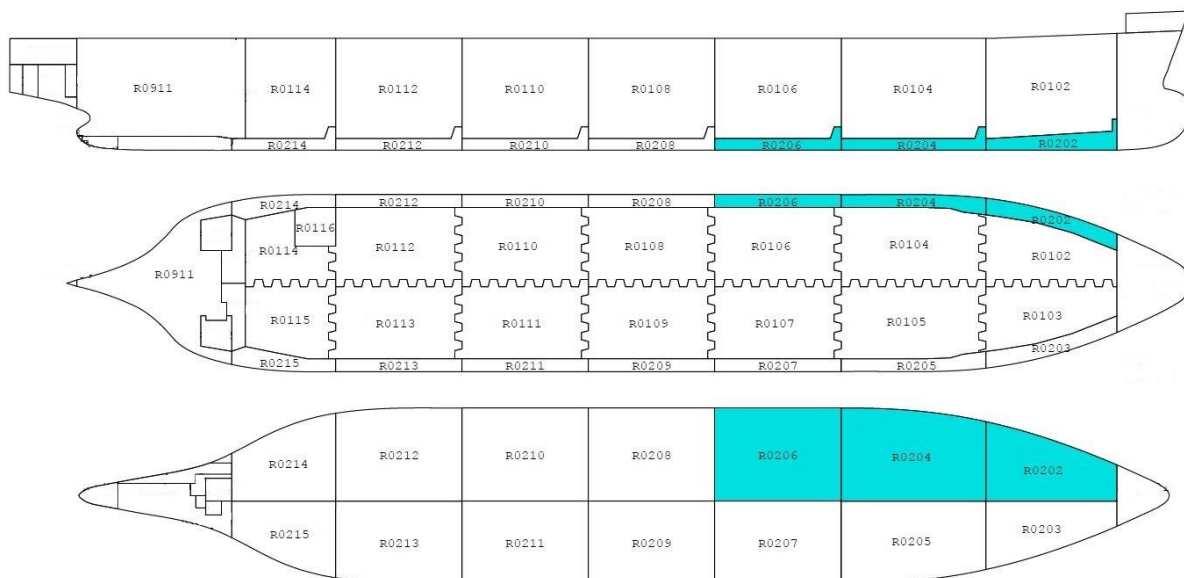
- Longitudinal extent: $0.4L$ measured from forward perpendicular, $0.4L=0.4 \times 177.028=70.811$ m
- Transverse extent: $B/3$ anywhere in the bottom, $B/3=27.4/3=9.133$ m
- Vertical extent: breach of the outer hull.

Figure 3. Compartments affected in damage situation no.1.

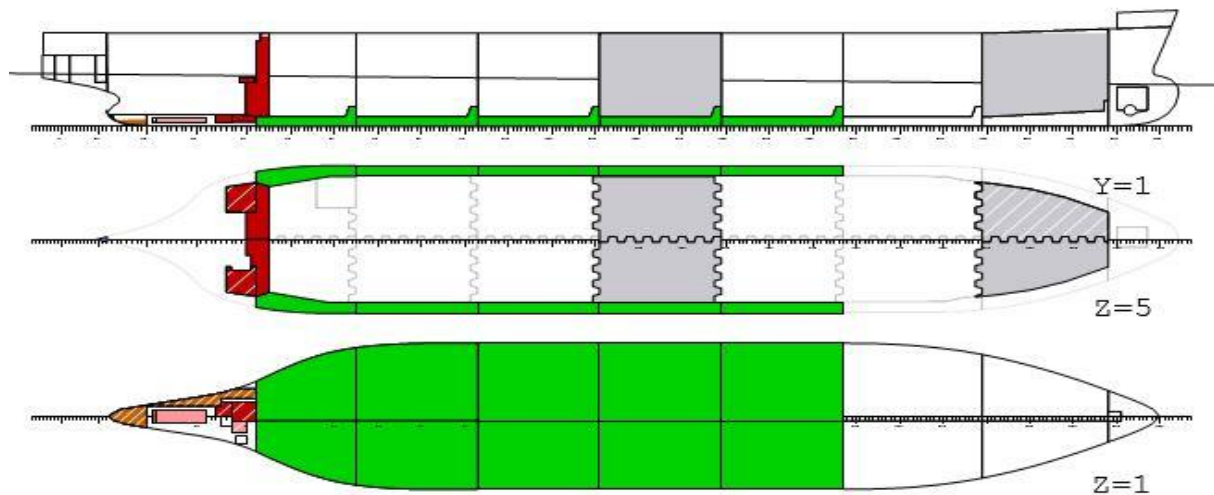
In this damage situation, the vessel was considered loaded in cargo tanks no.1 and no.4 (see figure 4) and the ship's hull was affected in the region of ballast tanks no.2 and 3 portside and cargo tanks no.2 and 3 portside (see figure 5).

Figure 4. Loading condition of ship in damage situation no.2.

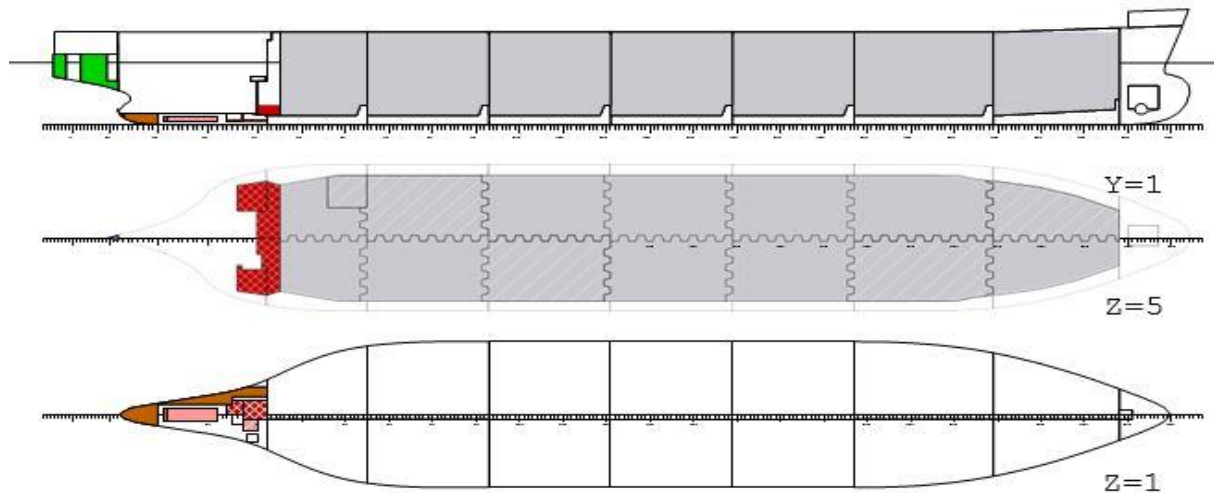
In this damage situation, the vessel was considered in full loading condition (see figure 6) the ship's hull was affected in the region of engine room bottom, engine room above bottom and steer gear room (see figure 7).

Figure 6. Loading condition of ship in damage situation no.3.

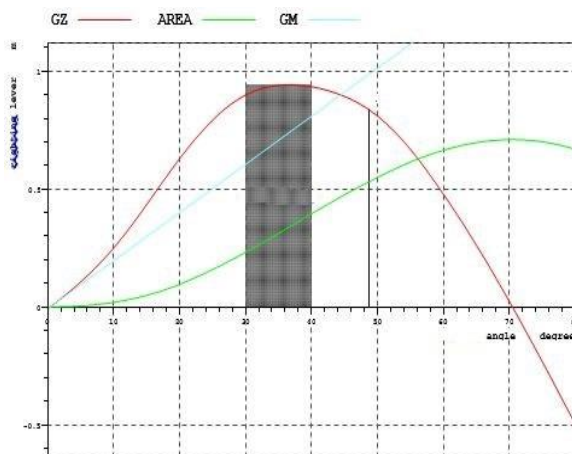
Figure 8. Righting lever curve prior damage situation no.1.

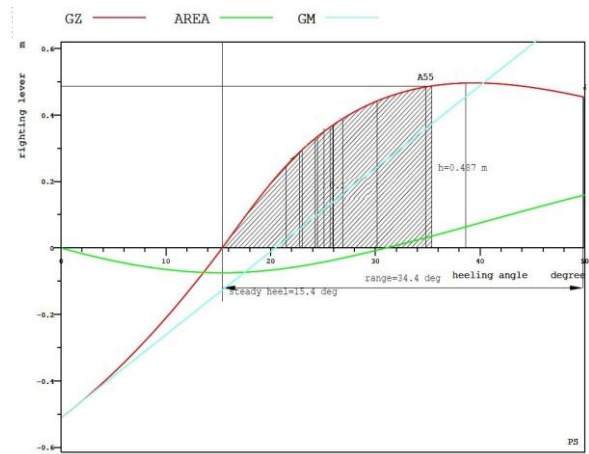
Requested	Calculated	Status	Min GM
Maximum heel	< 25 deg	15.374 deg	OK	0.347 m
Range of positive GZ	> 20 deg	34.441 deg	OK	0.441 m
Maximum GZ to be at least 0.1 m within the 20 deegreed range	> 0.1 m	0.487 m	OK	0.487 m
Area under GZ curve within 20 degrees	> 0.0175 mrad	0.111 mrad	OK	0.440 m

Figure 9. Righting lever curve for damage situation no.1.

- The metacentric height after flooding, for the maximum heeling angle decreasing considerably, especially for damage situations where the vessel was in full loaded condition (up to 70% in damage situation no.1 as illustrated in table 3 and up to 49% in damage situation no.3, as illustrated in table 7). This is the result of the effect of free surfaces, which generates a vertical virtual raise of ship's centre of gravity.
- Area under GZ curve within 20 degrees was decreasing up the values close to lower limits, especially for the damage situation no.3. This is the result of decreasing the restoring moment for small angles of inclination generated by the small values of metacentric height and implicitly of righting arms.

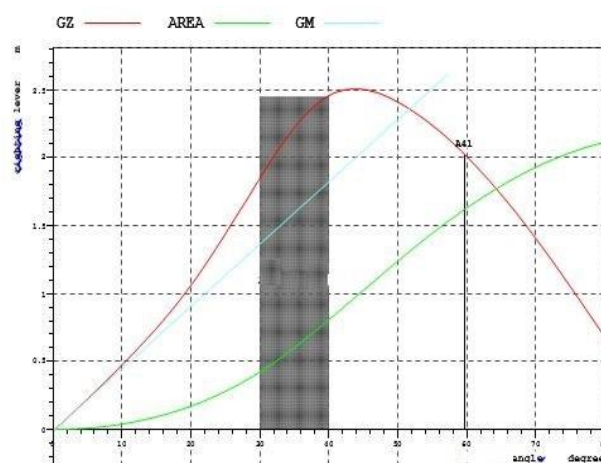
Requested	Calculated	Status
Area under GZ curve up to 30 deg.	0.055 mrad	0.423 mrad	OK

**Figure 10.** Righting lever curve prior damage situation no.2

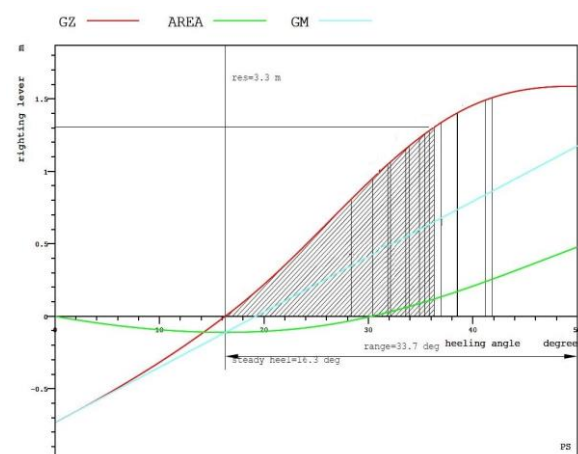
Requested	Calculated	Status	Min GM
Maximum heel	< 25 deg	16.297 deg	OK	1.288 m
Range of positive GZ	> 20 deg	33.703 deg	OK	0.779 m
Maximum GZ to be at least 0.1 m within the 20 degree range	> 0.1 m	1.304 m	OK	0.512 m
Area under GZ curve within 20 degrees	> 0.0175 mrad	0.229 mrad	OK	0.518 m

**Figure 11.** Righting lever curve for damage situation no.2

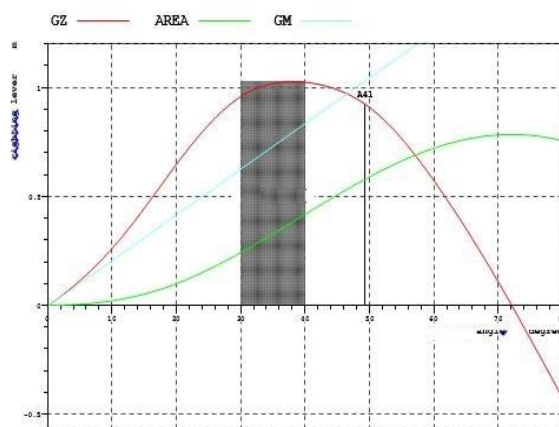
**Figure 12.** Righting lever curve prior damage situation no.3.

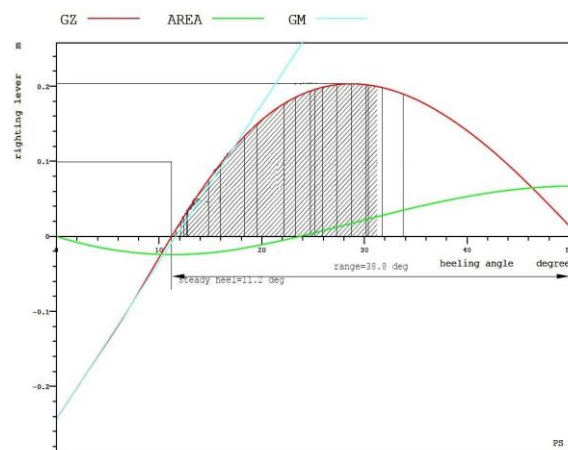
Requested	Calculated	Status	Min GM
Maximum heel	< 25 deg	11.226 deg	OK	0.734 m
Range of positive GZ	> 20 deg	38.774 deg	OK	0.889 m
Maximum GZ to be at least 0.1 m within the 20 deegred range	> 0.1 m	0.203 m	OK	0.979 m
Area under GZ curve within 20 degrees	> 0.0175 mrad	0.051 mrad	OK	0.910 m

**Figure 13.** Righting lever curve for damage situation no.3.
