Damage stability analysis in particular flooding situations of a multipurpose cargo ship

Abstract. Flooding of ship compartments is a very common event resulted from ships involvement in marine accidents, such as collision, grounding or structural breakdown. Once ship compartments are flooded to an extended level, the transverse stability starts to be affected and if the situation becomes dangerous, it can become critical or failing beyond the lower threshold values. In this damaged situation, a proper and accurate calculation and assessment of stability is very important. Calculation of damage stability for flooding situations is a very important subject for those who work in design and operation of ships. However, the subject was treated extensively in respect of tanker ships and less in respect of multipurpose cargo ships. The aim of work presented in this paper is to highlight some particular situations of flooding of compartments on board a multipurpose cargo ship when the stability parameters are decreasing enough so that fails to comply with recommended criteria. The particularity of the study for this type of ships came from the fact that they are fitted with large box typ

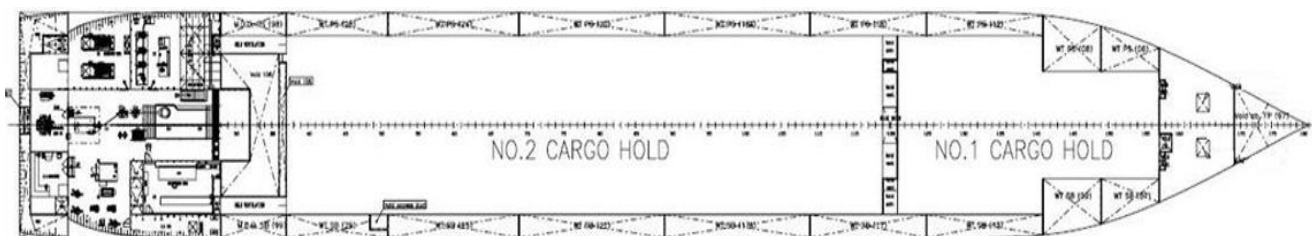
Vessel is fitted with seven pairs of double bottom ballast tanks and eight pairs of side ballast tanks (see figure 1).

Figure 1. Illustration ship's cargo holds and ballast tanks arrangement.
