In-situ structural health monitoring of glass fiber reinforced composites by tufted reinforcement

Abstract. Through-the-thickness reinforcement (TTR) techniques have been increasingly applied to fiber-reinforced polymer composite laminates to reduce the issues caused by the weak out-of-plane properties which can reduce significantly their load-bearing capacity. The present work investigates the electrical response of carbon tuft threads as reinforcements of GFRP omega stiffened panel. Besides the mechanical contribution of the tuft reinforcements to the composites structures, this study focuses on the evaluation of the electrical response on the tufted yarns as a means of monitor the structural health. The first studies consisted of evaluating GFRP composite laminate plates reinforced with carbon tufts by means of the electrical response through tufts to damage generated by multiple low-velocity impacts. Once the tufts exhibited their ability to respond continuously while increasing damage, pull-off mechanical tests were performed in the omega stiffeners assisted by electrical resistance measurements as well as acoustic emission (AE) and Digital Image Correlation (DIC). The result

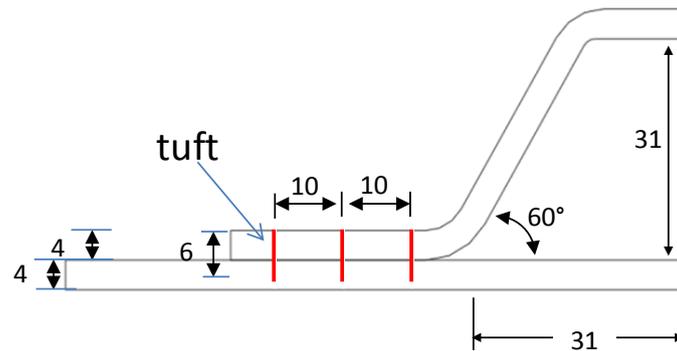
Figure 1. Schematic illustration of the final dimensions of the omega stiffened composites.

Non-crimp fabrics (NCF) made with unidirectional layers of glass fiber tows (0/90) and areal density of 600 g/m² were employed to manufacture the omega stringers. The structure layup consisted of $[0]_{10}$ to the stiffener and $[0]_{12}$ to the skin part. The dry preforms were reinforced by tufting with carbon/PBO threads following the weft direction and stitch pitch of 7 mm. VARTM process was also employed with EPOLAM 5015 resin system by maintaining the same parameters of cure cycle as described for the plates. The tufts position and dimensions of the molded specimens are exhibited in Figure 1, with specimens width of 30 mm prepared to pull-off tests.

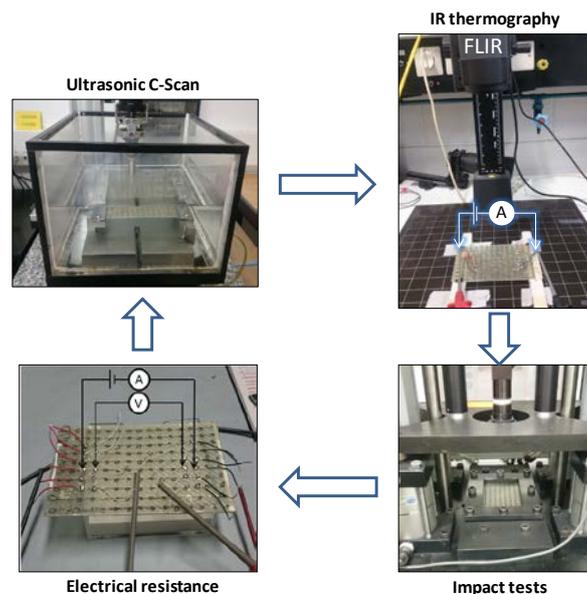
Figure 2. Experimental procedure employed to the investigation of the electrical resistance response before each impact loading

The laminated composite plate was manufactured to evaluate the feasibility of the carbon threads to respond to the damages created by multiple impact tests. Therefore, they have been submitted to various impact loading with energies of 5J, 5J, 10J and 10J so as to create the progressive damage. It was performed by Instron Dynatup 9250HV drop-weight impact machine, using a hemispherical indenter of 50.8 mm diameter and weight impactor adjusted to 14.2 kg. The electrical resistance of the tuft rows (6 tufted lines in the middle of the specimens) was measured before each impact test by using 4-wire sensing to perform more accurate response. The external points (pairs of current-carrying) injected a controlled direct current of 1mA while the internal points (voltage-sensing electrodes) each one placed 10 mm from the external probes, measured the electrical resistance. Moreover, a specific analysis consisted to evaluate the damaged area and heat dissipation before the impact loadings. The heat dissipation was investigated by the infrared camera during the current injection of 400mA between the 6 tuft rows in the middle of the specimen. The damaged area was characterized by C-Scan technique, scanning a zone of 50 mm x60 mm (width x length) centralized in the impact point via ultrasonic. The steps utilized for this approach are shown in Figure 2.

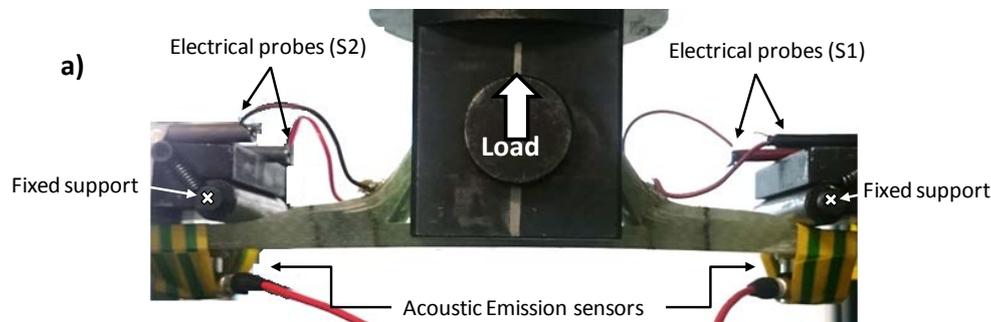
Figure 3. Pull-off test setup showing the electrical probes and AE sensors

The pull-off tests were carried out at a constant cross-head displacement speed of 1 mm/min. Two fixed rolls (10 mm diameter) were placed 74.5 mm distant from the longitudinal center of the samples and in contact with the skin top surface. The single roll (20 mm diameter) equidistant from the fixed rolls was placed in the bottom surface of the stiffener for loading the structure. The tests were monitored by DIC to evaluate the strain fields in the critical zone of the omega stringer from both sides of the contact flange/skin throughout the loading history and correlated with the software VIC 2D[®]. The subset and step size employed in the image correlation were 21 and 3 respectively. The AE analysis was also performed for monitoring damage events from the acoustic signals. The signal acquisition was carried out with two wideband sensors (Micro80 - 200-900 kHz) longitudinally positioned on the bottom side of the skin from 80 mm to the center. Furthermore, two-wire measurement was employed to acquire the resistance from both sides of the omega structure by using digital electrometers. Figure 3 exhibits the test apparatus for investigating the omega stringers under pull-off loading and its schematic illustration (symmetrical to the longitudinal center of the sample).

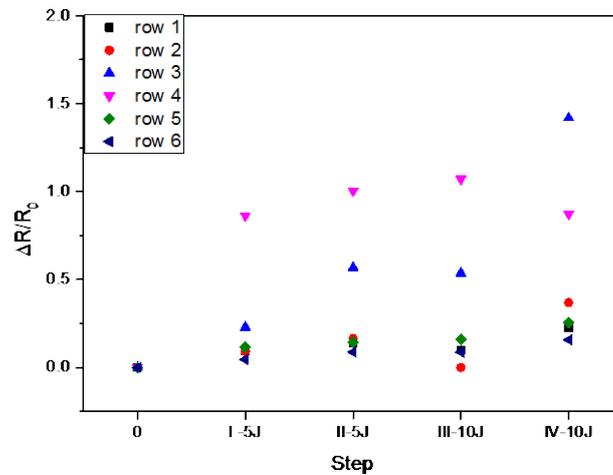
Figure 4. Electrical resistance measurements through different tuft rows before every impact test on the composite plate.

Figure 4 presents the results of electric resistance obtained before every impact tests to the 6 central tuft rows in the laminated plates. It is remarkable the significant increase of the row 3 and 4 are especially due to their proximity to the impacted zone. The line 4 was exhibited a important increase from the first impact test of 5J energy while line 3 increase gradually its electric resistance. The other rows also responds to impact damages generated during loading even if their response are weaker in comparison to the aforementioned tufts. Furthermore, they present a gradual increase of electric resistance from outside (row 1 and row 6) to inside rows (row 3 and 4), which is related to damage development in impact tests. A comparison between the analysis by C-Scan and infrared thermography (IRT) acquired before and after step III and IV impact tests is shown in Figure 5. The rise on amplitude of C-Scan images is mainly seen from the step III and IV (Figure 5a) and consists of significant damages created in the plate by impact loadings. The events are also reported by spots (rows 3 and 4) in IRT images (Figure 5b) concerning the heat concentration as a consequence of the damages generated during impact in the tufts. These damages difficult the current flow and therefore increase the heating in the specific region. This approach enables monitoring the health of tufts. Once that tufted threads are essential to the out-of-plane properties of laminated composites, monitoring their health may also be important for analyzing the state of health of the tufted structures.

The electrical method as employed in this investigation can also validate the manufacturing process by evaluating the electrical resistance of the tufts. A tuft which presents a significant deviation from the mean value of resistance may have had issues during tufting process, as incomplete insertion of the tuft, unloosening, or significant damage on the thread.

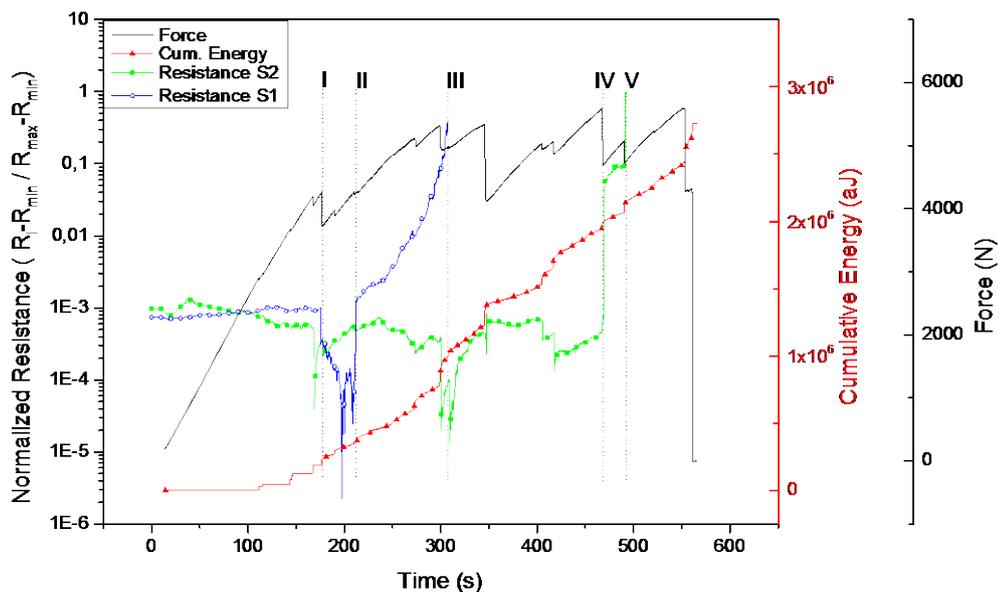
Figure 6. Omega stiffened panel response to pull-off loading assisted by electrical resistance measurements (S2-left side and S1-right side) and AE technique.

Figure 6 shows a typical behavior of the electrical resistance from both sides of the omega stiffened composite, named as Resistance S1 and S2, under pull-off test. Acoustic emission activities were also acquired during the test and presented as cumulative energy in the graph. The load drop events exhibited in the curve are also evidenced by AE cumulative energy as a rise in its value, as well as by the electrical resistance on both sides. The mentioned events are significant damages which occur during the tests. Delamination is responsible to the first load drop (steps I-II) and evokes a sharp fall of the electrical resistance, which is better verified in the measurements from the side S1, once the failure occurs on the same side (Figure 7a). This behavior is probably a combination of two simultaneous phenomena: the unloading post damage seen as a sharp drop in the load-time curve that unloads the tuft yarns and therefore enlarges the thread section area, and to the delamination which debonds the resin from the yarns and as consequence diminishes the electric resistance. The reduction of thread cross-section area yarns also leads to an increase in the length (L) when they are submitted to a longitudinal strain. It conducts to the fibers straightening and consequently increases the electrical resistance (R) as described

in Eq. (1). Besides, this straightening can induce changes in the contact network by reducing the number of the contact between fibers and also increases the resistance.

where L is the length of the conductor (m), A is the cross-sectional area of the conductor (m^2), and ρ is the electrical resistivity of the material ($\Omega \cdot \text{m}$). During delamination, the right side is unloaded, which results in an electrical resistance decrease (Resistance S1), while the left side is slightly loaded and exhibits an increase in its electric resistance (Resistance S2). From the event II, the strain is progressively raised in the left side which amplifies the resistance until the complete rupture of the threads, described as a significant augmentation of the electrical resistance (event III). The events between III and IV characterized by measurements of resistance in the left side (S2) were mainly owing to the delamination generated on the right side (S1) from the analysis performed by DIC. The sharp increase in the electrical resistance seen on the event IV is characterized as delamination on the same side of the S2 (Figure 7b). The increase of the electric resistance was unexpected to a delamination event, which is explained by a continued increase in the opening strain (ϵ_{yy}) even that delamination was supposed to unload the structure. It is due to a quick sequence of the events, from delamination (event IV) to tuft rupture (event V), and consequently did not let enough time to unload the structure.

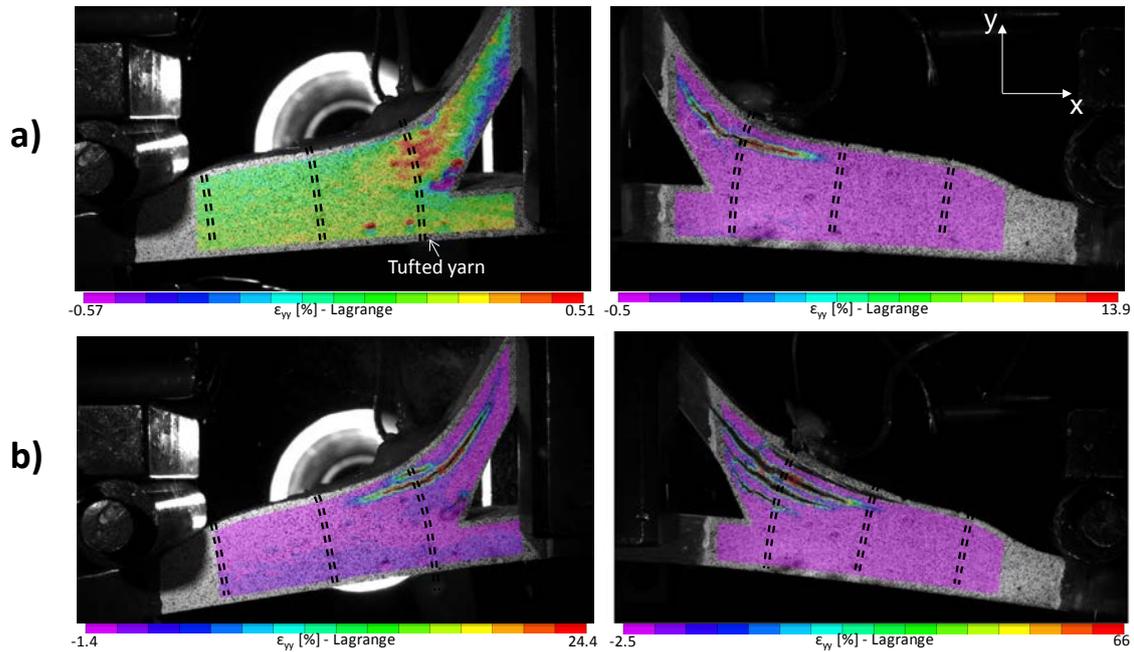
Figure 7. Longitudinal Strain fields (ϵ_{yy}) measured by DIC at a) Step I and, b) Step IV.
