# METHODOLOGY FOR INSPECTION OF WOOD PATHOLOGIES USING ULTRASONIC PULSES

Edgar Vladimiro Mantilla Carrasco<sup>1</sup>, Amanda Rocha Teixeira<sup>2</sup>

Key words: Wooden structures, ultrasound, nondestructive testing, phytosanitary evaluation.

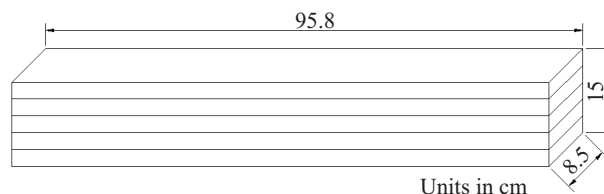
**Figure 3** – Dimensions of the glued laminated timber beam.

Materials used in the experiment included a glued laminated timber beam from species *Eucalyptus grandis* (Figure 3), a James Mark II ultrasound device with a pair of ultrasonic pulse transducers acting as the emitter and the receiver, at a 500 kHz frequency (Figure 4).

The selection of a glued laminated timber beam was based on the fact that the piece not only had largely intact areas that allowed measurement of a reference time but also areas with presence of cracks, holes and galleries (caused by insects) of various shapes and sizes. The beam was intentionally manufactured with these internal defects.

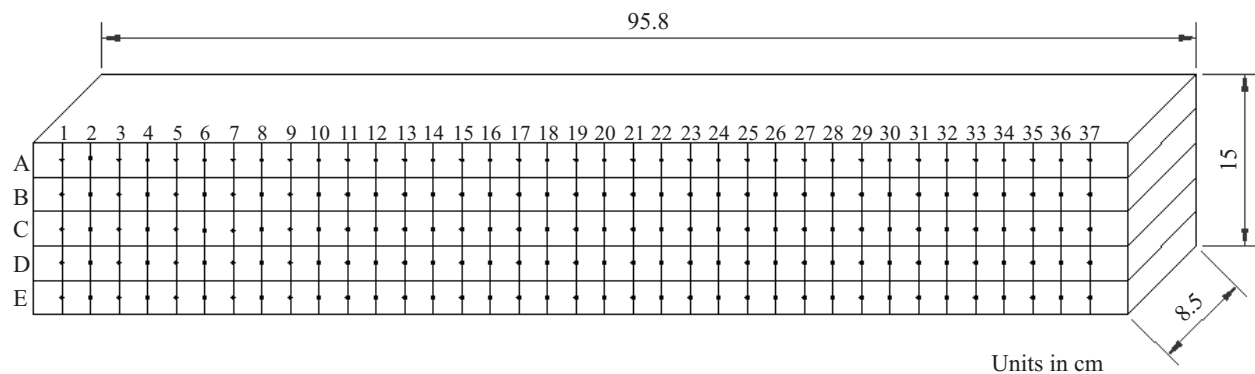
**Figure 5** – Schematic representation of the first grid pattern.

After measuring the reference propagation time, an inspection grid was designed on the beam (Figure 5). A square grid was considered whose edge corresponded to approximately  $10\lambda_m$ , or ten mean wavelengths, adopting

Measurements were taken every 2.5 cm ( $\approx 10\lambda_m$ ) starting on one side of the beam, in all five laminates, as illustrated in Figure 5. Then, propagation times of ultrasonic pulses were measured in all points of the grid pattern.

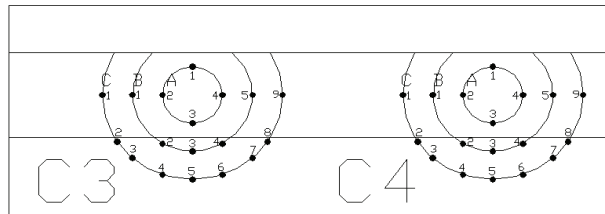
**Figure 10** – Area 3 in detail.

The second grid pattern was based on the results of the first. Propagation times of pulses obtained with the first grid were compared with reference times of each laminate. Whenever pulse time readings from the first grid pattern exceeded reference time values, the area was considered one with high potential of degradation. The second grid pattern covered only such areas, as seen in Figures 6 and 7. Figures 8, 9 and 10 illustrate such areas in greater detail.

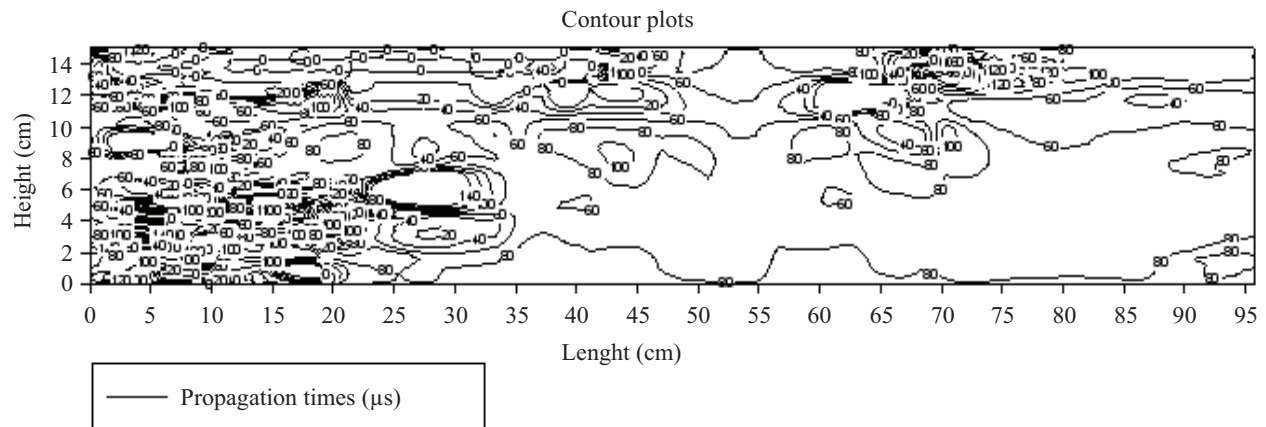
**Figure 11** – Contour plots indicating areas with same propagation times.

With the propagation time readings obtained from the second grid, curves were generated, using SigmaPlot® version 10, to represent areas with same propagation times, as seen in Figure 11. This software allowed converting these curves into isochromatic patterns for better viewing of the areas considered degraded (Figure 12).
