Mitigation of subsurface crack propagation in railroad rails by laser surface modification¹

R.J. DiMelfi a,^{*}, P.G. Sanders a, B. Hunter a,², J.A. Eastman a, K.J. Sawley b, K.H. Leong a, J.M. Kramer a

^a Argonne National Laboratory, 9700 S. Cass Avenue, Argonne, IL 60439, USA

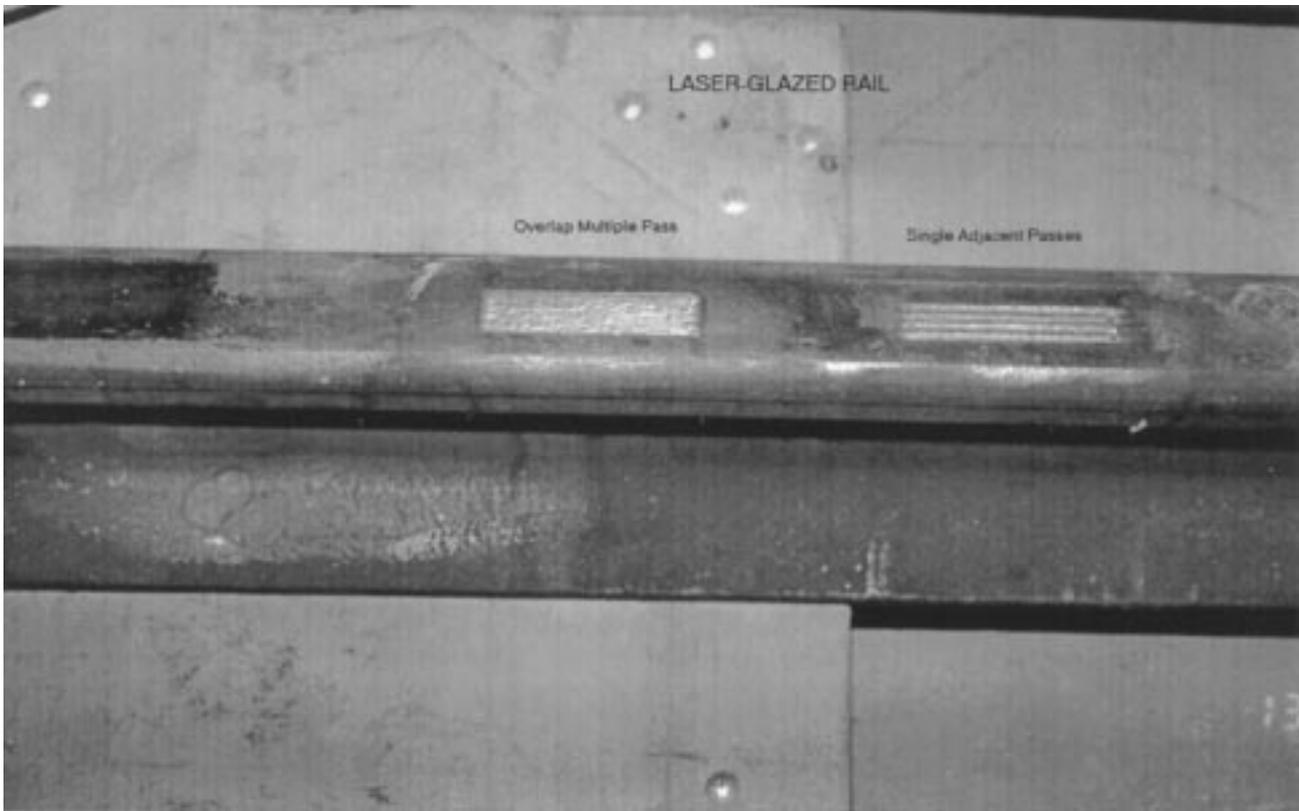
Fig. 14. A photograph of a section of unused railroad rail that received two 10 cm (4 in) long laser glaze treatments on its top surface: a multiple overlapping pass treatment done with a circular beam (left), and a multiple pass treatment made up of single adjacent passes done with an elliptical beam (right).

Encouraged by the friction results just described for samples extracted from AISI 1080 steel test plates, we laser glazed two sections of a six-foot length of railroad rail provided by the AAR for further testing. This length of rail is suitable for insertion in the AAR Transportation Technology Center's Cyclic Rolling-Sliding Wear Machine in Pueblo, CO. The glazed sections (Fig. 14) were centered on the top of the rail. They are each ~ 10 cm (4 in) long, in the rail travel direction, about ~ 2 cm (0.75 in) wide, and are separated by 10 cm

(4 in) of untreated surface. One of the glazed regions involves a multiple pass treatment with overlapping laser tracks. In this case, a beam with a 2 mm diameter circular cross-section, moving at 2 cm/s, is used to produce a single laser track that is 4 in long. Then the beam is offset by 1 mm and its travel direction reversed, so that it produces a neighboring 4 in long laser track that partially overlaps the first. This is repeated until (20 passes in total) an overlapping glazed region of 10 cm \times 2 cm (4 in \times 0.75 in) is produced. The other glazed region is also a multiple pass treatment, but the adjacent tracks do not overlap. In this case, an elliptical (cross-section) beam with a 5 mm minor axis perpendicular to the direction of travel, moving at 1 cm/s, was used to produce each separate laser track. The tracks were separated by 5 mm, so four passes produce the desired 10 cm \times 2 cm (4 in \times 0.75 in) glazed region. As a reminder, we should note that a goal of this work is to reduce the friction at the gage corner of the rail, not the top. However, we treated the top surface of this six-foot test rail in order to facilitate friction measurements.
