Effect of sealed anodic film on fatigue performance of 2214-T6 aluminum alloy

The aim of present study is to investigate the influence of anodic film, grown by sulfuric acid anodizing and sealed in nickel-acetate solution, on fatigue strength of aluminum alloy 2214-T6 by conducting axial fatigue tests at stress ratio 'R' of 0.1 and -1 . The influence of sealed anodic film is to degrade the stress-life (*S-N*) fatigue performance of the base material at all stress levels. Effects of pre-treatments like degreasing and pickling employed prior to anodizing were also studied and no influence of these pre-treatments was observed on fatigue life. The surface and cross-section observations of anodic film were made by scanning electron microscope (SEM) before and after fatigue tests. The surface observations have revealed cavities which resulted from dissolution of coarse Al_2Cu particles during anodization and network of micro-cracks on anodic film surface which were initiated as a result of sealing process. Some of these micro-cracks were found to penetrate up-to substrate and have detrimental effect on subsequent fatigue strength. The decrease in fatigue life for anodized-sealed specime

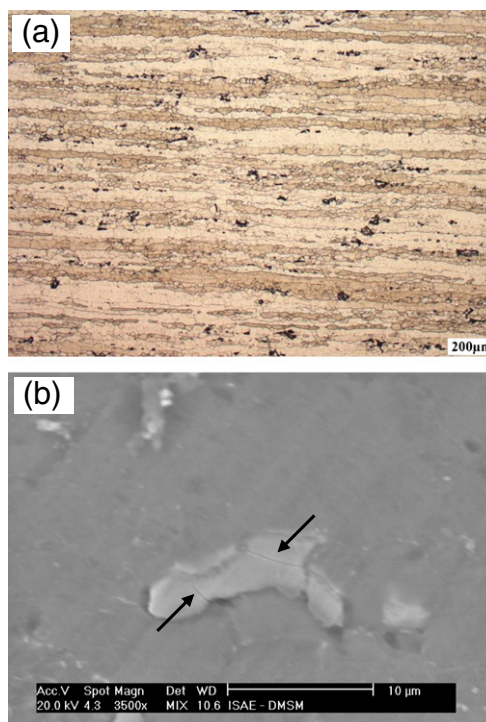
Fig. 1. (a) Optical micrograph of 2214-T6 aluminum alloy microstructure and (b) Cracked particle observed prior to fatigue loading.

Metallographic analysis of the microstructure by optical microscope revealed that it is composed of unrecrystallized and recrystallized grains and latter are elongated in the rolling direction as shown in Fig. 1. Two types of constituent particles were found in this material: Al_2Cu and AlSiMnFeCu and their average size varied between 8 and 12 μm . These types of particles have also been reported earlier [12] for the given alloy. Microstructure was also analyzed by SEM and it was observed that some of the constituent particles of second type (AlSiMnFeCu) had cracks prior to any fatigue loading.

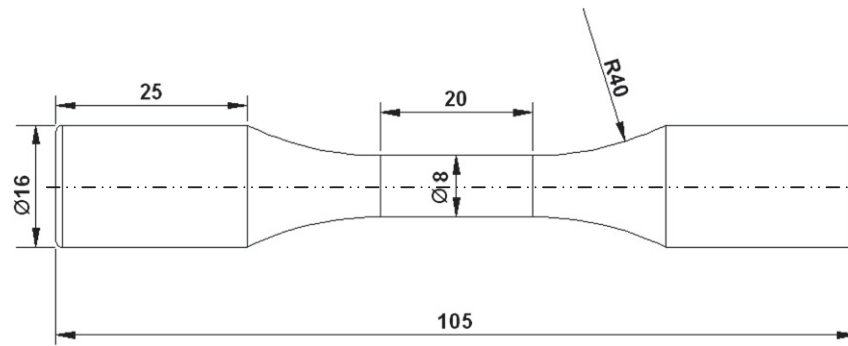
Fig. 2. Fatigue specimen geometry (dimensions in mm).

Fatigue test specimens have been designed according to the useful fastening system of the fatigue testing machine and to prevent buckling of the shaft of the specimen during fatigue tests under stress ratio of -1 . Connection profiles have been sized in order to reach a stress concentration factor ' K_t ' of 1.04 [13]. Geometry of specimens is shown in Fig. 2. Surface of specimens has been machined with initial surface roughness $R_a = 0.7 \pm 0.1 \mu\text{m}$ by lathe turning with the rolling axis parallel to loading axis without using lubricant. The initial roughness of $0.7 \mu\text{m}$ is deliberately produced to mimic the surface roughness generated for components used by industrial partner.

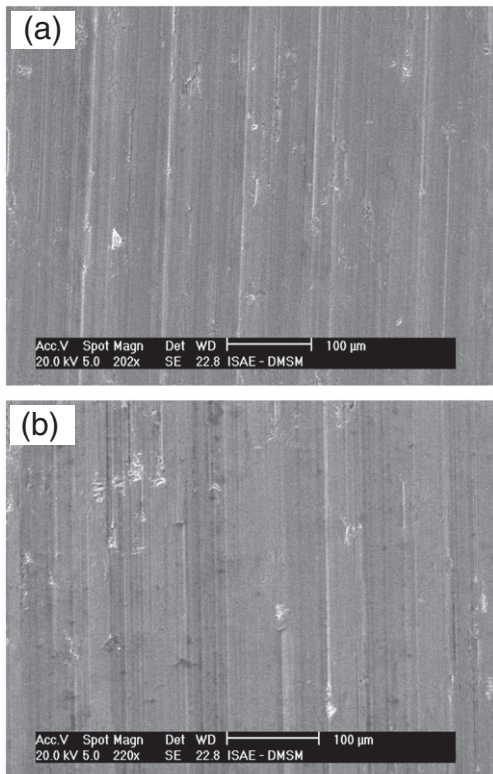
Fig. 3. (a) SEM micrograph of the surface of machined specimen and (b) SEM micrograph of the surface of pickled specimen.

The long pickling time prior to anodization could result in the formation of pits with significant fatigue life implications [15]. Also in the previous work for 7010-T7451 aluminum alloy, Shahzad et al. [16] have shown that pickling process reduced the fatigue life considerably. In fact, in that previous case, pickling process used in [16] was found to attack constituent particles resulting in pits at surface which in turn acted as stress concentration facilitating crack initiation and subsequent crack growth. Therefore, microscopic examination was made after pickling process to verify that if this changes the surface topography of the specimen. Concerning present 2214-T6 aluminum alloy, comparison of micrographs (Fig. 3a and b) before and after pickling process, allows us to say that pickling process did not change

the surface topography of the specimens. Moreover, EDS analysis showed that constituent particles Al_2Cu and AlSiMnFeCu were always present for the pickled specimens.

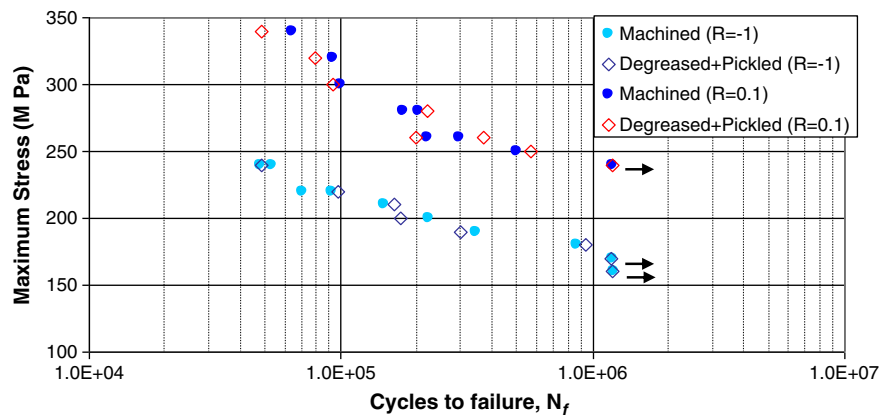
Fig. 5. Fatigue test results for as machined and as degreased + pickled specimens showing no change in fatigue life.

To further validate the fact that pickling has no effect on fatigue behavior of this alloy, some specimens were tested in pickled conditions and results presented in Fig. 5 showed no change in fatigue life as compared to machined specimens.

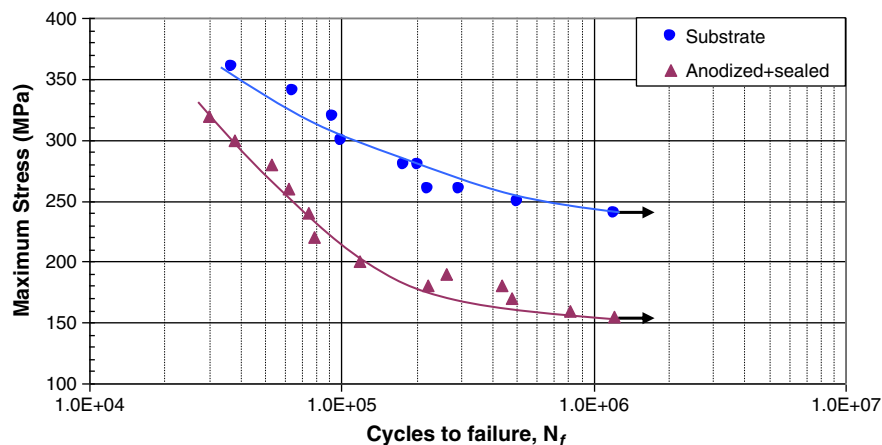
Fig. 6. S-N curves for bare and anodized specimens at stress ratio, $R = 0.1$.

Fatigue test results for bare and coated specimens are given in Figs. 6 and 7 for $R=0.1$ and -1 respectively. It can be clearly seen that tendency of sealed anodic film is to degrade the fatigue performance for the given alloy at all stress levels as compare to bare specimens. For fatigue life of 10^6 cycles, there is a decrease of 35% for $R=0.1$ and 41% for $R=-1$. It can be noted that the fatigue strength of anodized coated specimens showed a dependency on the applied stress ratio. However, the presence of anodic film did not modify significantly the effect of stress ratio as shown in Fig. 8 on which Haigh diagram has been established for 10^6 cycles for machined and anodized specimens: the slope for the two segments did not change significantly: -0.418 for machined and -0.394 for anodized specimens.

From Figs. 6 and 7, one can note that with the increase in the applied stress amplitude, S-N curves tend to converge thus reducing the negative effect of the anodic film. This behavior of convergence for high stress can be observed for both stress ratios. One possible explanation for this phenomenon may be the differences in relative importance of crack nucleation versus crack propagation in high and low stress regimes. Indeed, fatigue life is essentially divided into two regions: crack nucleation life (dominant for low stresses) and crack propagation life (dominant for high stresses). In addition, as the anodic film is significantly thin compared to the total section of the specimen, a pronounced effect of film on fatigue crack growth behavior and hence on fatigue crack propagation life would not be expected: this results in a slighter effect of the film for high stresses. On the other hand, crack nucleation is known to be sensitive to surface condition. Therefore, the anodic film would be expected to influence fatigue nucleation life and hence fatigue lives at low stresses more significantly.

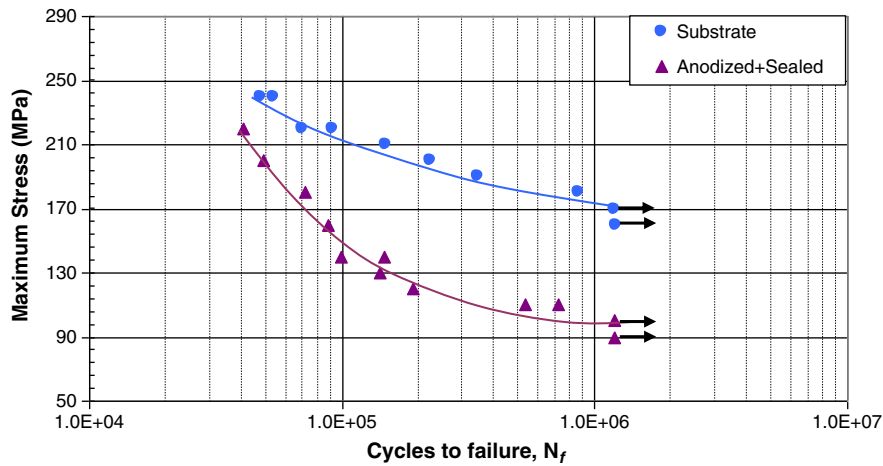
Fig. 7. S-N curves for bare and anodized specimens at stress ratio, $R = -1$.

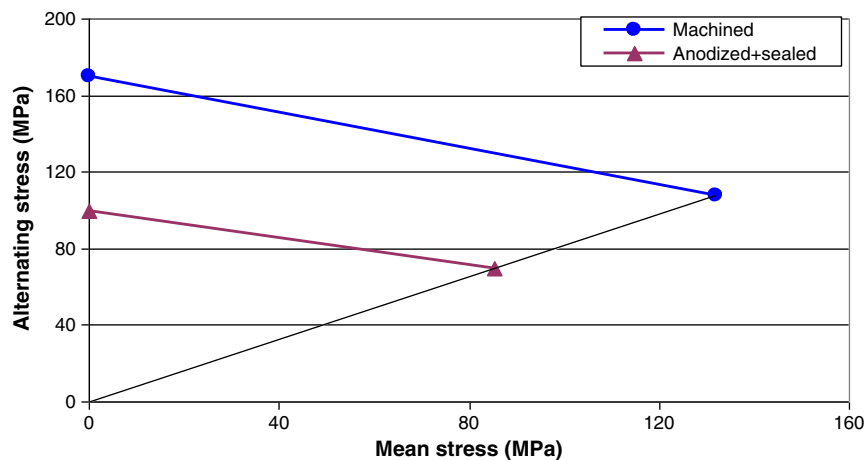
Fig. 8. Haigh diagram to evaluate the effect of mean stress at 10^6 cycles between machined and anodized specimens.

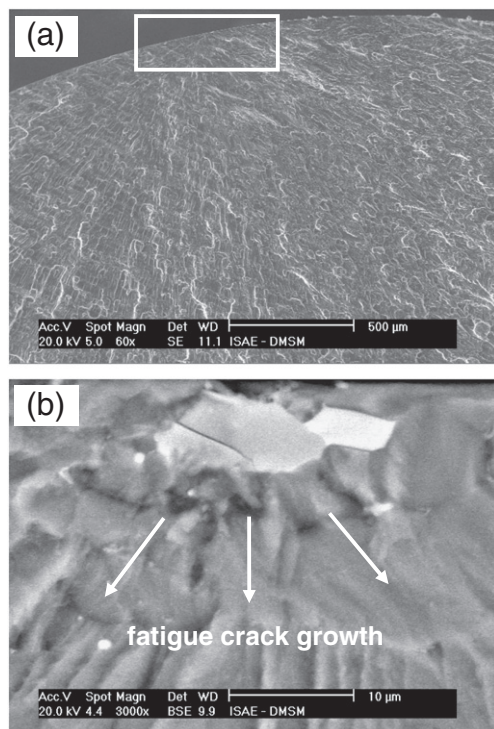
Fig. 9. (a) SEM image for bare specimen at low magnification showing crack initiation site and (b) higher magnification of (a) showing cracking of particle and subsequent fatigue crack growth.

the fatigue cracks were initiated by the cracking of the constituent particle ($AlSiMnFeCu$) and there was no evidence of debonding at the interface of matrix/particle (Fig. 9).

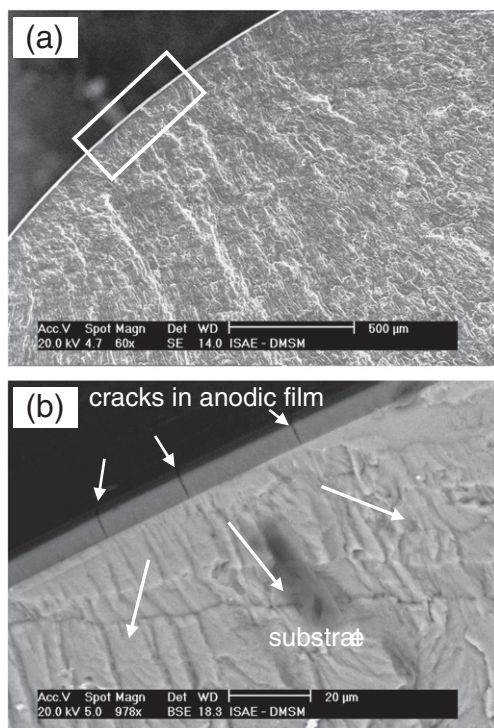
Fig. 10. Fracture surfaces of anodized specimen ($R=0.1$), at low and high magnification showing fatigue cracks initiated within the film and propagated towards substrate.

The sealed anodized specimens exhibited various fatigue crack initiation points, which propagated resulting in fracture. For most of the anodized specimens, cracks developed in the film and then propagated towards the substrate. Such mechanism is shown in Fig. 10, which presents the fractured surface of one of the anodized specimen tested at 180 MPa.

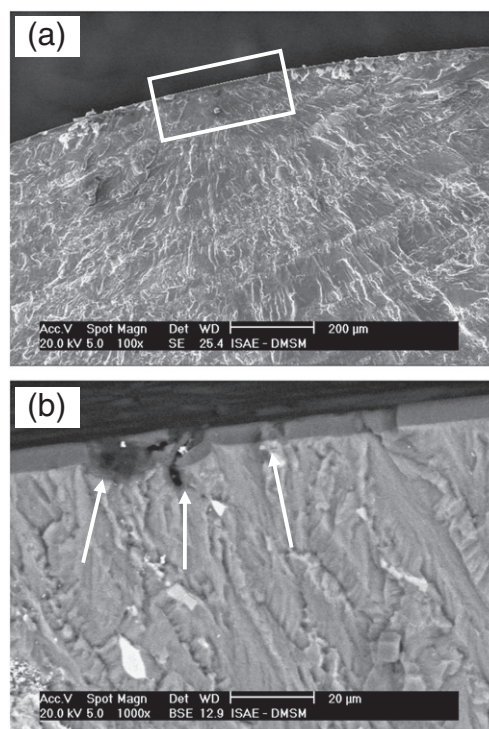
Fig. 11. SEM images of anodized specimen; $R=-1$, $\sigma_{\max}=200$ MPa, $N_f=51025$ cycles at low and high magnification showing the crack initiation from cavities in film.

Besides the cracking of anodic film, the presence of pit like defects (cavities) in the film was also found to be another source of crack initiation for substrate as can be seen in Fig. 11. These pits may cause local stress concentration and may have a provocative effect on the subsequent cracks growth in the substrate. The phenomenon of initiation from cracking of film and cavities was observed for both stress ratios. For anodized specimens, the main controlling factor for crack initiation appears to have been provided by the film. Constituent particles ($AlSiMnFeCu$) played no role in fatigue crack initiation in the anodized specimens.

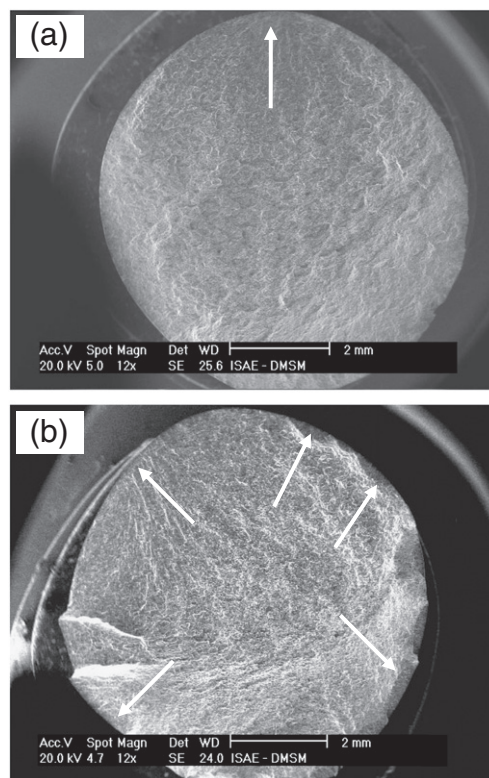
Fig. 12. (a) Bare specimen showing single crack initiation; $\sigma_{\max}=260$ MPa, $N_f=219640$ cycles (b) anodized specimen showing multi-site initiation, $\sigma_{\max}=260$ MPa, $N_f=61548$ cycles.

At the same stress level, the number of cracks formed on fractured surface of the anodized specimens was larger than that of the untreated specimens as indicated by arrows in Fig. 12. The fracture surface is not flat (Fig. 12b) which also reveals that number of fracture steps exists, indicating that fracture has occurred as a consequence of the propagation of several cracks that initiated from film. Shiozawa et al. [20] have also demonstrated this phenomenon that number of crack initiation sites increased for the anodized specimens

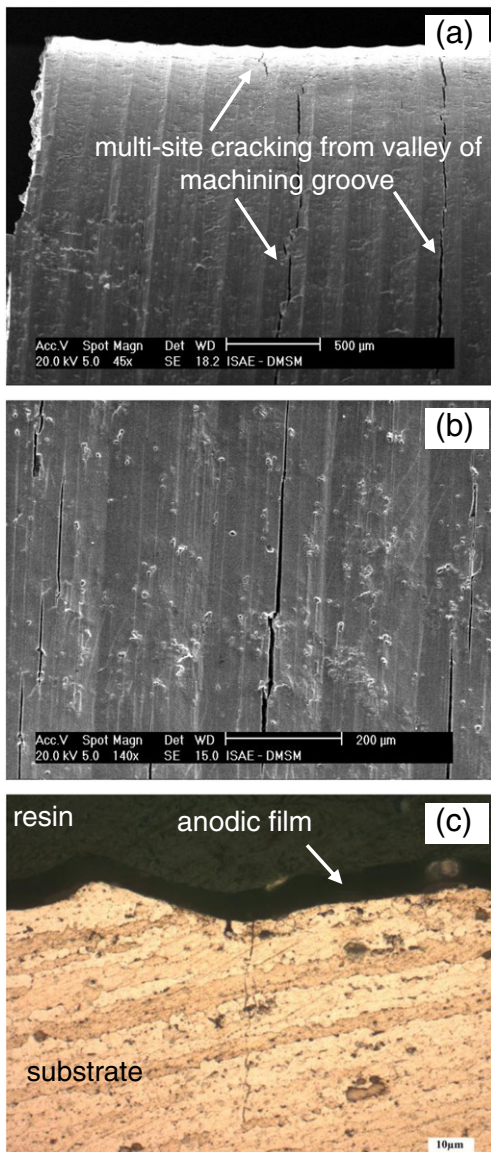
Fig. 13. (a) and (b) Secondary cracks on anodized specimen surface showing multi-site initiation at low and high magnification (c) transversal section image showing fatigue cracking in anodized specimen.

initiation. Fig. 13 shows that most of the secondary fatigue cracks were initiated at the valley of machined groove and started from pit like defects. To validate the fact that anodic film follows the machined surface profile, one fatigue tested specimen was cut along the long axis of the specimen. Then specimen was polished using diamond paste of 1 μm . Optical image shows that anodic film has followed the machined surface profile.
