**Phased Construction Completion Report  
for Bldg. K-1401 of the  
Remaining Facilities Demolition Project at the  
East Tennessee Technology Park  
Oak Ridge, Tennessee**

Date Issued—March 2008

Prepared for the  
U.S. Department of Energy  
Office of Environmental Management

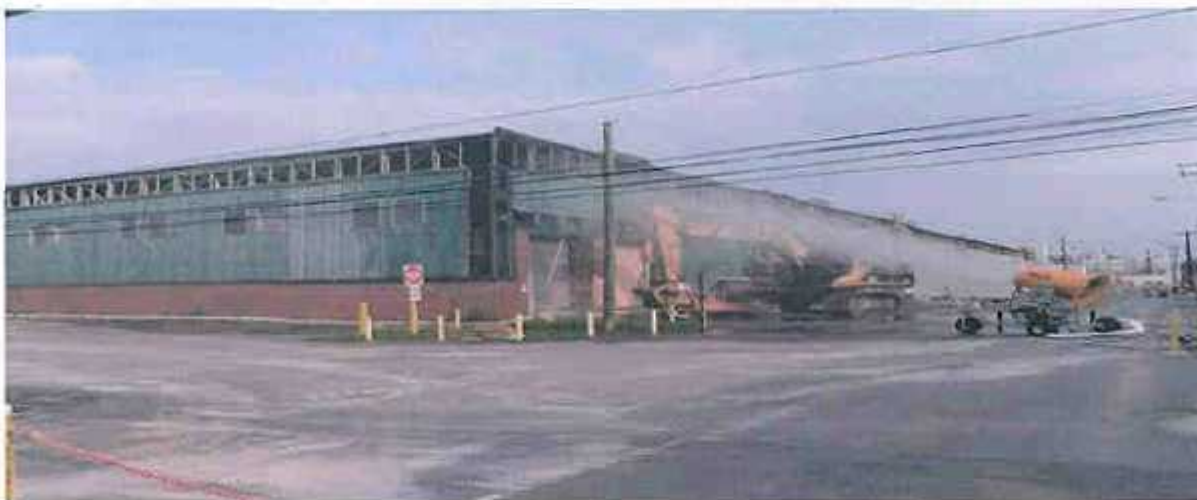
Fig. 3. Bldg. K-1401.

Bldg. K-1401 (Fig. 3) was demolished as follows:

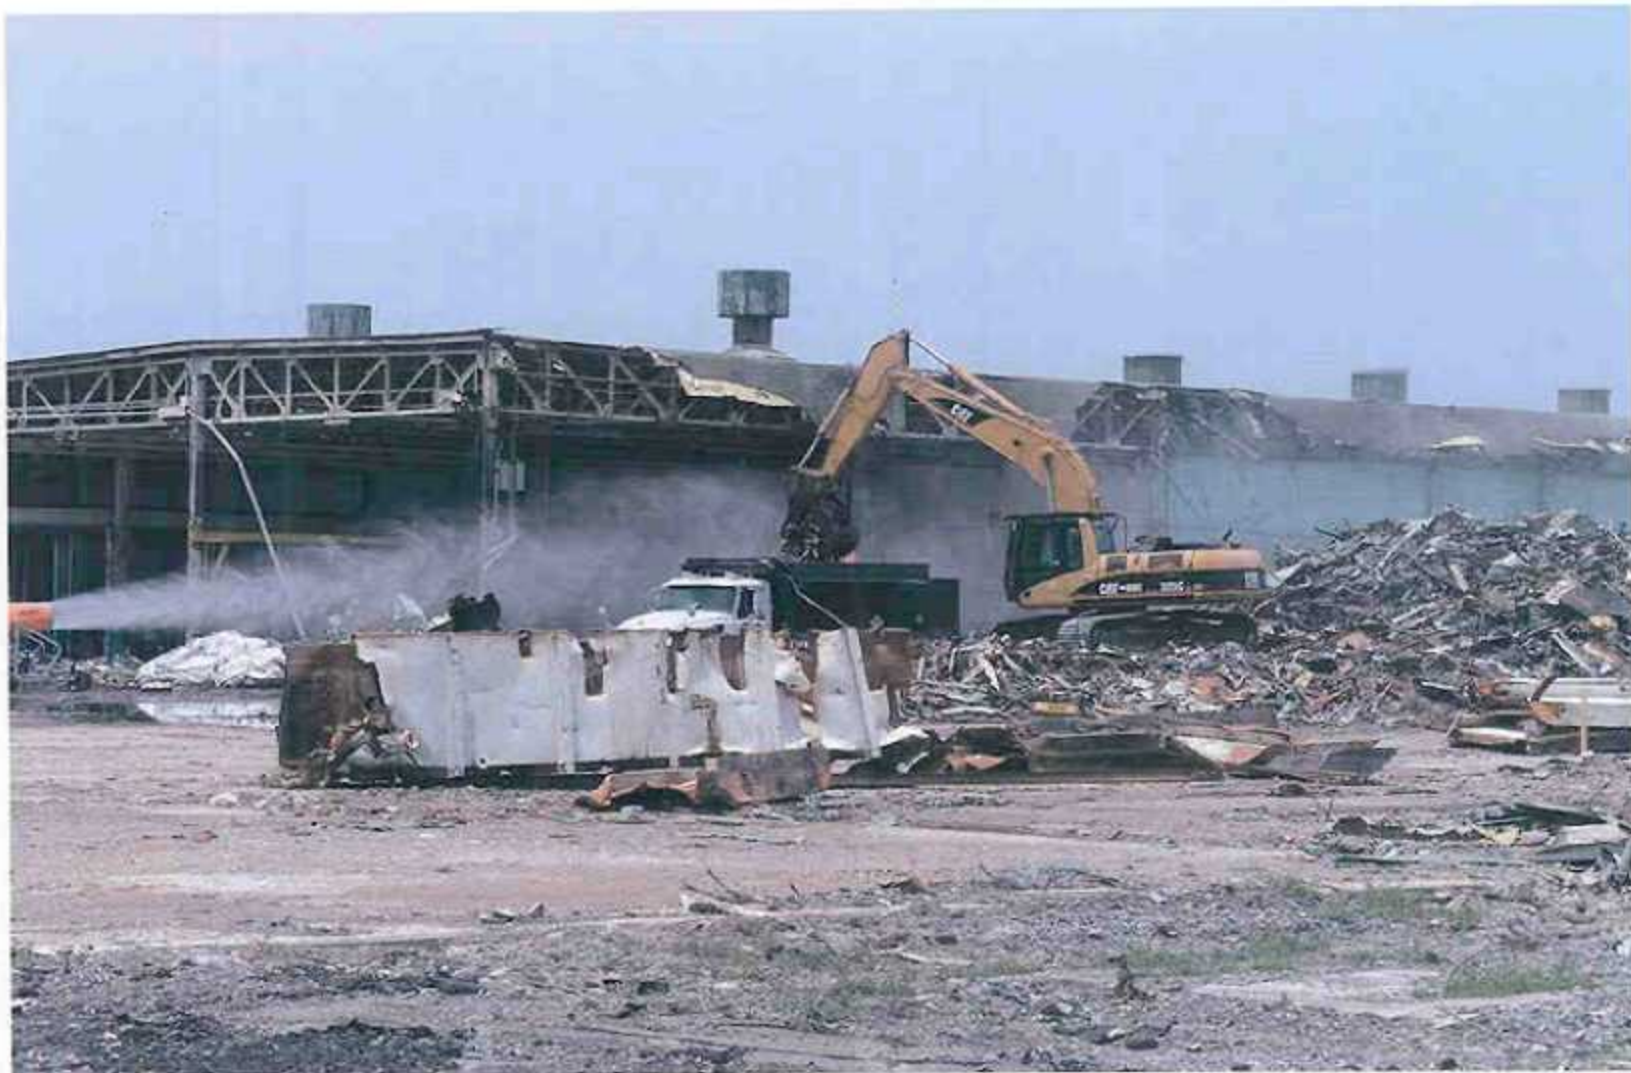
**Fig. 4. Bldg. K-1401 during demolition.**

- Asbestos was removed, double-wrapped, and shipped to EMWMF.
- The remaining building structure and its contents were demolished and disposed at EMWMF (Fig. 4).

- The facility was demolished and size-reduced with mechanical equipment. The floor over the basement was collapsed into the basement. Any debris in the basement from the demolition of the first floor slab was removed and disposed with the balance of the Bldg. K-1401 waste. All debris was loaded into dump trucks and hauled to EMWMF for disposal.

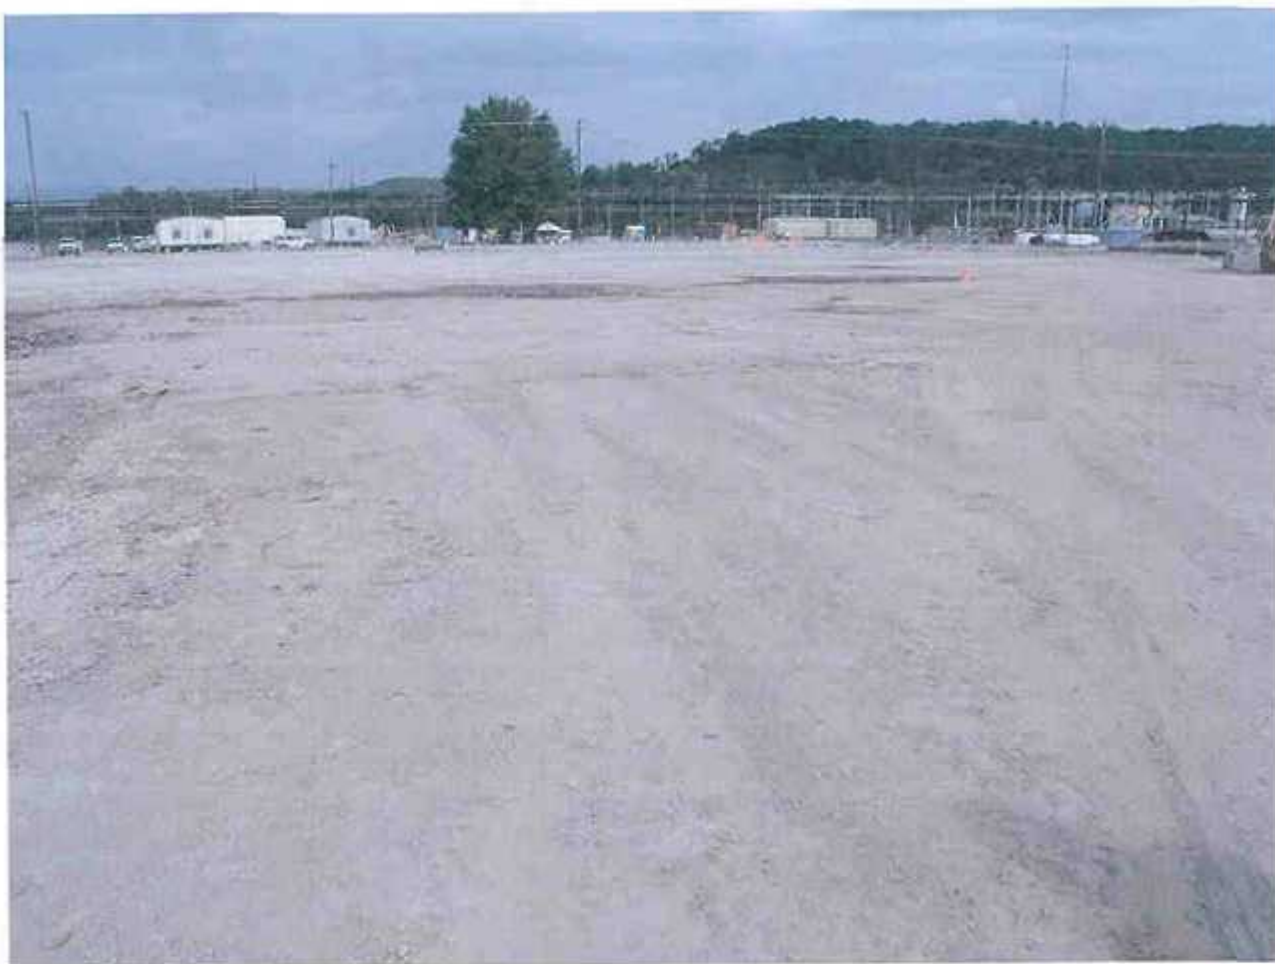
**Fig. 5. Bldg. K-1401 slab.**

The concrete slab (Fig. 5), basement (Fig. 6), and pits (Fig. 7 and 8) remain. Plans are for the basement and pits to be backfilled and the slab to be removed by the end of Fiscal Year 2008. The basement, pits, and a small portion of the slab are posted as a radiological Contamination Area. The remaining portion of the slab is posted as a Fixed Contamination Area (Fig. 9). Some areas were surveyed and released as clean when the residual radiological contamination was below the release limits of DOE Order 5400.5 (DOE 1993). Table 1 contains a summary of the results of the basement radiological survey, and Table 2 contains a summary of the slab survey. The survey results for the pits indicate no remedial action is necessary as part of the Zone 2 Record of Decision (DOE 2005a).

The basement floor and slab are contaminated with polychlorinated biphenyls. The concentration in the basement is below the cleanup levels defined in the Zone 2 Record of Decision (DOE 2005a), and a fixative was applied to the contaminated location (Fig. 10) on the pad. This characterization information was provided to the Remedial Action Program. Interim land-use controls have been implemented (see Sect. 9) until final remediation decisions are made under the Zone 2 Record of Decision (DOE 2005a).

Based on the surveys performed and the remaining postings for the slab, annual radiological surveys will be performed until remediation activities take place.
