Assessment of adaptation strategies to flooding: A comparative study between informal settlements of Keko Machungwa in Dar es Salaam, Tanzania and Sangkrah in Surakarta, Indonesia

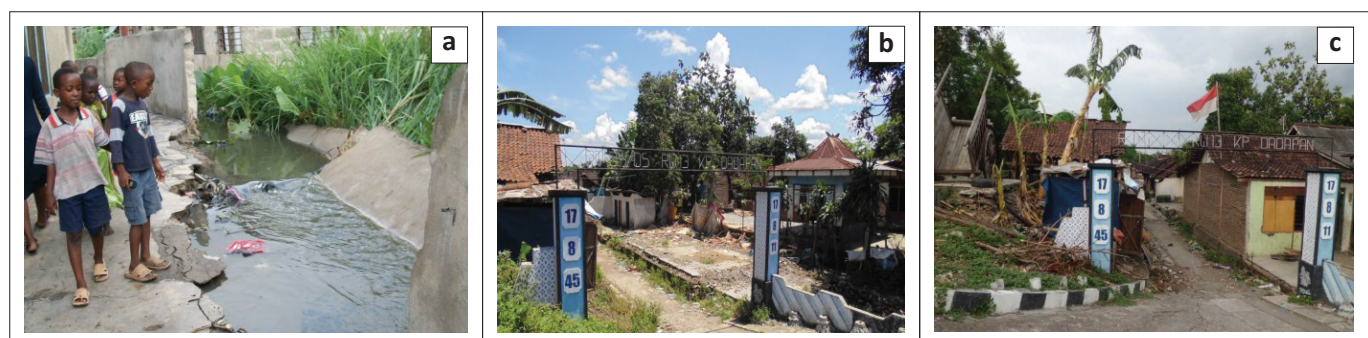
FIGURE 4: Flood damage to properties as seen by, (a) collapsed protective wall in Keko Machungwa and (b) destroyed house in Sangkrah after flooding (c) same house before flooding.

our boys. They are so helpful'. Unfortunately, observations also revealed that flood protection structures and sometimes even entire buildings were destroyed by floods (Figure 4).

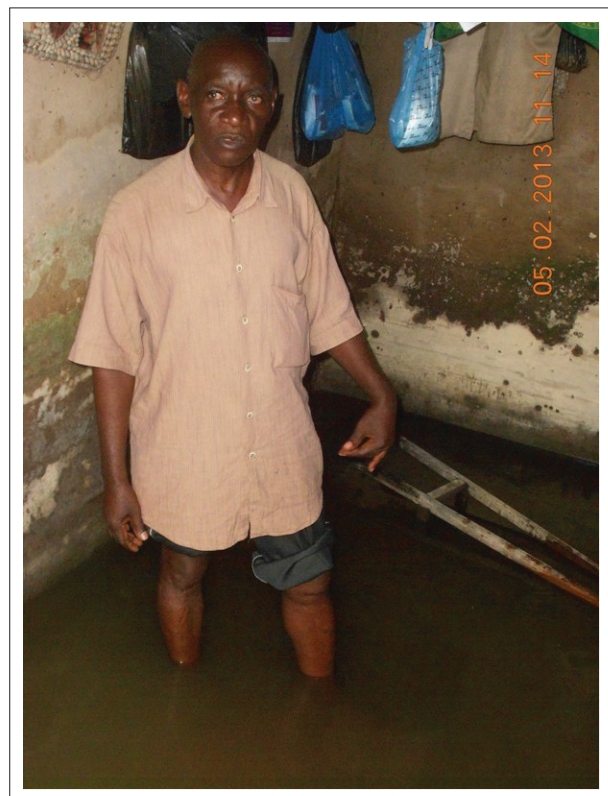
FIGURE 6: Dampness and waterlogging inside a house in Keko Machungwa resulting from underground water percolation.

Another observed area of variation from FEMA guidelines (2008) was technical suitability of materials used to construct home floors in the two cases. It was observed in Sangkrah that the majority of interviewees (72.9%) constructed their home flooring using ceramic materials, whereas in Keko Machungwa, about 81.4% stated that most were built with sand and cement flooring materials (see Table 1). This was a deviation from the recommended use of waterproof cement and ceramic materials in the construction of home flooring by FEMA (2008). Inadequately constructed sand and cement floors in Keko Machungwa increased the vulnerability of buildings as it allowed underground water to percolate into houses. This infiltration raised water depths and dampness

levels in walls (Figure 6). About 52.9% of houses in Keko Machungwa were reported to be affected by water infiltration problems.
