M. SOLECKA^{*,#}, M. KOPYŚCIAŃSKI^{*}, J. KUSIŃSKI^{*}, A. KOPIA^{*}, A. RADZISZEWSKA^{*}**EROSIVE WEAR OF INCONEL 625 ALLOY COATINGS DEPOSITED BY CMT METHOD**

The article presents the investigation results concerning the determination of the characteristics of erosive wear caused by the impact of Al_2O_3 solid particles on the surface of Inconel 625 alloy after plastic working and the same material after weld cladding process using the CMT method. Erosion wear tests were performed at two temperatures: 20°C and 650°C. The erosion tests were conducted using the standard ASTM G76. A jet with a specified abrasive waight was directed to the surface of the tested material at an α impingement angle varied in the range of 30-90° at a velocity imparted to the abrasive by the medium, which was compressed air. The eroded surface was examined using a scanning electron microscope (SEM), while the depths of craters caused by the erosion tests were measured with an optical profilometer. The predominant mechanisms of the formation of mass losses during solid particle erosion were microcutting and microfissuring.

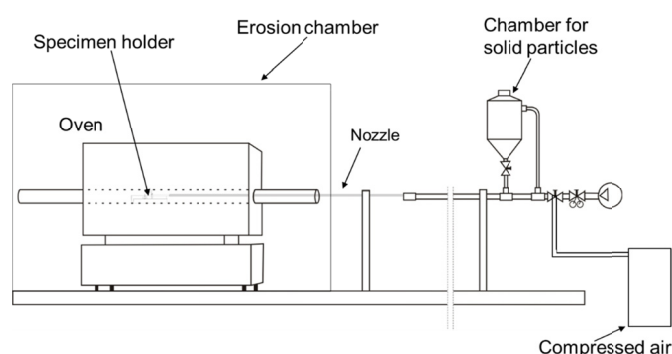
Fig. 1. The diagram showing the position of to simulate erosive wear

The erosive wear tests were performed using the author's testing stand. The abrasion wear testing stand is shown in (Fig. 1). The proposed concept of the device for erosive wear process simulation refers to the method that reproduces the mechanism of impact erosion that is caused by the impact of hard particles, where the abrasive carrier is a stream of compressed air [17]. The basic objective was to enable the tests to be conducted under high-temperature conditions. To be able to perform the tests not only at ambient temperature, but also at an elevated temperature, the device was equipped with a pipe furnace, for which a special holder was designed to enable the control of the impingement angle of abrasive hitting the specimen. The erosive wear process simulation stand according to ASTM G 76 consisted of a compressed air source, an abrasive batching system, a mixing chamber and a nozzle [18]. Compressed air and solid particles are delivered to the mixing chamber, from where the mixture is discharged via a 1 mm-diameter 570 mm-long nozzle. After leaving the nozzle, accelerated abrasive particles carried by the air stream hit the surface of a test sample positioned at a distance of 5 mm from the nozzle, with a specified kinetic energy. During testing, the velocity of solid particles discharged from the nozzle should be approx. 90-110 m/s. The air flowrate should be maintained at a level of approx. 16 m³/h at a pressure of 0.3 MPa. The tests were conducted, respectively, at ambient temperature, i.e. 20°C, and at a temperature of 650°C, which simulates the boiler operation temperature. The test specimens, in the form of an 12×20×2 mm rectangular prism, were fixed on the table at an appropriate abrasive particle impingement angle.

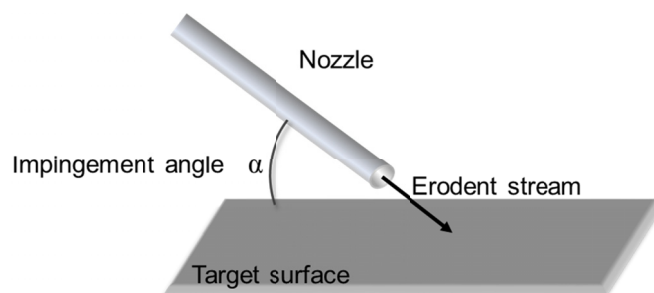
Fig. 2. Schematic diagram depicting the impingement angle of solid-particle erosion [19]

To determine the erosion wear resistance, the weld clad layer of the Inconel 625 alloy and the same material after plastic working condition, were subjected to erosive wear testing at different abrasive solid particle impingement angles of, respectively: 30°, 45°, 60° and 90°. The differentiation of abrasive particle impingement angles, as well as the temperature, allowed the determination of the course of erosive wear processes. As the abrasive, Al₂O₃ with a grain size distribution of 180-220 μm was used. The particles of the abrasive used were characterized by high hardness – above 2000 HV, and the presence of sharp edges. Using a precision laboratory balance, all specimens were weighed prior to and after the erosive wear test. On that basis, the ratio of the specimen mass loss to the mass of the abrasive striking the specimen was determined. In the erosive wear tests, the impingement angle of incidence of abrasive particles was measured between the particle incidence direction and the disc surface (Fig. 2).

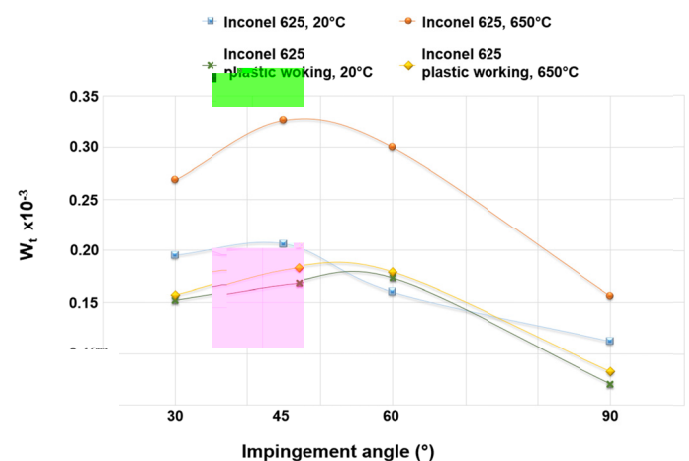
Fig. 3. Graph showing the dependence of erosive wear (W_t) with respect to the impingement angle incidence of the abrasive material

Assuming the coefficient as the intensity of the material erosive wear (W_t), a diagram has been plotted (Fig. 3), which illustrates the dependence of the material erosive wear on the abrasive particle incidence angle for two materials tested at two temperatures. It can be noticed from the diagram that the material wears faster at elevated temperature, which may suggest that erosive wear intensity at higher temperature (650°C) is often due to the erosive wear of the surface and the formation of an oxide protective layer on the material surface, which is brittle and more prone to chipping off as a result of erosion. It is supposed that the greater mass loss of Inconel 625 clad layer compared to the material after plastic working may be due to the greater inhomogeneity. Then Inconel layer has worse mechanical properties for example elongation or tensile strength in comparison with plastic worked alloy. Therefore material after

plastic working has higher corrosion resistance than clad layer. During heating, the surfaces of the specimens become oxidized before undergoing erosion. Thus, if the oxide film on the layer is thicker, the erosion loss will be greater. It was also found that the greatest mass loss, for the investigated Inconel 625 alloy and for the same material after plastic working, took place at an abrasive impingement angle of 45°. The smallest mass loss for all of the tested materials was found at an impingement angle of 90°. Inconel 625 after plastic working is characterized by a much smaller mass loss compared to the weld clad made of the same material (Fig. 3) [19].

At an elevated temperature, the wear profile is distinct at the impingement angle 45° for both materials, as confirmed by the data in (Fig. 3).

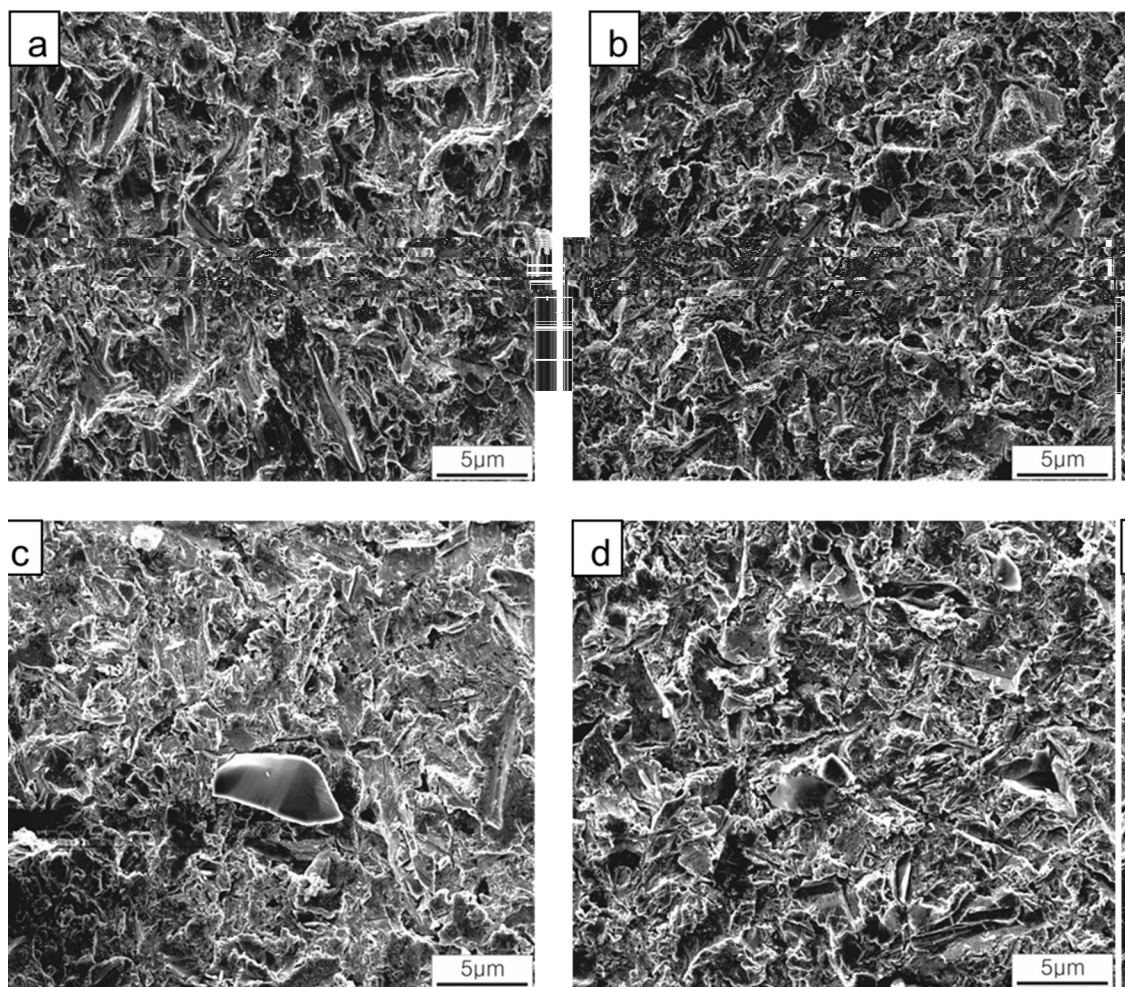
Fig. 4. Typical erosion scars and SEM micrographs of Inconel 625 eroded areas with impingement angles of: a) 30°, b) 45°, c) 60°, d) 90°. Erodent Al_2O_3

The examination of the eroded surface, illustrated in figure 4, shows that, at the abrasive particle impingement angles of 30° and 45° (Fig. 4a,b), a visible removed material occurred due to microcutting, while at greater abrasive particle impingement angles of 60° and 90° (Fig. 4c,d), due to microcutting and microfussuring – the removal of the material occurs due to the formation of sub-surface cracks. At greater impingement angles, the contribution of abrasive solid particles, which were stuck in the eroded material surface, was also observed. This relationship

was observed for all investigated materials. The SEM pictures taken in eroded specimen regions indicate that the predominant mechanisms responsible for the erosion process are microcutting and microfussuring. They depend on the shape of erodent particles and their kinetic energy at the moment of hitting of the tested material. In the fussuring process, after plastic working in the form of an elongated furrow with characteristic creases occurs on the material surface. The detachment of material from the groove is a sign of erosive wear.

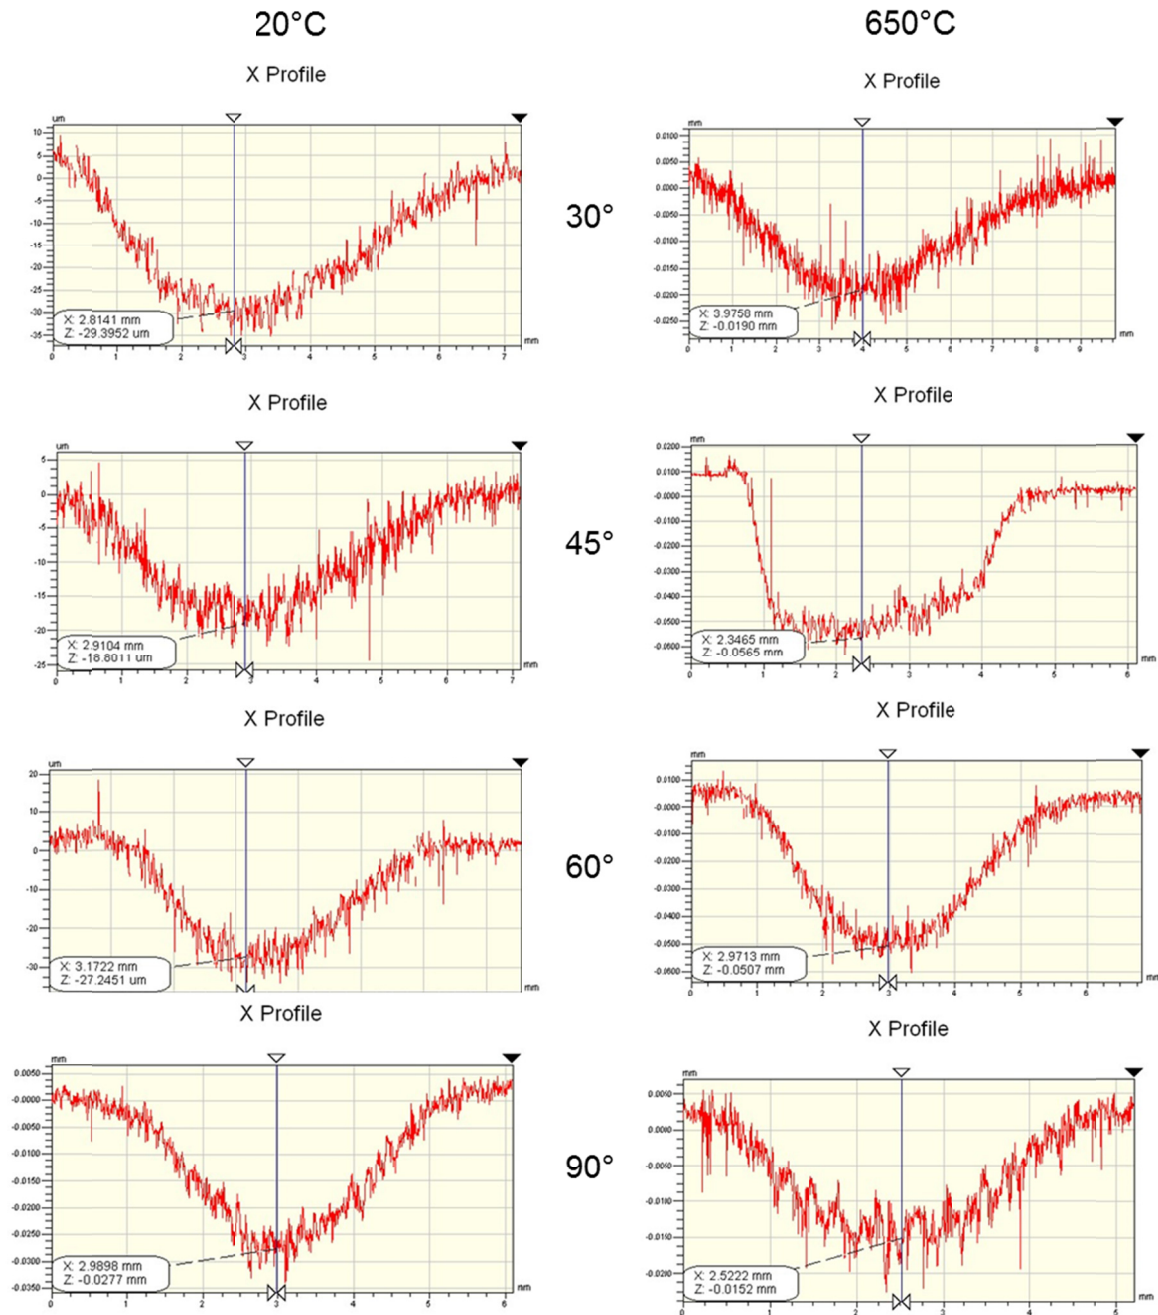
Fig. 5. Erosion craters profiles in Inconel 625 after plastic working

The changes in the shape of the eroded material surface are very well illustrated by surface profiles recorded using an optical profilometer. (Fig. 5) shows the surface profiles of Inconel 625 alloy and after plastic working after erosive wear for the temperatures 20°C and 650°C. While (Fig. 6) shows the surface profiles of Inconel 625 weld clad layer after erosive wear. Changes in the surface shape with increasing impingement angle are perfectly visible in these profiles. For smaller impingement angles, the shape is elongated in the direction of the x axis, whereas for angles equal to 90° it is more symmetrical. At an elevated temperature of 650°C, the shape changes for the eroded surface are, for both materials, more visible than for the temperature 20°C; this is especially true to the angle 90°.

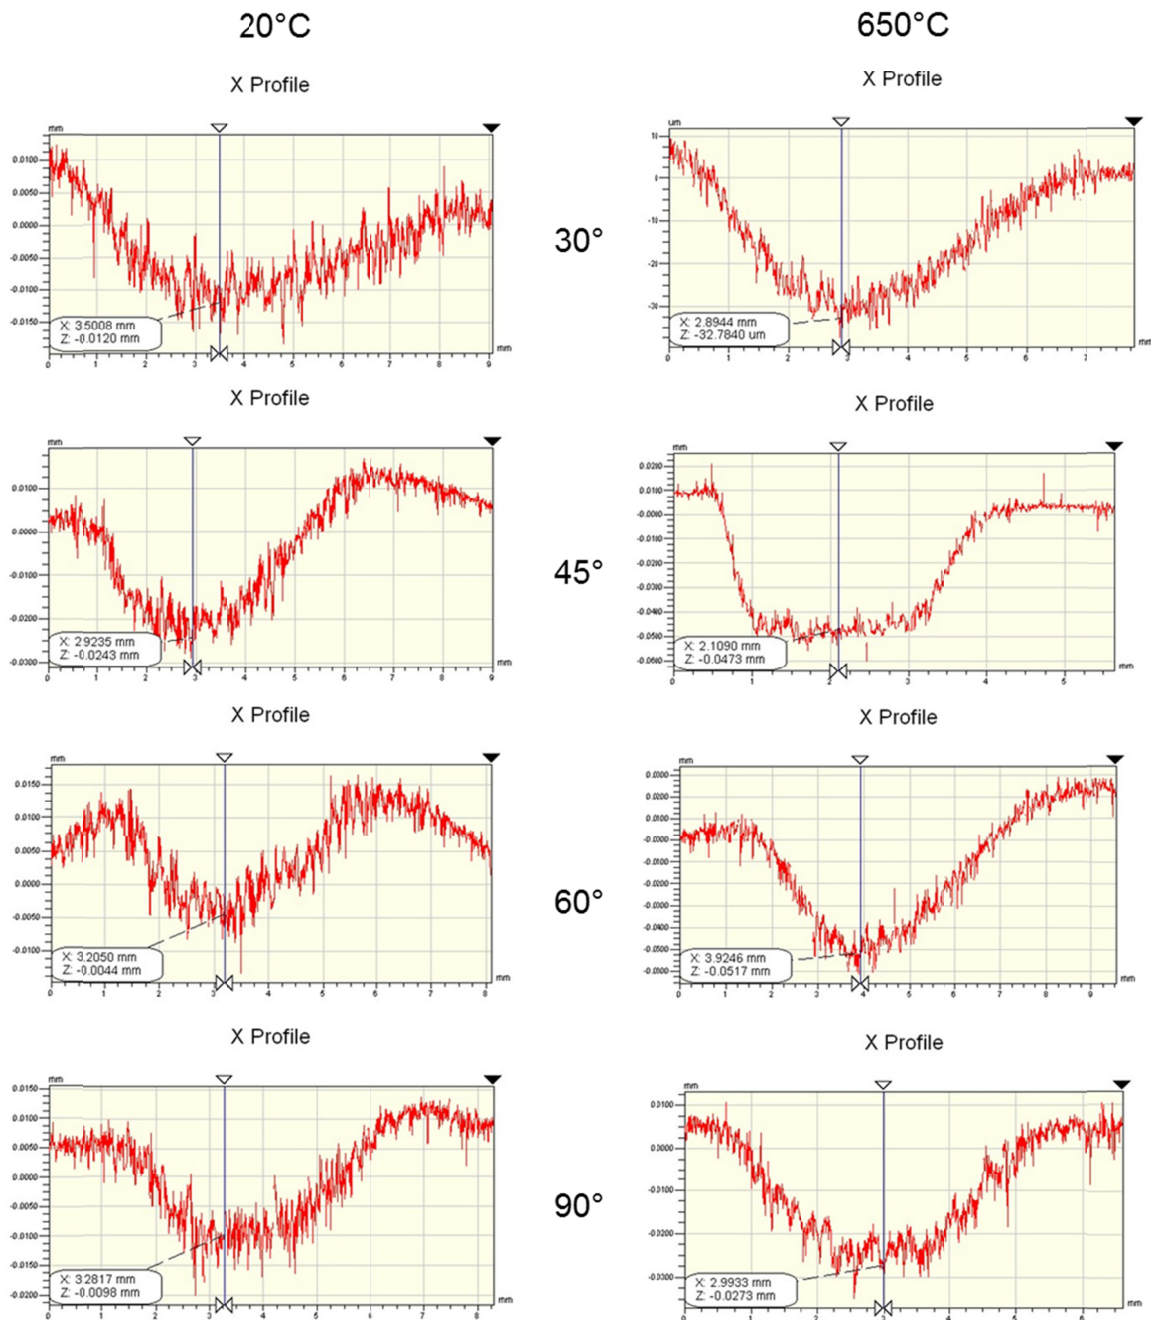
Fig. 6. Erosion craters profiles of the Inconel 625 clad layer with impingement angles of 30°-90°
