On-Road Development of John Deere 6081 Natural Gas Engine

Final Technical Report

July 1999—January 2001

D.L. McCaw and W.A. Horrell

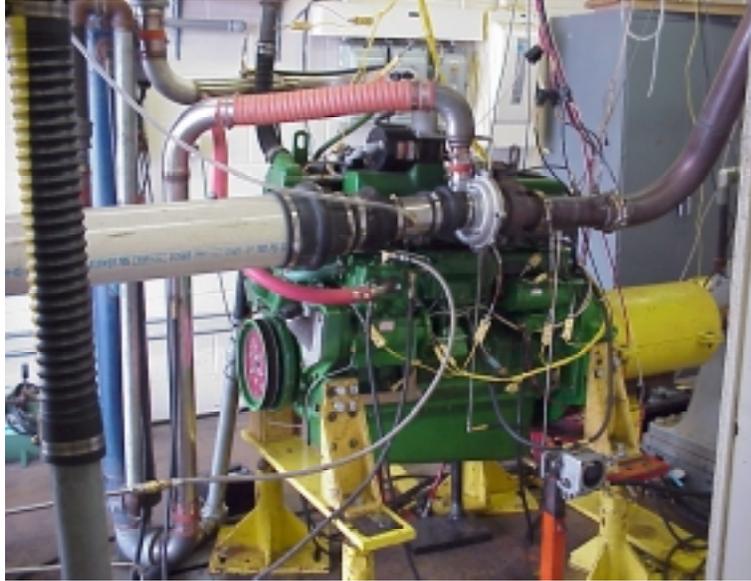
Photo 2.1 - Durability Test Engine Installation

A photograph of the durability test engine as installed in the test cell is shown in Photo 2.1. The engine was instrumented to measure power and fuel flow as well as pertinent temperatures and pressures.

The durability test was started on November 15, 1999. A few minor problems were experienced during the first 100 hours. At 36 test hours, the waste-gate actuator failed. The actuator was replaced and no further problems were noted. At 51 test hours, the exhaust manifold gasket on cylinder #1 was found to be leaking. No damage to the manifold or head was found, so the gasket was replaced and the test continued. At 54 test hours, a slight misfire was noted. The cause was determined to be a poor connection between the ignition coil and the spark plug boot. This was corrected and no further misfires were noted. The spark plugs were examined, valve recession measurements were conducted, and no significant wear was noted.

The John Deere 8.1L NG engine serial number RG6081H000237 completed the 250 hours of life testing without further problems. In addition to the 250 hours that were required and co-funded as part of this program, this engine was run for another 750 hours of life testing at John Deere's expense. Following the 1,000 hours of testing, it was then returned to the John Deere Product Engineering Center for a complete tear down and final inspection. The tear down and inspection of the durability engine following 1,000 hours of life testing found it to be in excellent condition. No major problems of any type were found during tear down inspection or during the suppliers' inspection of the key components from this engine.

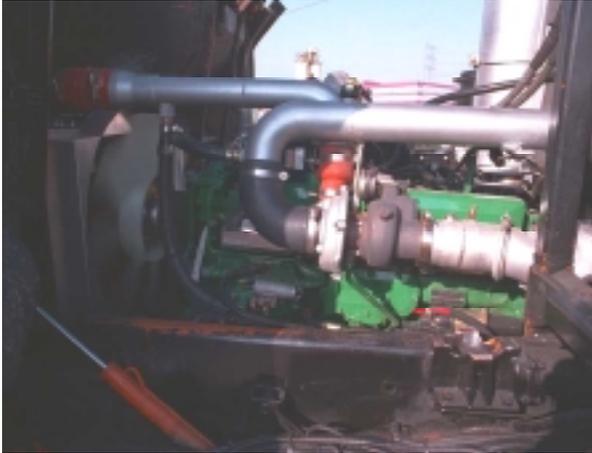
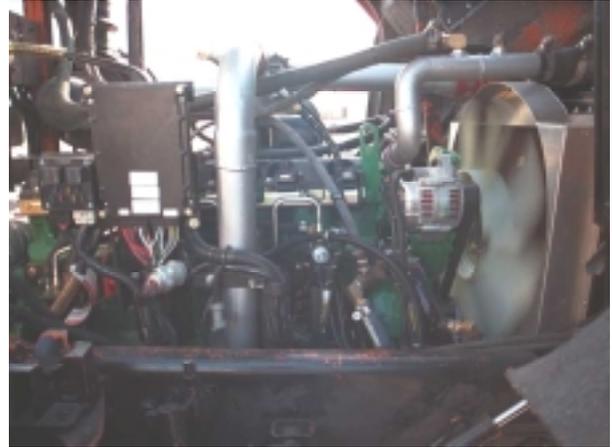
Photos 5-1 & 5-2. Left hand and Right hand Views of the John Deere 8.1L NG Engine in Chassis.

Photographs of the first WMI trash truck following the retrofit with the John Deere 8.1L NG engine are shown in Photos 5-1 through 5-5.

During August 1999, Ecotrans installed a John Deere natural gas engine S/N RG6081H066432 into the first of four Peterbilt P320 trash truck chassis owned by WMI. The truck was a 1994 model year with 127,853 miles on it. The replaced engine was a Cummins 8.3 L diesel. In addition, Ecotrans fitted this vehicle with four natural gas tanks, modified the Allison transmission to handle higher torque, recored the radiator, and fabricated new engine mounts. Ecotrans also adapted various vehicle systems such as: exhaust, inlet air, and electrical systems to interface with the new engine.
