# LAND DISPOSAL OF SAN LUIS DRAIN SEDIMENTS

## *Progress Report*

*October 1998 through November 2000*

Earth Sciences Division  
Lawrence Berkeley Laboratory  
University of California  
Berkeley, CA 94720

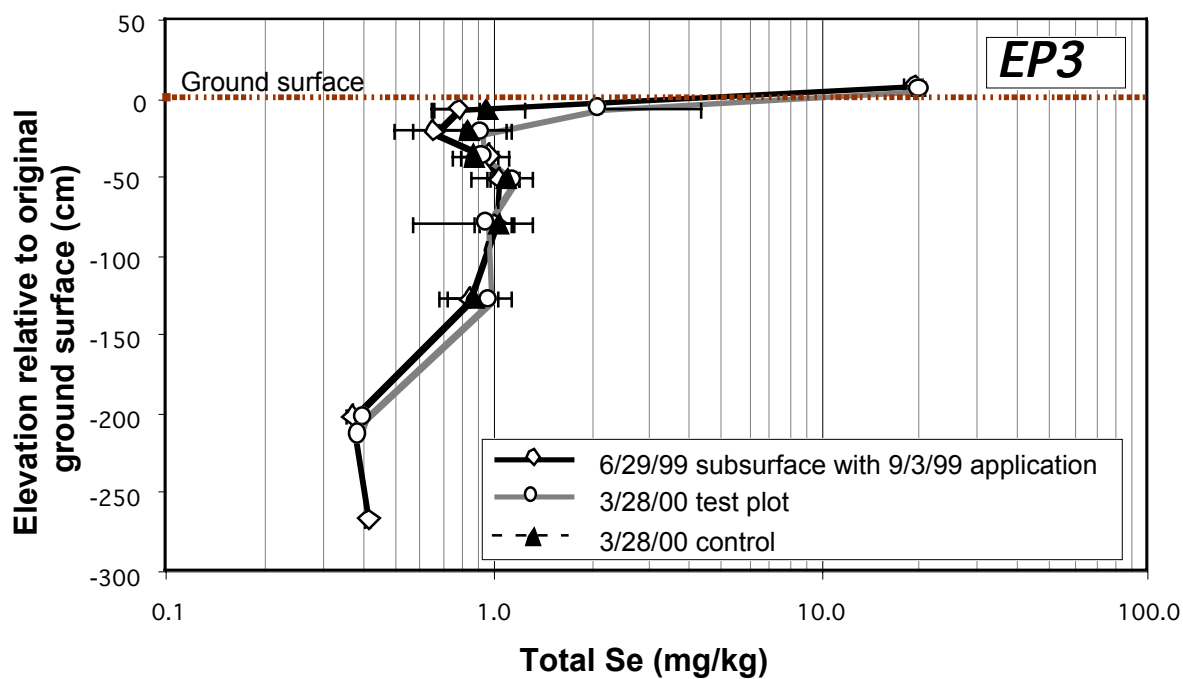
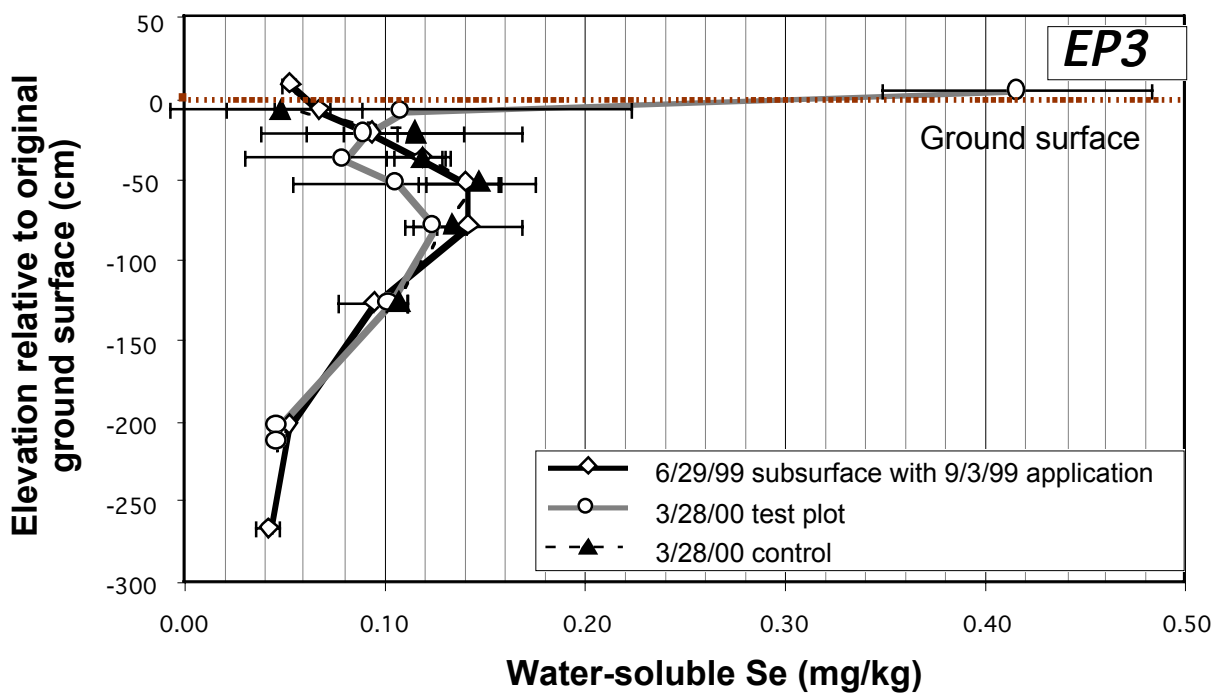
Figure 4.3. Total (a) and water-soluble (b) selenium concentrations normalized to soil mass in plot EP-3. Error bars represent one standard deviation on either side of the mean.

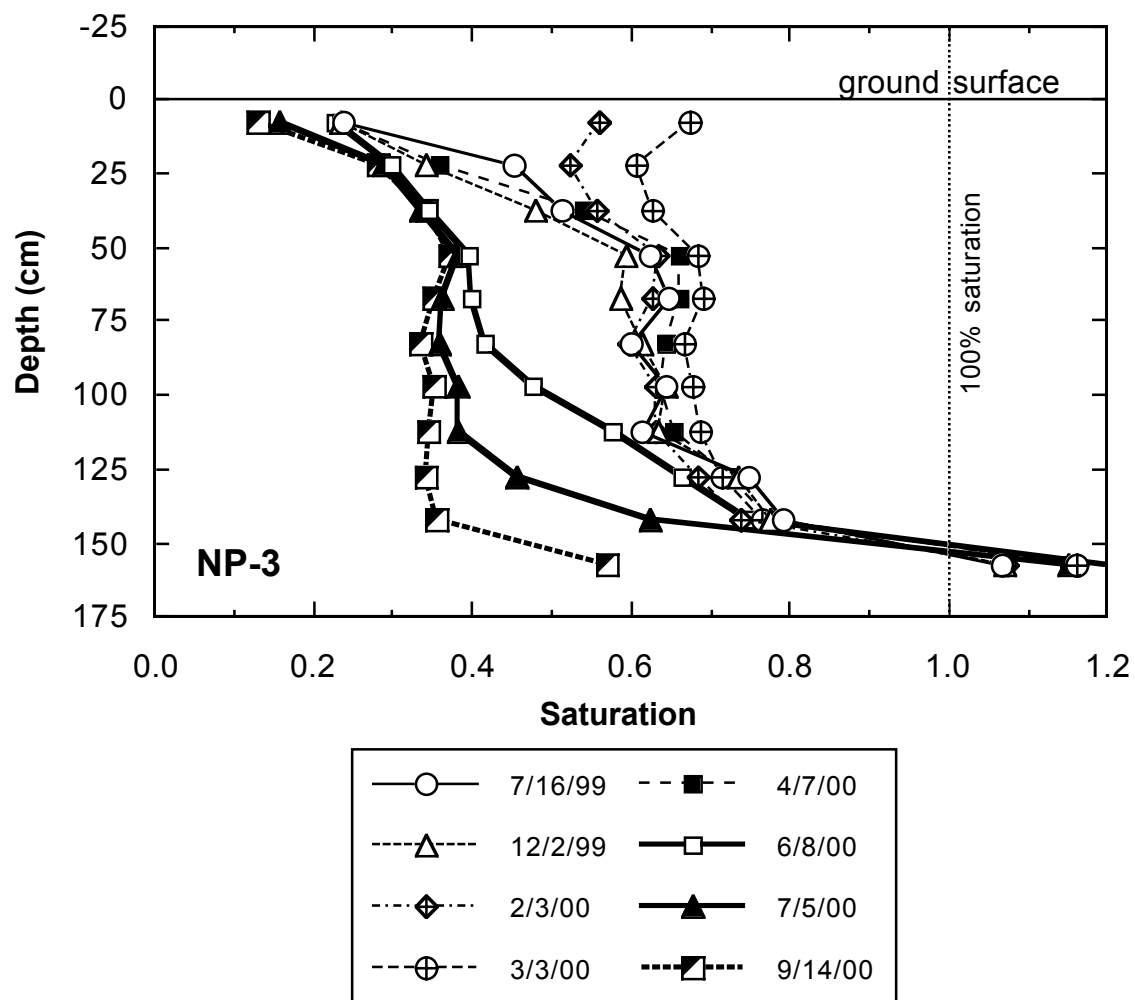
Figure 4.9. Sediment profile saturation at EP-1 (access hole NP-3) based on neutron probe measurements.

Neutron probe measurements and tensiometer readings were used in the embankment plots to measure moisture content and water potential, respectively. Moisture content (expressed as saturation) was derived from a calibration based on moisture measured in sediment cores vs. neutron probe readings in those boreholes shortly after sampling. This calibration curve is shown in Fig. 4.8. Representative results of moisture content (expressed as saturation) measurements from each of the embankment plots are shown in Figs. 4.9-4.11. Although there are some differences amongst the plots, the general trends are similar. Saturation increases in the winter, in particular at the sediment surface. Increases observed on 2/3/00 and 3/3/00 follow the bulk of the year's rainfall events. Within one month of the latter measurement, near-surface moisture content decreases to background levels. The extent of rainfall infiltration is marked by increases in moisture at depths of 0.40 m in EP-1, 20 cm in EP-2, and 10 cm in EP-3, relative to the original ground surface. Later decreases in saturation at greater depths (7-9/00, between 0.50 m and 1.00 cm) are likely a result of evapotranspiration.

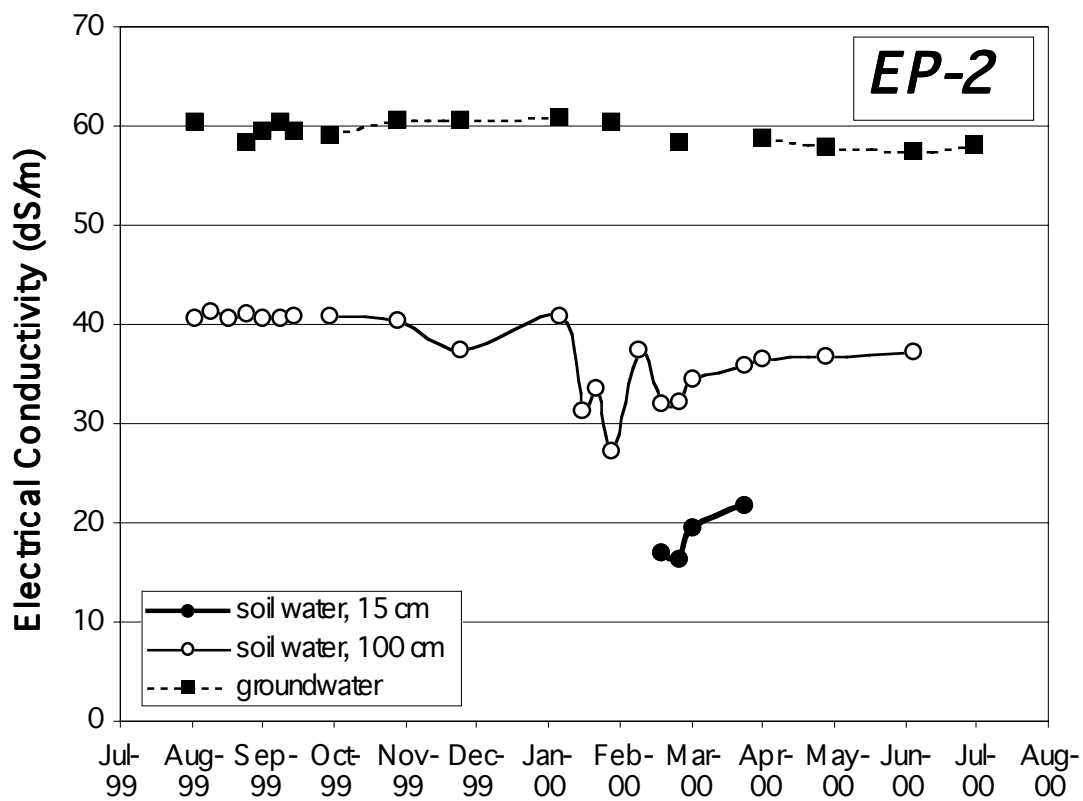
Figure 4.17. Soil water and groundwater EC in EP-2.

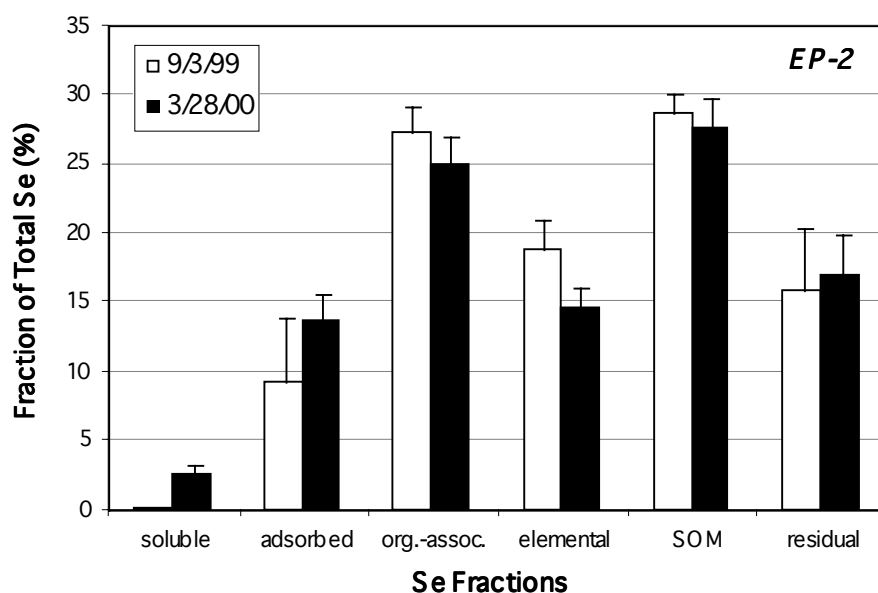
Figure 5.1. Selenium fractions in SLD sediment applied to EP-2.

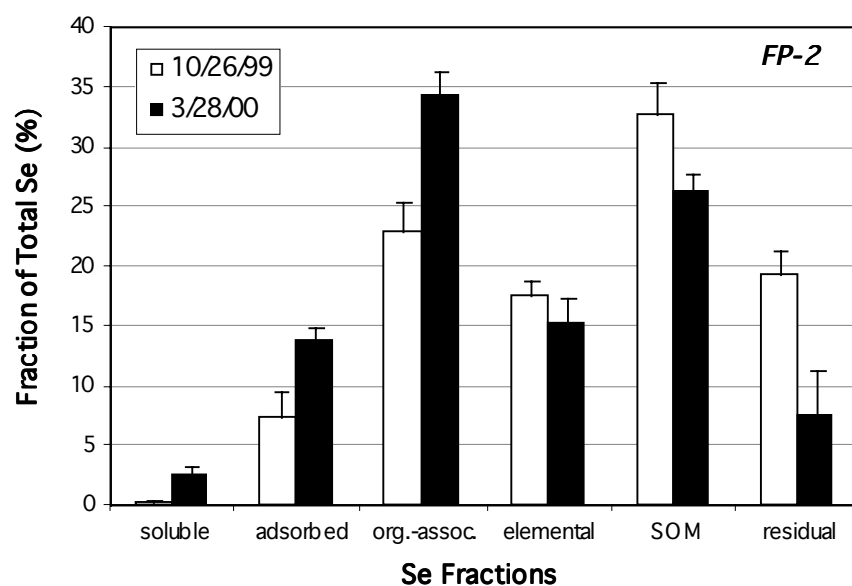
Figure 5.4. Selenium fractions in SLD sediment applied to FP-2.

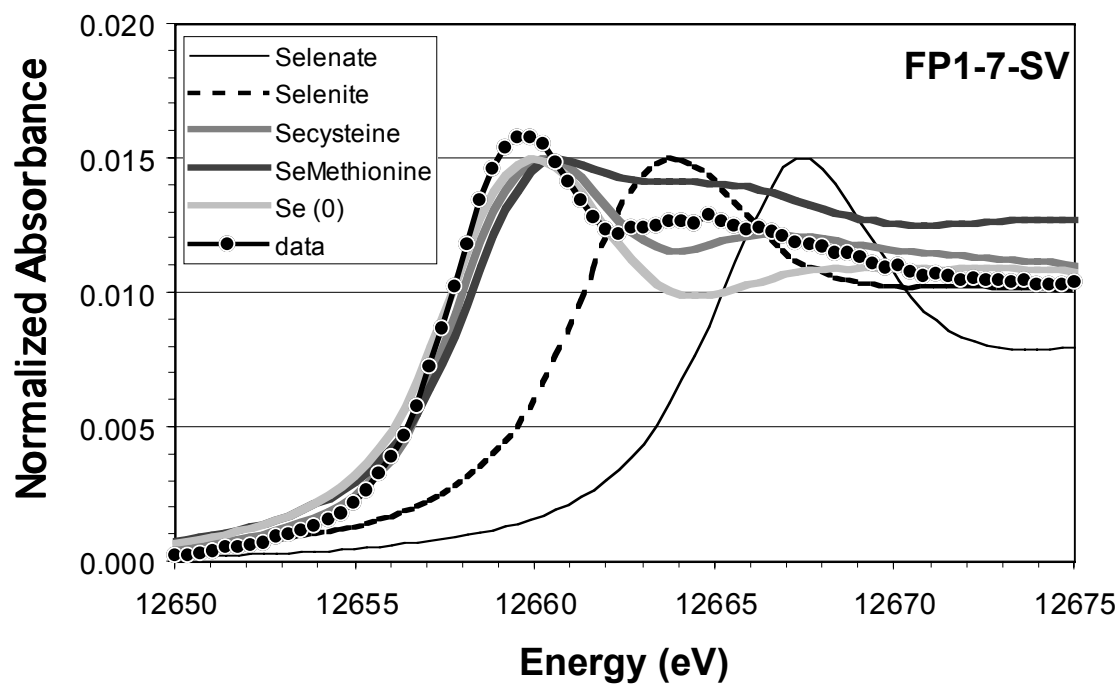
Figure 5.6. Selenium K-edge absorption spectra of Se standards and SLD sediment sample FP1-7-SV, collected on 10/21/99 immediately after application.

A number of samples were run in March and June 2000, but several of the results were compromised by beam instability and other experimental problems. Here we present two successful runs. The findings confirm the dominance of reduced Se species. In sample EP2-9-SV, (Fig. 5.5), which represents the initial sediment application to plot EP-2, and contained  $37.7 \mu\text{g g}^{-1}$  Se, the spectrum can best be fit with 100% elemental Se, although fits with 53%  $\text{Se}^0$  and 47% Se-cysteine are also satisfactory. Spectra of standard Se compounds are shown for qualitative comparison. The shape of the curve over the range of 12650 to 12680 eV was taken into account when running a fit for one, two, or three Se species. The initial SLD sediment sample applied to farm plot 1 is represented by sample FP1-7 and is shown in Fig. 5.6. The shape of the data is more complex and suggests the presence of  $\text{Se}^{+4}$ . Both a 100% Se-cysteine fit and an 87%  $\text{Se}^0$  plus 13%  $\text{Se}^{+4}$  fit adequately matched the data. The similarity of the elemental Se and organo-Se (especially Se-cysteine) standard spectra, and particularly their peaks, is a reminder that the distinction of these species in complex field samples is challenging. Nonetheless, the data confirm the predominance of reduced Se species in SLD sediment, with no detectable  $\text{Se}^{+6}$ . These findings agree qualitatively with results of sequential extractions. Additional x-ray runs were conducted in January 2001 and will be presented in a future report.

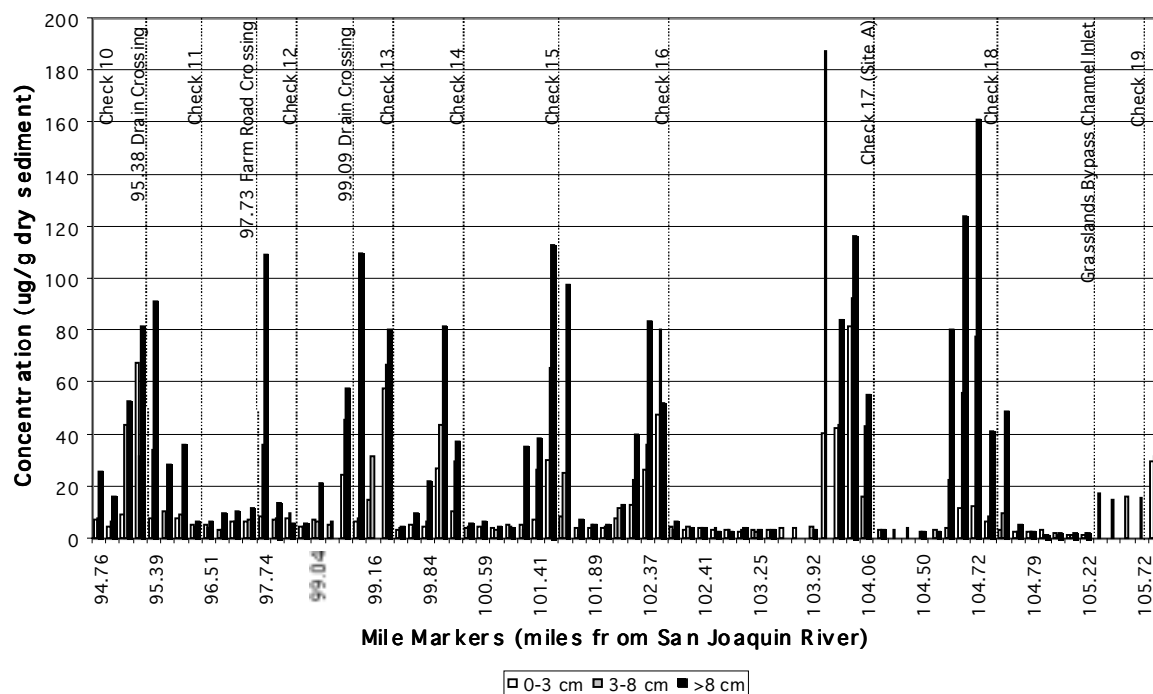
**Chart 3: Distribution of the Mass of Se  
along the San Luis Drain**  
LBNL Survey, December 1998 - March 1999

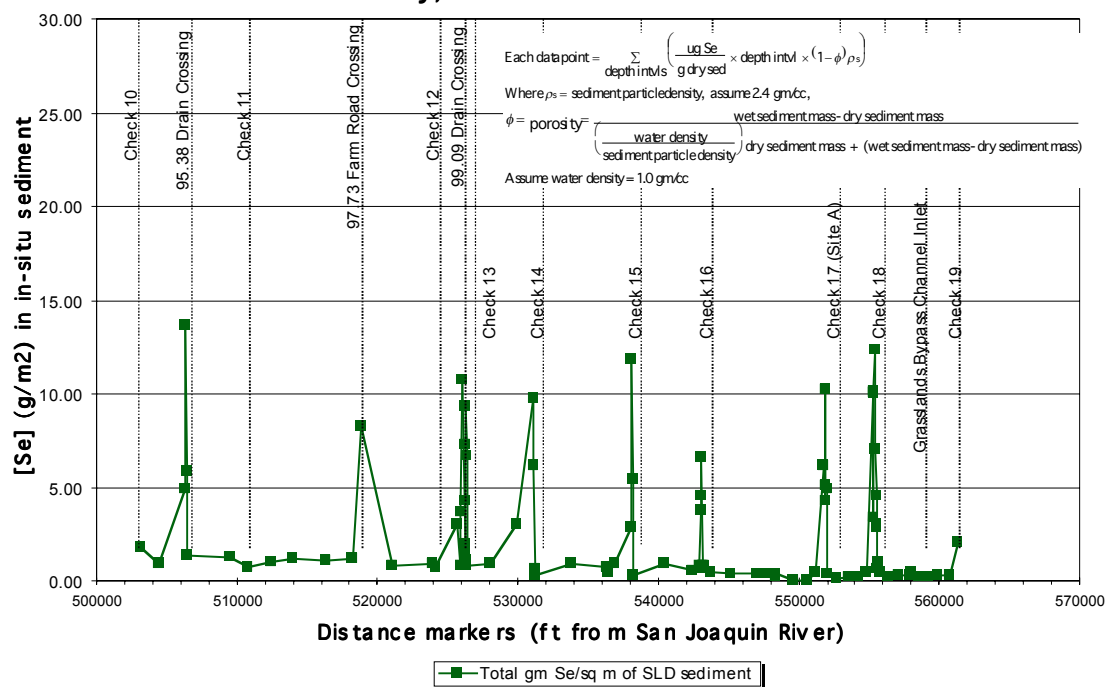
**Chart 4: Details of distribution of  
Se and sediments at Check 13**

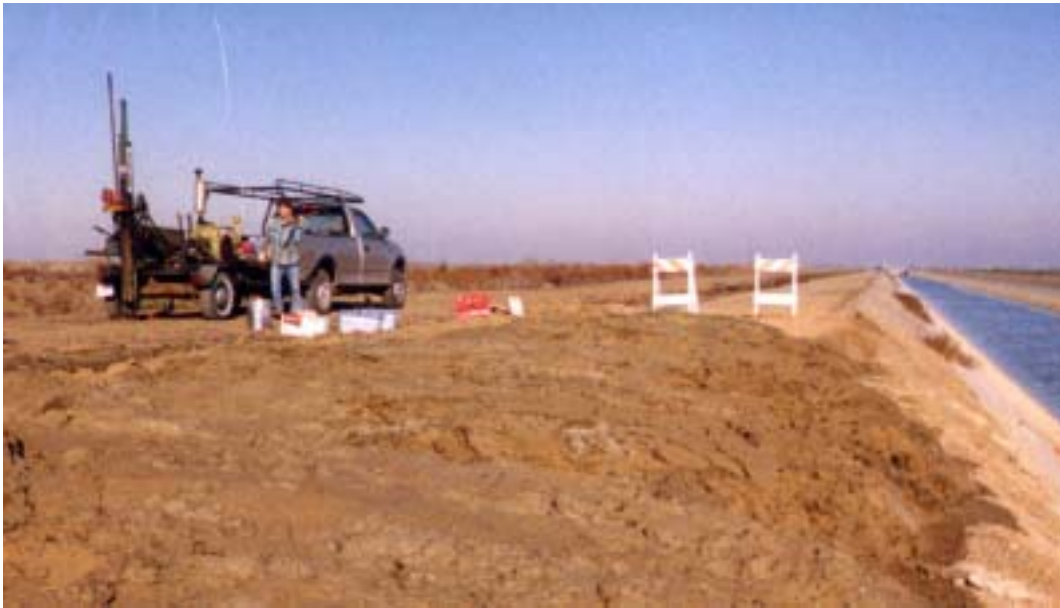
*Figure C.1. Dredged SLD sediment (EP-1) drying on berm. Soil core sampling and instrument installation in progress (December 1998). View to the north.*

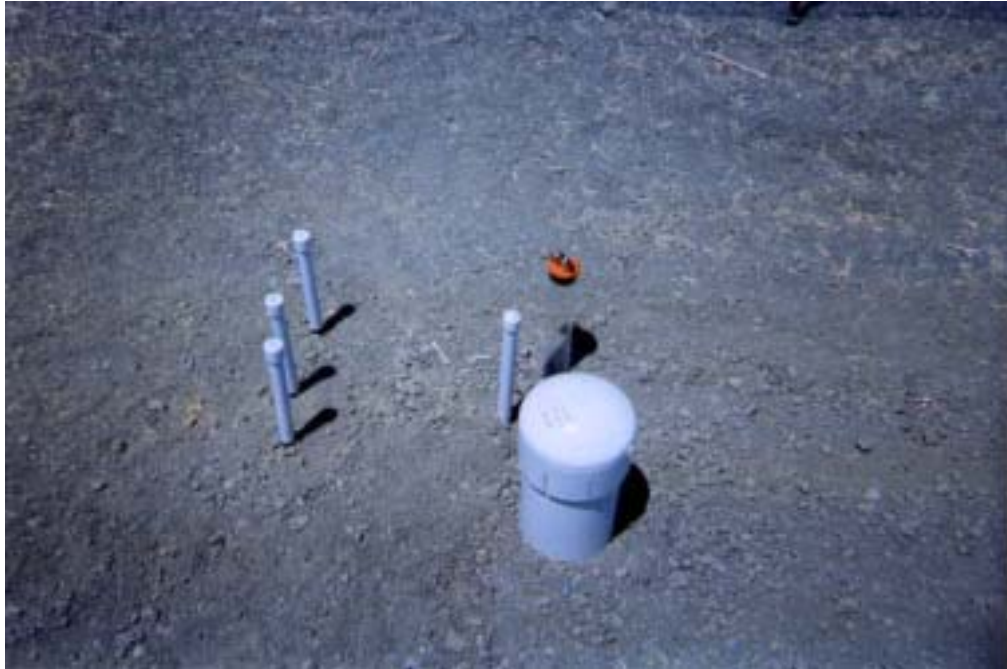
*Figure C.3. Instrument cluster 7 in EP-2. From left to right: tensiometers (covered with PVC pipe), neutron probe access pipe (clear acrylic), and soil water suction lysimeters (under large PVC cap).*

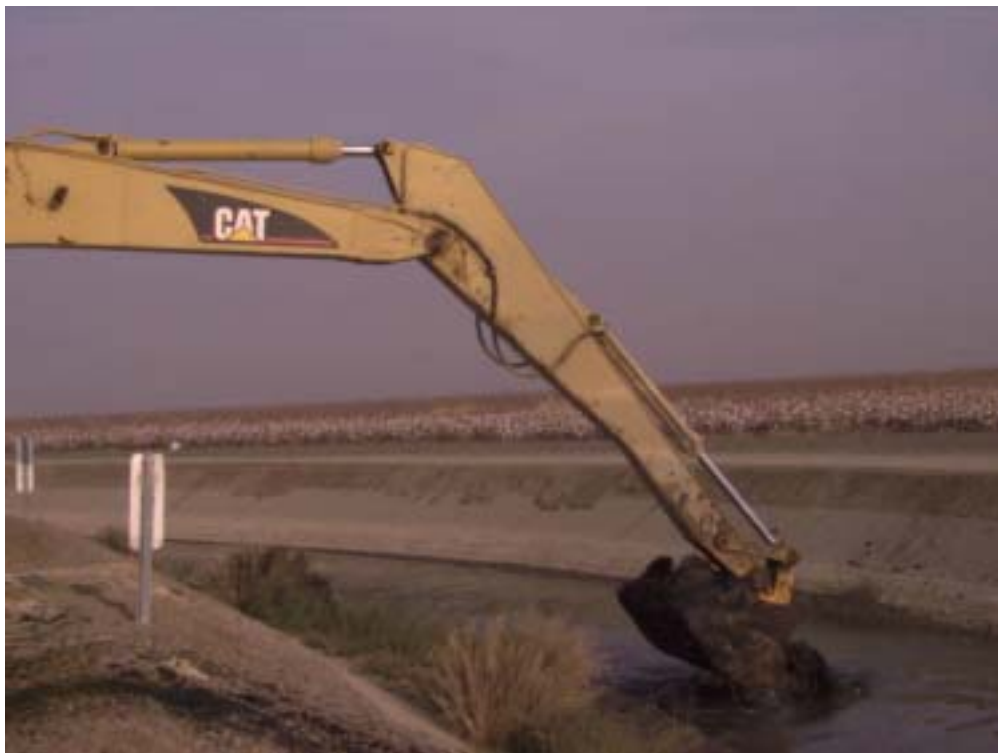
*Figure C.4. Dredging of SLD sediment.*

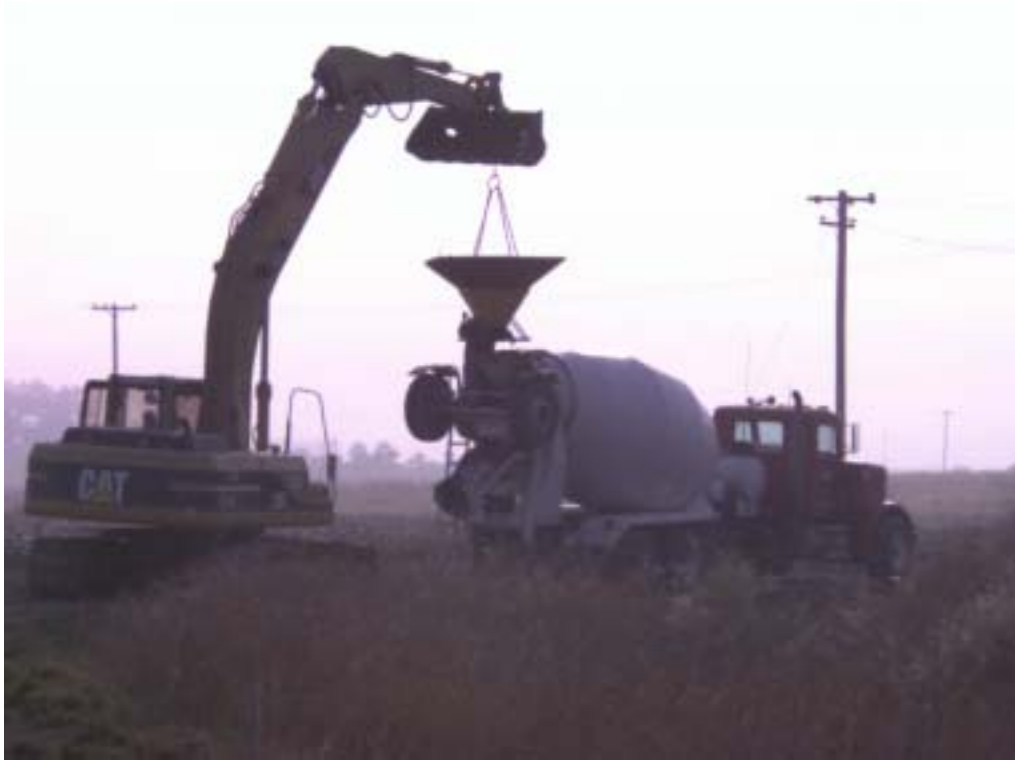
*Figure C.5. SLD sediment being placed in cement truck via hopper.*

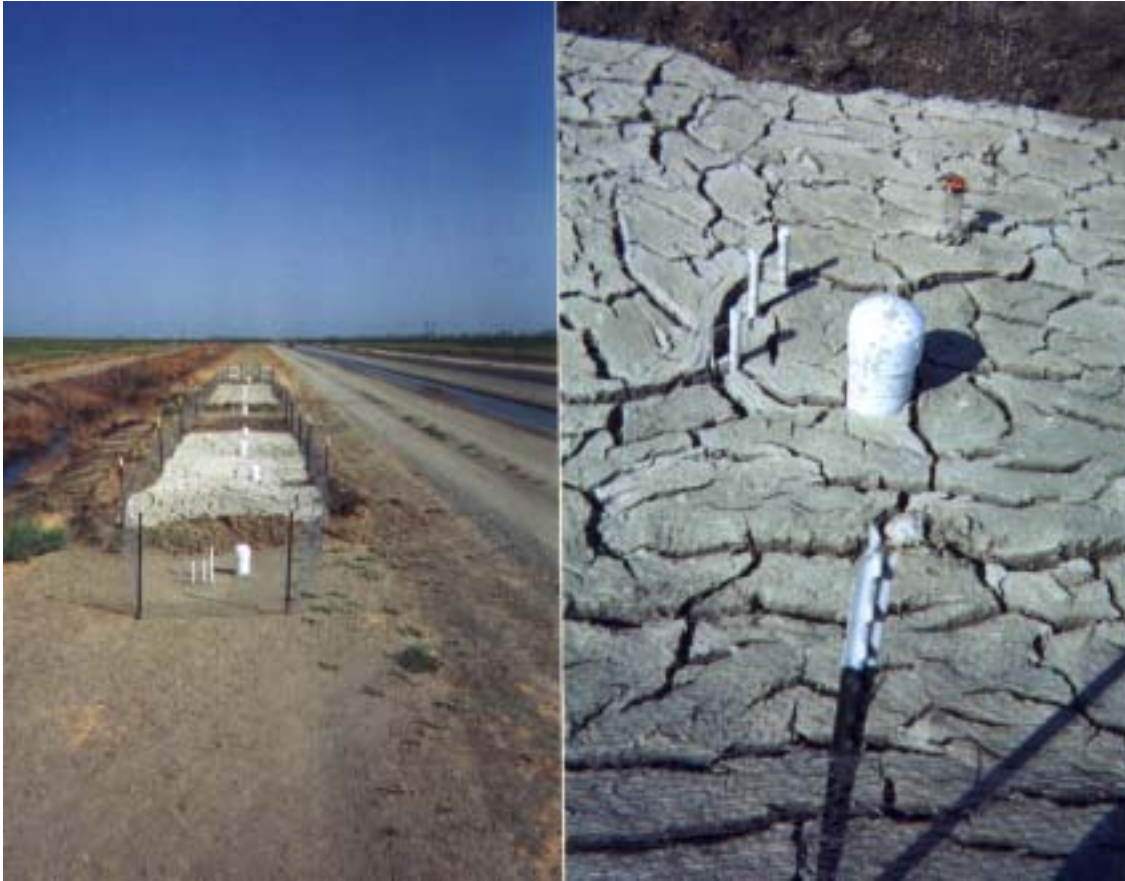
*Figure C.7. Left: Sites EP-2 and EP3 after a few days of drying (9/9/99). Close-up view of drying cracks around one of the monitoring clusters (right).*

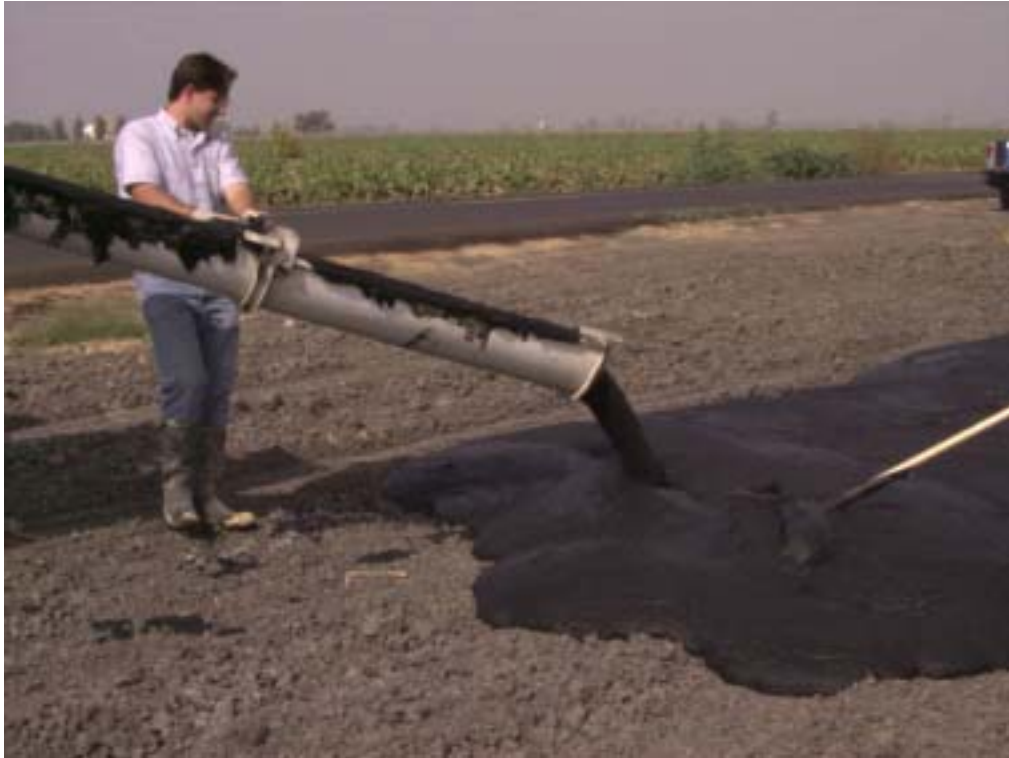
*Figure C.8. Application of SLD sediments to FP-1 using cement-truck chute (10/21/99).*

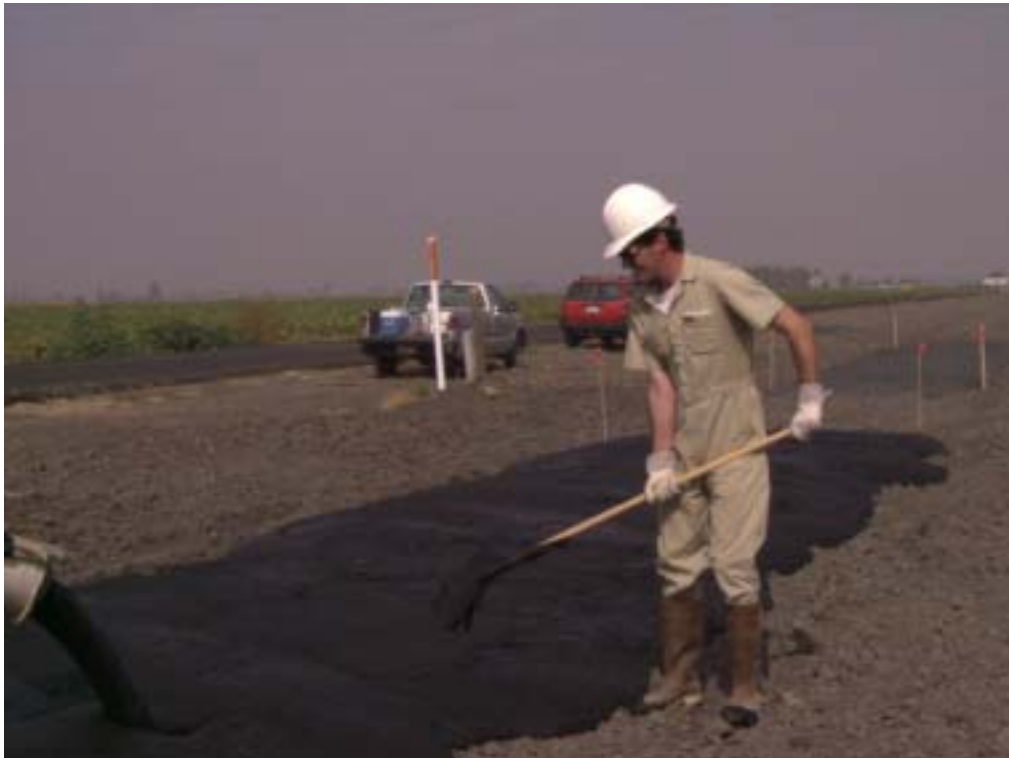
*Figure C.9. Spreading of SLD sediments in FP-1 using cement rake (10/21/99)*

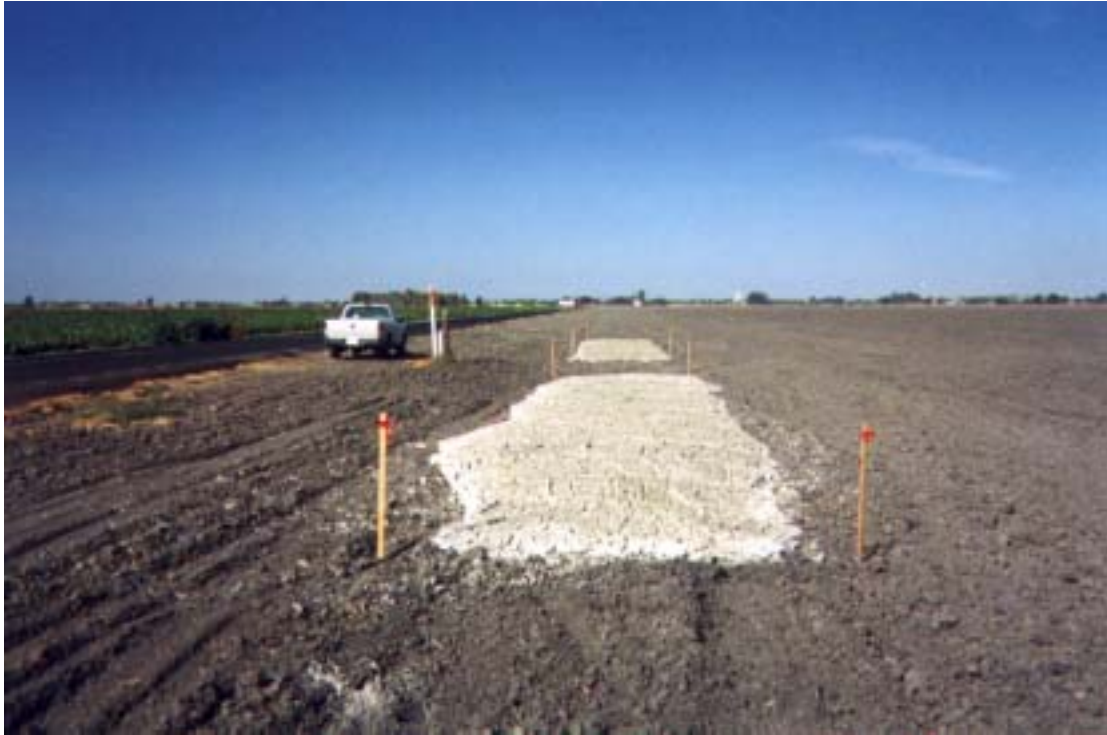
*Figure C.10. Sites FP-1 (foreground) and FP-2 after a few days of drying (10/28/99). View to the north.*

The application was subsequently incorporated into the soil by the following sequence of events. By 10/28/99, the farm plot applications had become gray and fissured with drying cracks. There had been no record of rain at the test site up to 11/5/99. On 11/15/99 the farm plots were plowed by shanks that cut to 0.45-0.50 m depth, with 0.45 m lateral separation. On 11/19/99, the plots
