Title: Advanced Cuttings Transport Study

Type of Report: Quarterly Technical

Reporting Period Start Date: April 1, 2004

The University of Tulsa

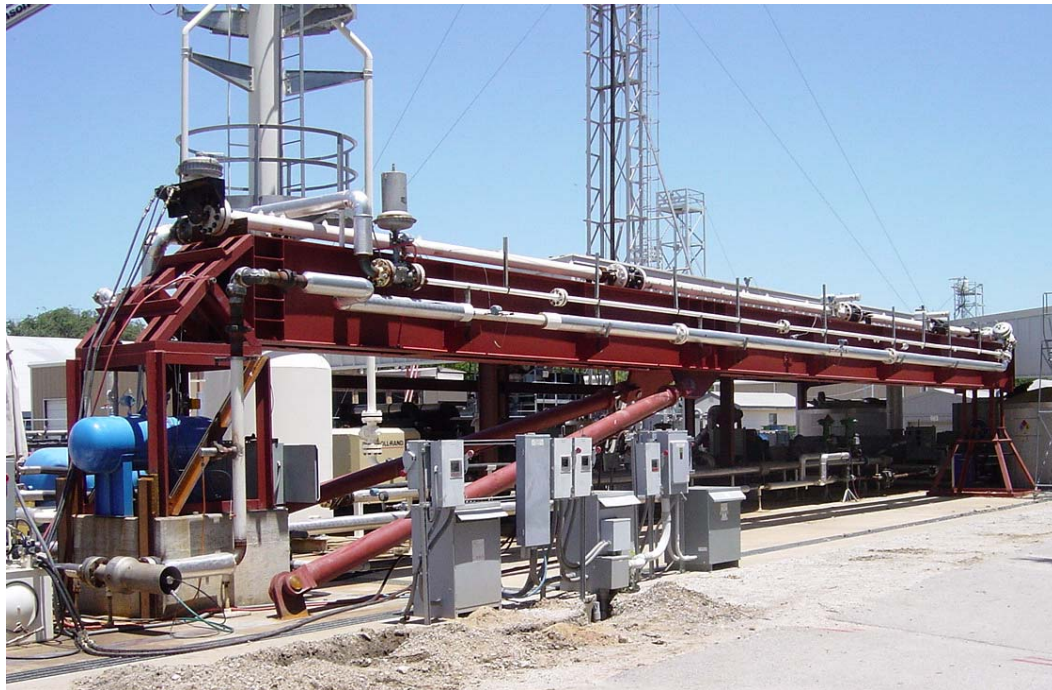
Fig. 2.1 Mast together with the hydraulic cylinders

After installation of the mast, the annular test section and pipe rotation system were reassembled. One additional view port was installed in the test section. Nuclear densitometers have been calibrated and reinstalled. During the installation, the densitometers have been reoriented to fit with the test section and its support system. The expansion tank was relocated to beneath the mast support (Fig. 2.1).

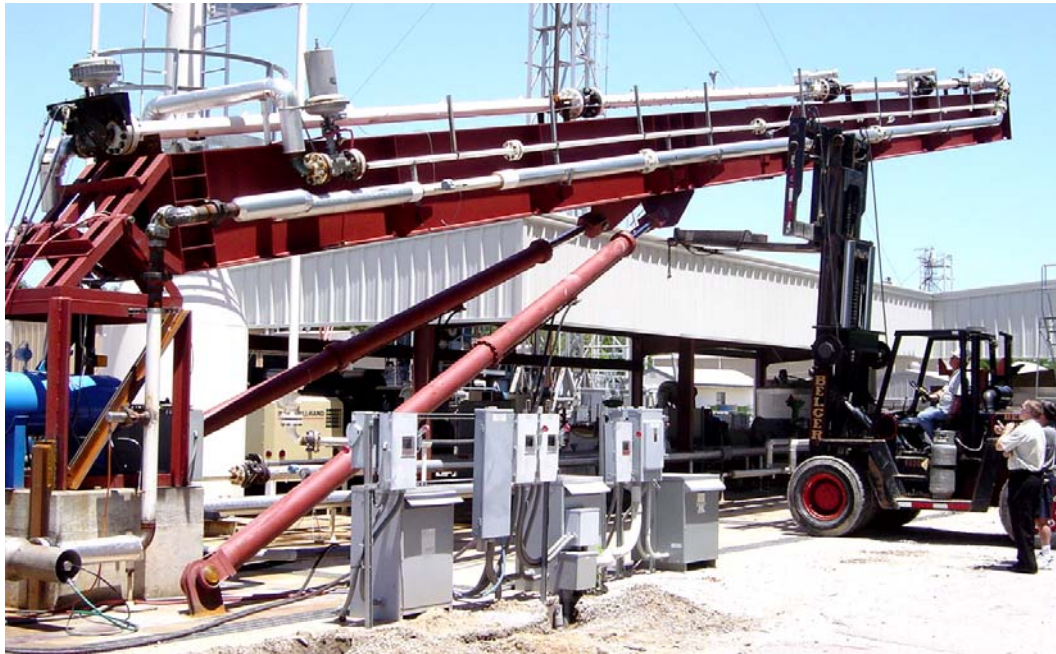
Fig. 2.2 Mast when raised approximately 10 degrees

degrees (Fig. 2.2). We then continued upward using only the hydraulic cylinders to approximately 25 to 30 degrees inclination (Figs. 2.3a & 2.3b). All went very well.

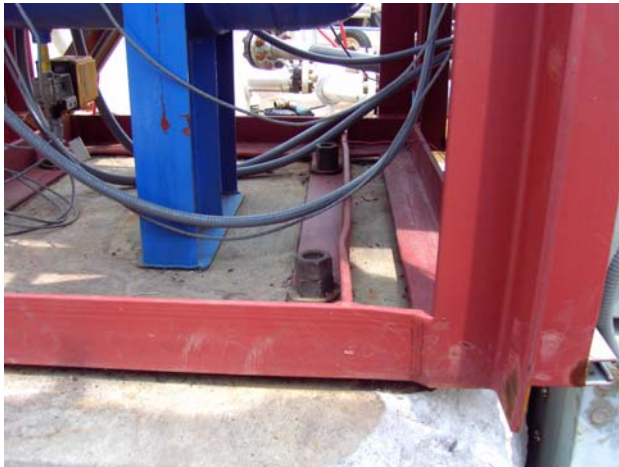
Fig. 2.4 Deformed mast support structure

We decided next to lower the mast and lift from horizontal without the assist of the fork lift. While lowering the mast, it moved laterally a couple of degrees. Upon visual inspection, severe spalling of the concrete on the face of the support pillar, and deformation of the steel support structure, was observed. With the aid of a crane, the mast was then lowered to its original horizontal position.

No damage appears to have occurred in the mast itself, the hydraulic cylinders, attachment points for the hydraulic cylinders, the concrete base, the steel I-beam sub-structure, the attachment j-bolts, or the concrete pillar other than superficial spalling on two corners. The support structure is sound and will continue to provide excellent support to the mast for all future experiments in the horizontal configuration. The support structure will, however, have to be re-built to be able to operate the mast in any elevated configuration.

There is not one single component or action that stands out as the definitive explanation of failure of the support structure. Certainly in the higher stress condition created during the initial lift of the mast from horizontal, and through continued lifting, no problems were evidenced at all. Quite the contrary, knowing we were past the critical stress stage it was a moment of congratulation that all was going flawlessly. When the mast was begun to be lowered, however, one cylinder obviously favored the other and torsion was imposed to such a degree that the support structure became deformed (see Fig. 2.4). The design of the support structure is shown in Fig. 2.5.

As it became deformed, the front corners (those corners closest to the hydraulic cylinders and resting on the concrete) imposed a point load onto the concrete and caused it to spall off in those areas. As the mast was continued to be lowered, the support structure further deformed, and the mast rotated.

The mechanism which caused one cylinder to be favored is complex beyond our means to understand at this juncture. Perhaps when we are able to disassemble the support structure we will learn more. Without any instrumentation on the cylinders to monitor the pressure on each cylinder's piston we can't say absolutely that, for example, one cylinder received more pressure than the other and that caused the torsion. We do know how the hydraulic pump and the valves and lines that go to the cylinders work and we can see that it should not be possible for one cylinder to see more pressure than the other.

However, due to the length of the mast there is an opportunity to magnify any tendencies toward misalignment. Also, there was no overt effort to design the support structure for strength against torsion. Therefore, it is our hypothesis that the hydraulic cylinders not pushing at the same rate was the primary causative problem. Repairs, of course, are dependant on the availability of sufficient budget; however we anticipate that the repairs we will proceed with will include a support structure which will be resistant to torsion and a means by which the cylinders may be collectively monitored and individually controlled. We will be consulting with others who have experience with hydraulic systems similar to this to help us.

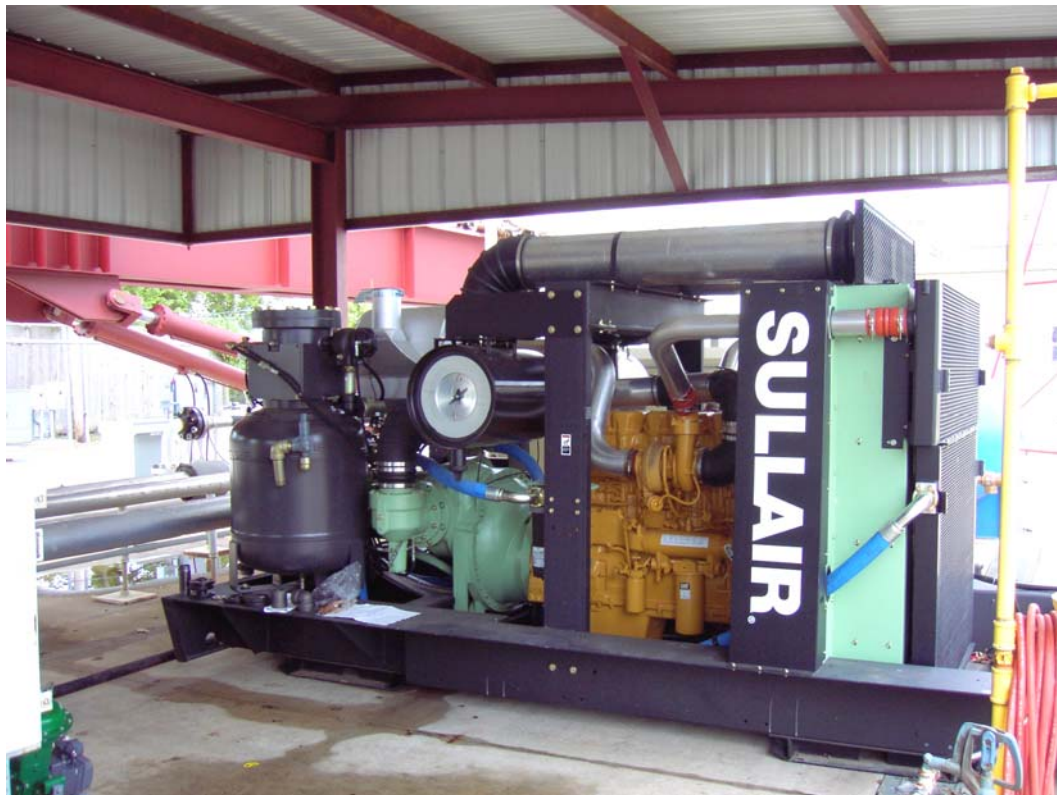
Fig. 2.6 New air compressor

At this time, the facility is ready for testing in the horizontal position. As reported in last quarter's report, a new air compressor has been purchased for the ACTS test loop. Pictured below (Fig. 2.6), this compressor has been and set in place.

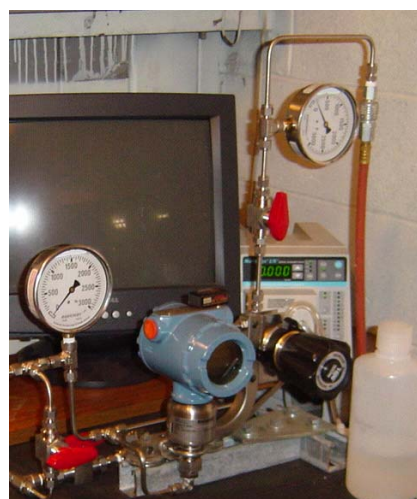
Fig. 3.4 Air and liquid injection systems

Some auxiliary components are necessary for proper functioning of the Foam Generator/Viscometer; these are: i) a low-volume metering pump (Fig. 3.4) that can meter and pump proper the amount of liquid into the mixing chamber; and ii) a gas source (Fig. 3.4) with pressure regulators, gauges and control valves to introduce gas at a selected pressure into the mixing chamber and the pneumatic chamber. The pneumatic chamber maintains constant pressure in the mixing chamber when foam flows from the mixing chamber to the viscometer.

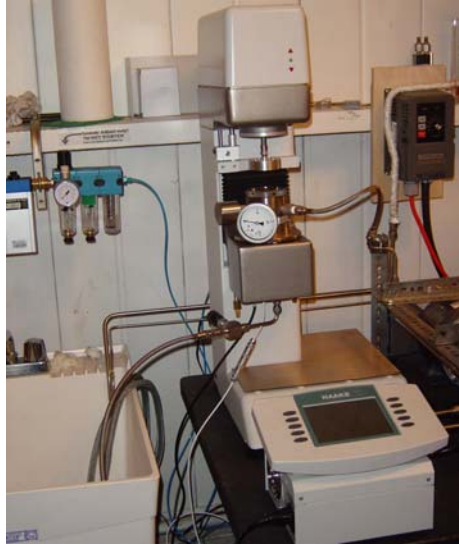
Fig. 3.5 Viscometer (RS300)

The Thermo Haake RS 300 viscometer (Fig. 3.5) was specifically selected because it enables foam to enter at the top of the measurement cup and leave at the bottom; thus, during the rheology measurement process, any foam degradation such as drainage and bubble coalescence is compensated by introducing new foam into the measuring cup. It allows using rotors with different roughnesses; and rotary speeds to give a controlled shear rate. It also has elevated pressure and temperature measurement capabilities. The foam texture can be assessed at the view-port upstream of the viscometer using a microscope and CCD camera (Fig. 3.6).

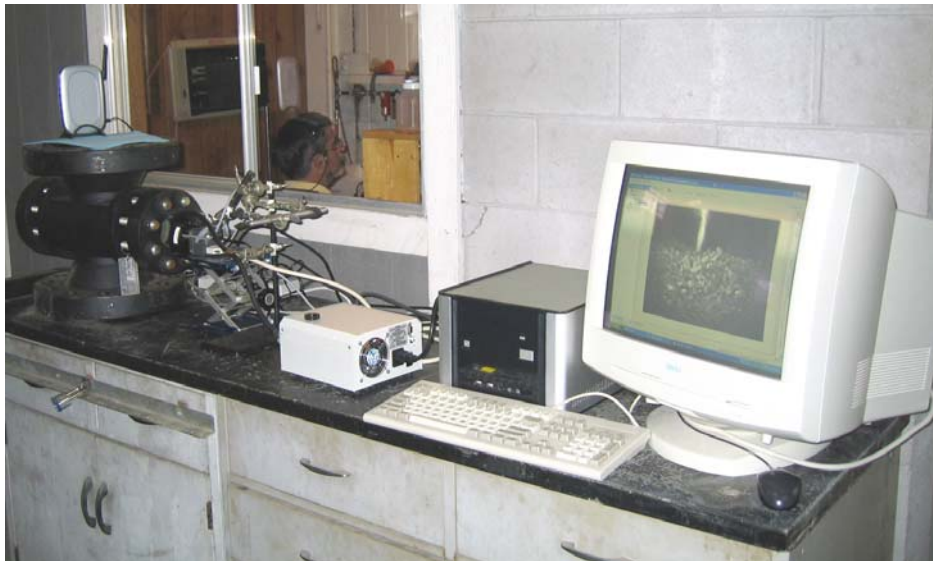
Fig. 7.1 On-line vision system

A picture showing a setup of on-line system is shown in Fig. 7.1. The CCD camera (Hitachi KP F-120 CL progressive scan with 1.45M pixels, see Fig. 7.2) was installed close to the view port (Fig. 7.3) to capture real-time images. A camera link grabber (National Instruments PCI-1428) was installed on the in-line computer and connected to CCD camera through a 2-meter camera link cable. The camera link grabber was used to process the signals obtained by the CCD camera.

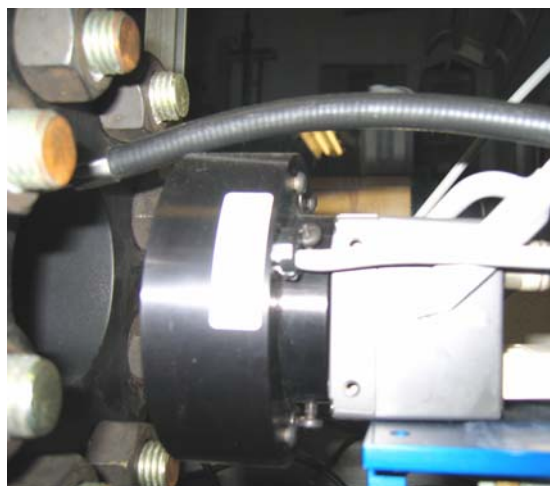
Fig. 7.7 CCD camera with fiber light and ring light installed

Lab tests were conducted to check the on-line vision system. Sharp images were obtained through the CCD camera with the use of the ring light or the fiber light. Figure 7.7 shows the picture of CCD camera with both light sources (Fiber light and Ring light) installed. Preliminary results indicate that fiber light provides a better image while ring lights show reflection problems. During the lab tests, it was found that up to 15 frames per second can be achieved when grabbing continuous images. The "Client-Server" control system was tested in the lab. Tests results showed good response rate.

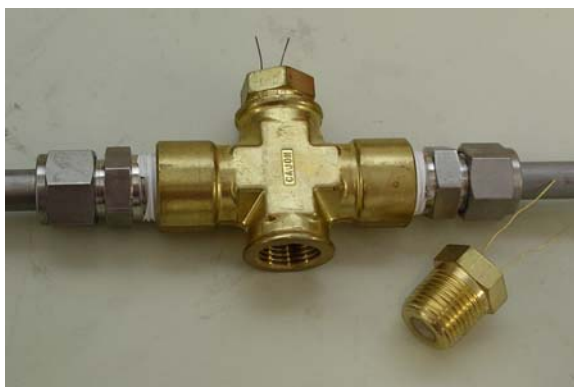
Fig. 7.8 Prototype device for measuring the average bubble size of foam

Figure 7.8 shows a prototype of the device for measuring the average bubble size for the foam generator-viscometer. This prototype is constructed from a $\frac{1}{2}$ " fitting. Light is supplied by a white light-emitting diode (LED) shown at the top of the photo, and the transmitted light is recorded by a photodiode, located in the fitting shown removed. Both the LED and photodiode are separated from the foam by small glass windows.

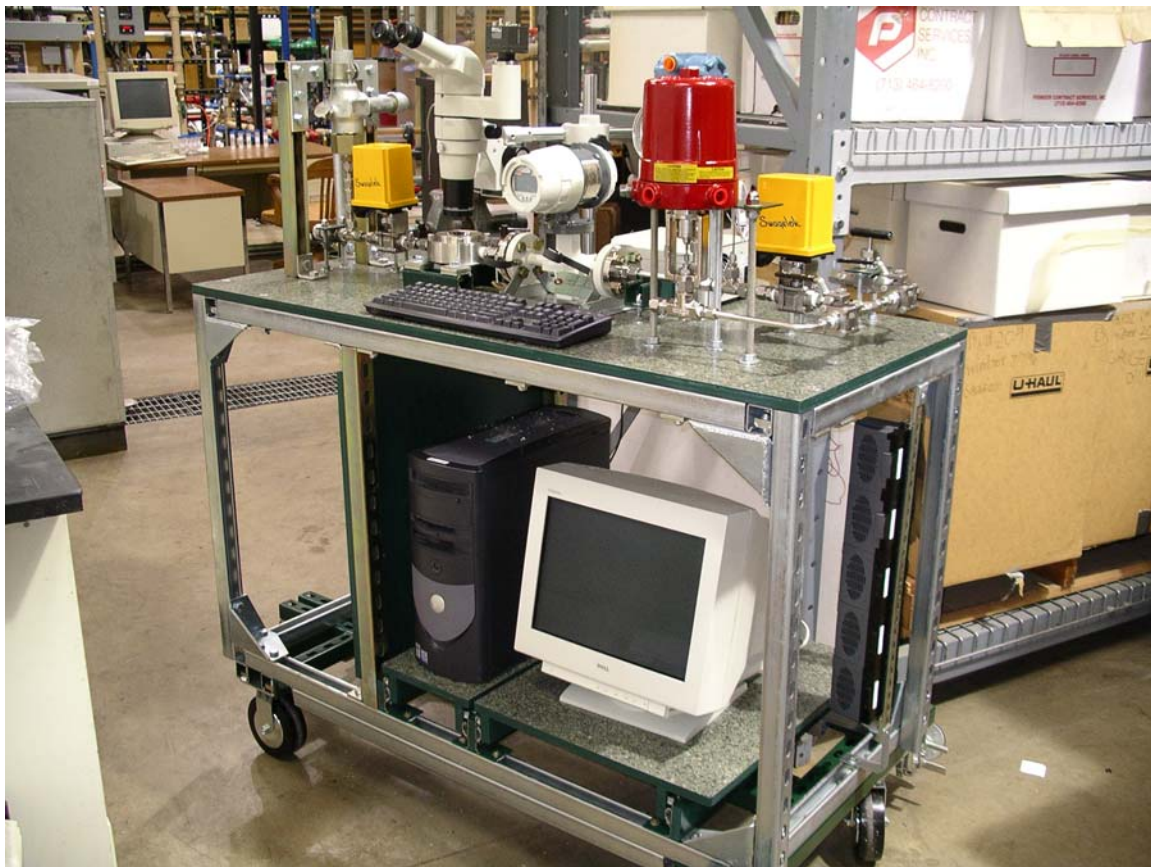
Fig. 7.10 ACTF bubble characterization cart

The CPU and computer monitor are shown below the instrumentation platform. The computer is connected to the electrical components on the instrumentation platform through the data acquisition system, shown mounted vertically just inside the right rear corner of the Cart next to the monitor. Communication between the Cart and the Control Room is done wirelessly. Roll-out shelves help access to the CPU and monitor. Large, heavy-duty 6" wheels allow the Cart to be moved into place at several monitoring stations on the ACTF. Once in place, floor jacks can be activated to stabilize the Cart.
