**Development and Evaluation of Passive Integrated
Transponder Tag Technology, 2000-2002**

Sandra L. Downing, Earl F. Prentice, Edmund P. Nunnallee, and Bruce F. Jonasson

April 2004

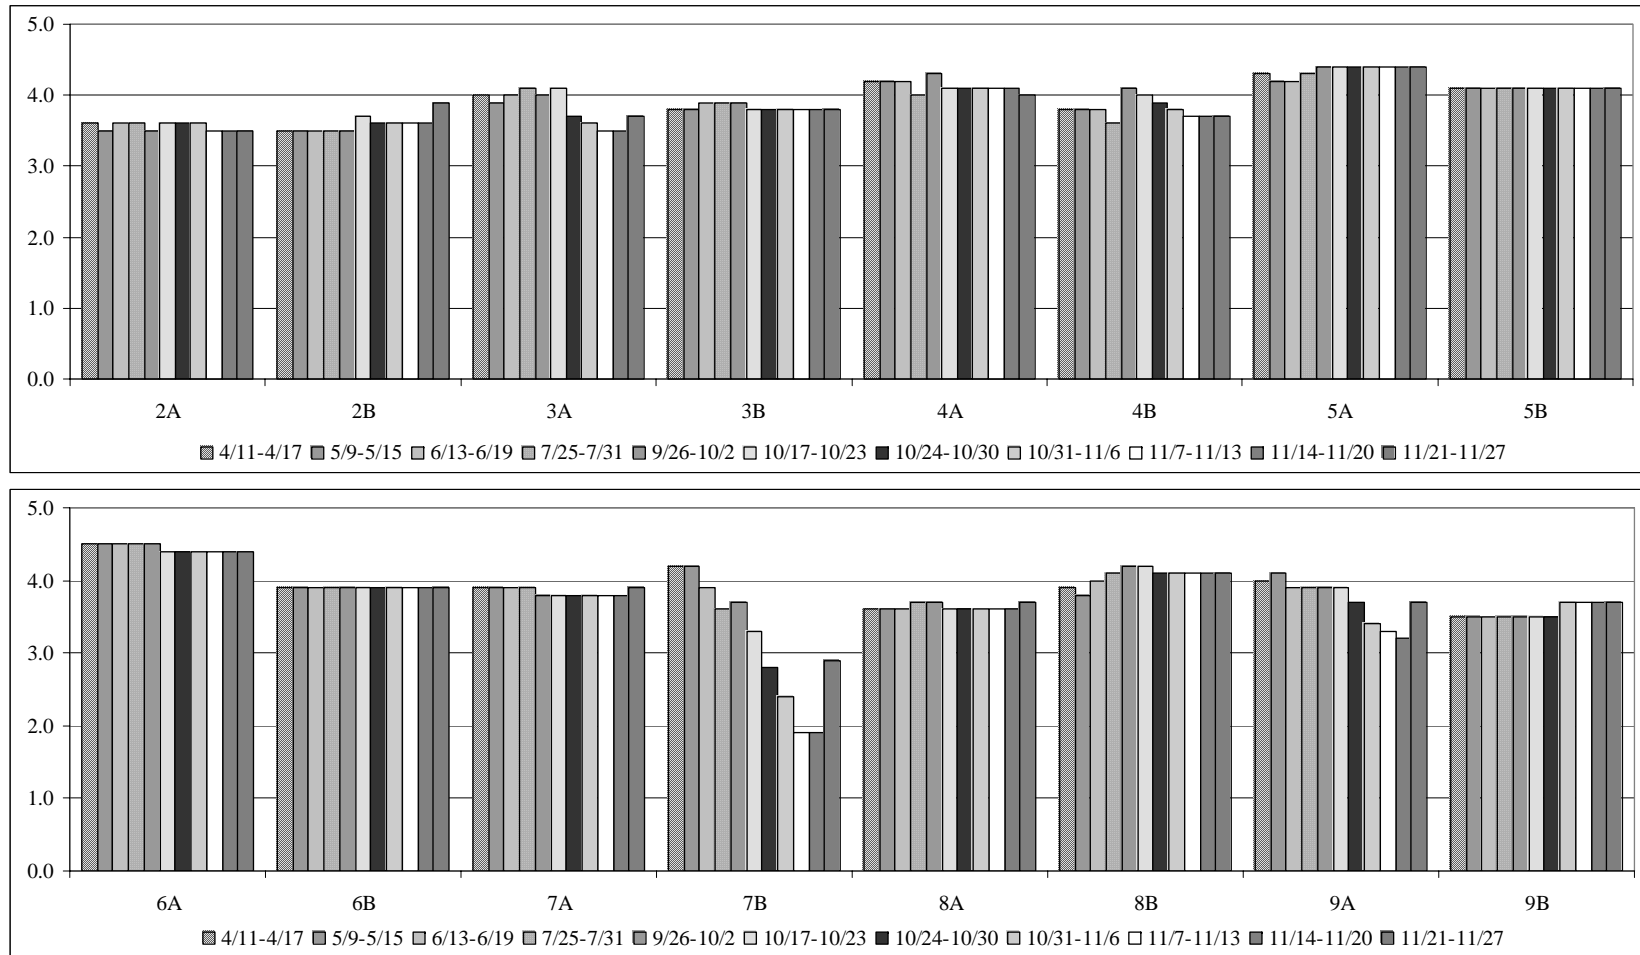
Figure 1. Antenna tuning current values collected during 2001 for the interrogation units in the upper eight-weir section of the prototype system installed into BWSL. Some of these 2001 values show the stair-step pattern exhibited by antennas containing moisture (Antennas 3A, 7B, & 9A). The transceivers were retuned on 22 November.

This new antenna design appeared acceptable until the end of October 2001, when the tuning values for several transceivers at BWSL dramatically decreased. These values displayed a stair-step pattern, where current would drop and then remain constant for a time and then drop again. Simulation tests conducted to duplicate the problem suggested strongly that some moisture had reached either the antenna wires or the capacitors.

This design appeared acceptable until the end of October 2001, when the tuning current values for several transceivers at BWSL (Orifice antennas 3A, 7B, 9A) dramatically decreased (Fig. 1). The values for Antenna 4B decreased to a lesser degree. The current values displayed a stair-step pattern, where they would drop and then remain constant for a time and then drop again. Simulation tests conducted in the laboratory to duplicate the problem suggested strongly that to achieve this stair-step pattern it was necessary for some moisture to reach the high voltage side of the antenna (either wires or the capacitors). Retuning the antennas on 22 November did improve the current values for the problematic antennas (Fig. 1).

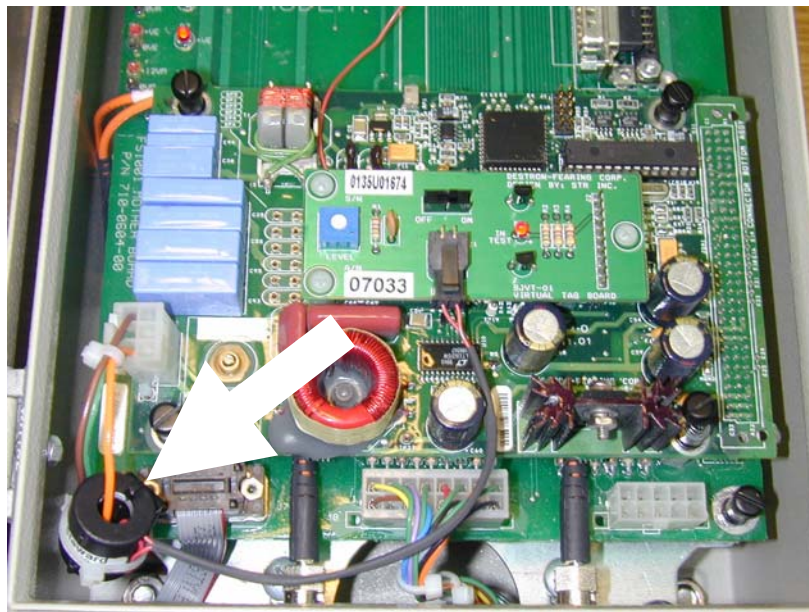
Figure 2. Arrow points to the virtual test tag designed for the FS1001A transceiver. The new component was attached to the analog board within the transceiver.

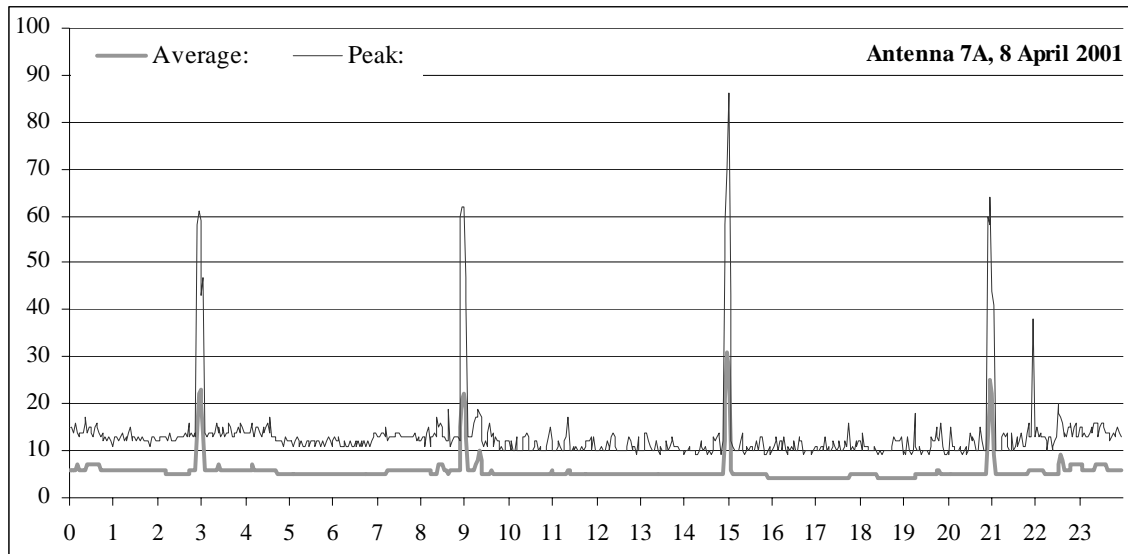
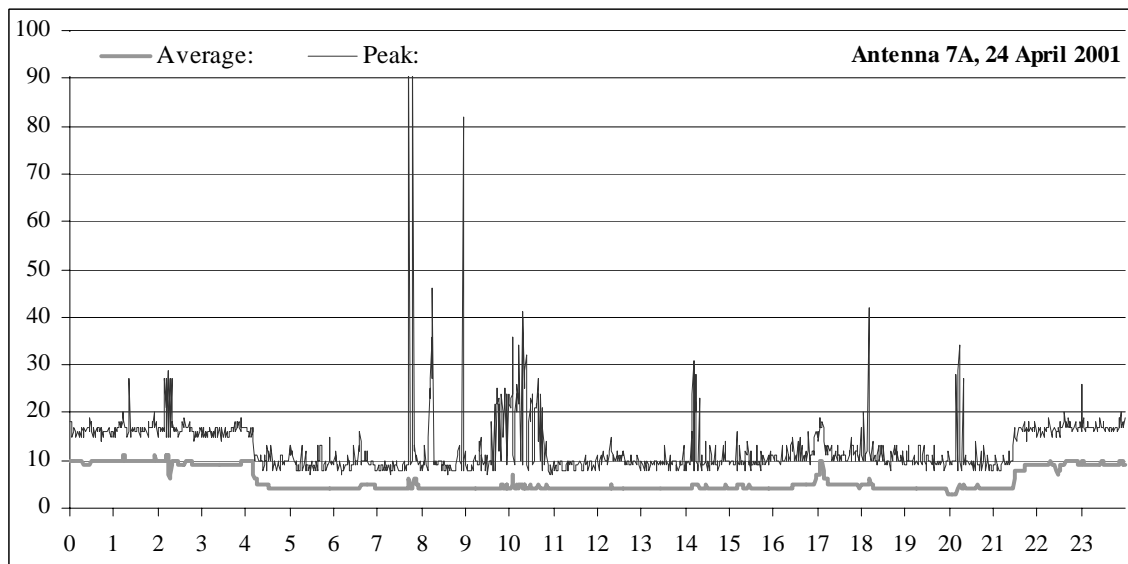
Figure 3. Daily graphs of the average and peak noise levels (percentages) for Antenna 7A in BWSL for 8 April (top) and 24 April (bottom). Filters were installed on the line side of each of the three motor controllers for the screen cleaners located in the downstream-migrant channel of Powerhouse II on 24 April. On 24 April, the cleaners were run continuously for about an hour (0930-1045 on graph).

When the transceivers were installed, we found that the variable frequency drives in the motor controllers for the screen cleaners in the downstream migrant channel of Powerhouse II were causing considerable electromagnetic interference (EMI) with some of the transceivers. The noise levels were substantially attenuated when filters were installed on the line side of each of the three motor controllers.

During this time, the average noise level did not significantly increase, but there were spikes of moderate amplitude in the peak noise levels. This pattern suggests that the filters removed a large amount of the noise, but not all. General noise monitoring of the transceiver installation continued during 2001, but no further action was necessary in regard to noise generated by the screen cleaners.

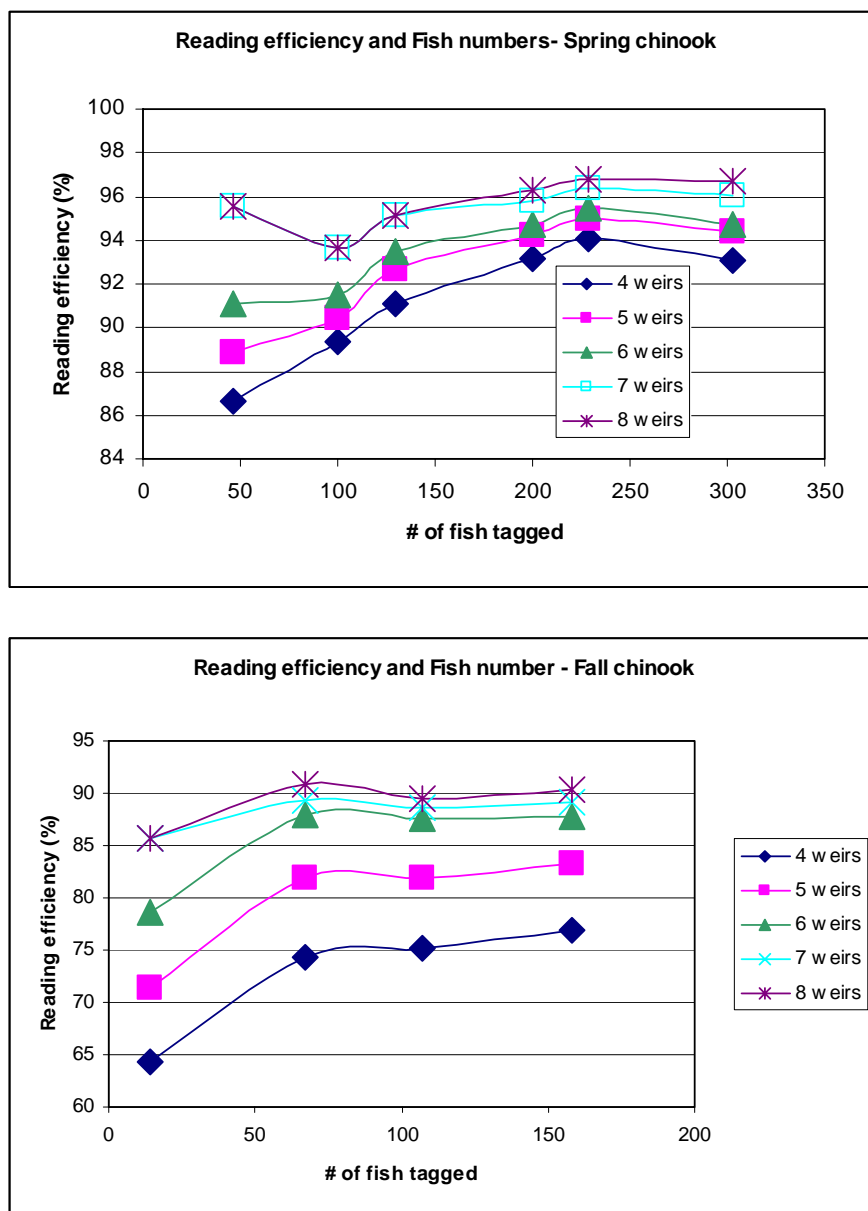
Figure 14. Figures show the relationship between numbers of chinook salmon tagged and precision of reading efficiency values for different number of weirs. The data displayed in the top figure are from the spring chinook salmon data collected during April 2001 and data displayed in the bottom figure are from the fall chinook salmon data collected during September 2001.

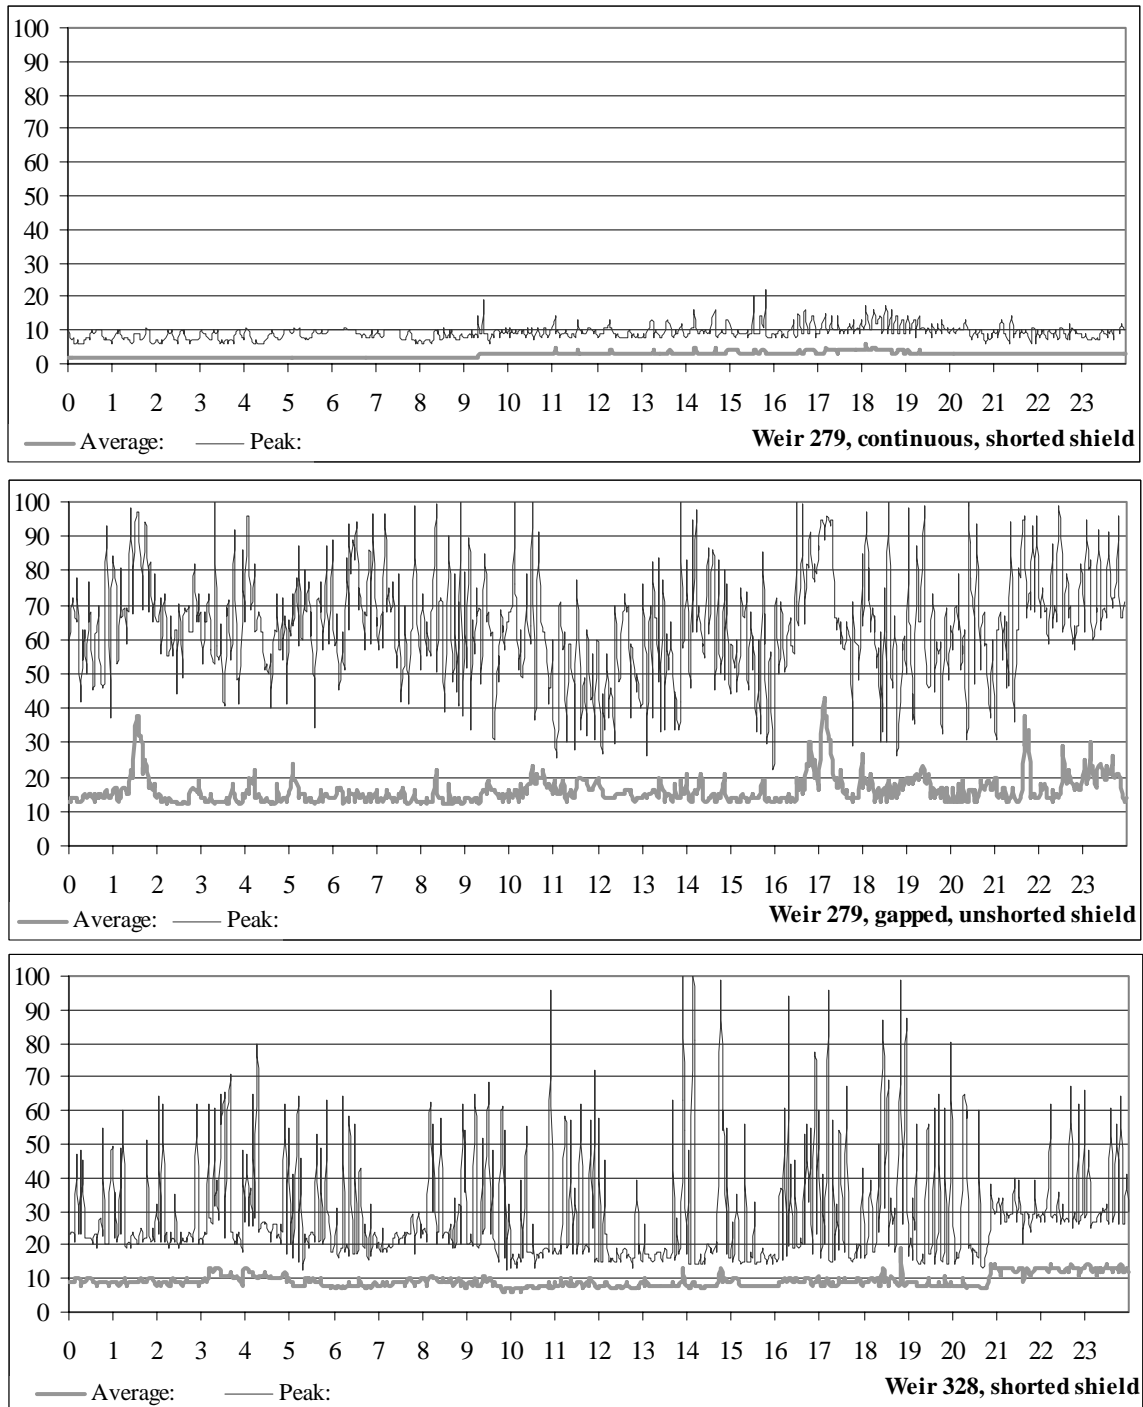
Figure 15. Hourly average and peak noise levels (percentages) on 17 April 2001 for the 3 antennas installed in McNary Oregon Ladder. Top--antenna in Weir 279 with continuous shorted shield; middle--antenna in Weir 279 with gapped unshorted shield; bottom--antenna in Weir 328 with shorted shield.

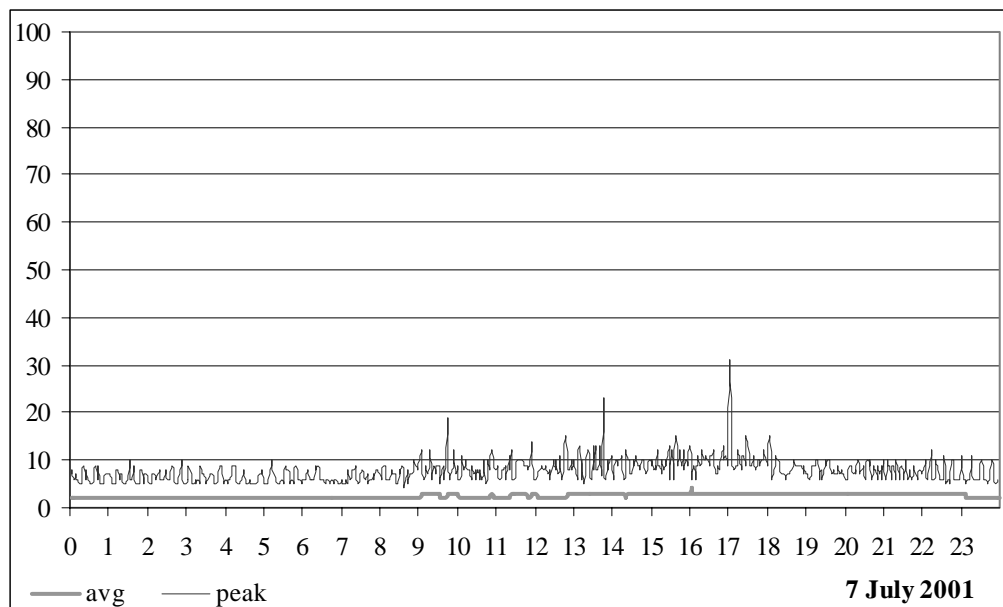
Figure 16. Hourly average and peak noise levels (percentages) on 7 July 2001 for the antenna with the continuous shield located in Weir 279 at McNary Oregon Ladder. The graph shows a slight increase in peak noise levels as the transceiver temperatures rose above 60°C during the afternoon.

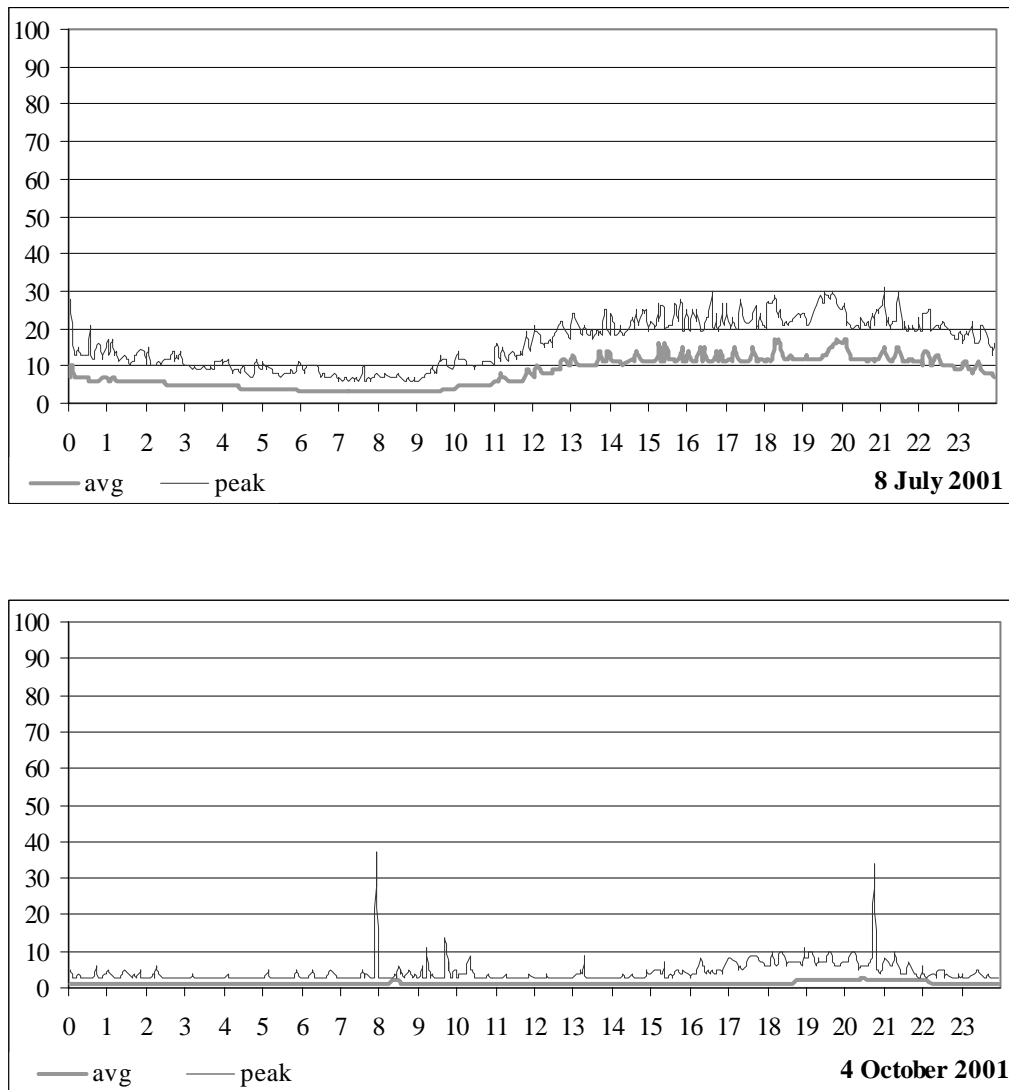
Figure 17. Daily graphs for 8 July (top) and 4 October 2001 (bottom) of the average and peak noise levels (percentages) for the antenna with the continuous shield located on the powerhouse deck of McNary Washington Ladder. The summer graph shows an increase in average and peak noise levels during the afternoon and evening.

Therefore to monitor the ambient noise for a longer time period, we used an orifice antenna installed on the upper powerhouse deck. The transceiver and computer for this setup were placed in a nearby room where they were protected from the high heat present on the deck. We collected the ambient noise data from mid June to the middle of October. In general, the average noise levels were below 10% and then rose to slightly above 10% in the afternoon and evening (because the transceivers remained around 50°C all day, we assume this increase was due to a peak load effect being generated by the nearby high voltage lines; Fig. 17). Starting in the middle of September, there was no longer a peak demand, and consequently the average noise levels remained low throughout the day (Fig. 17).

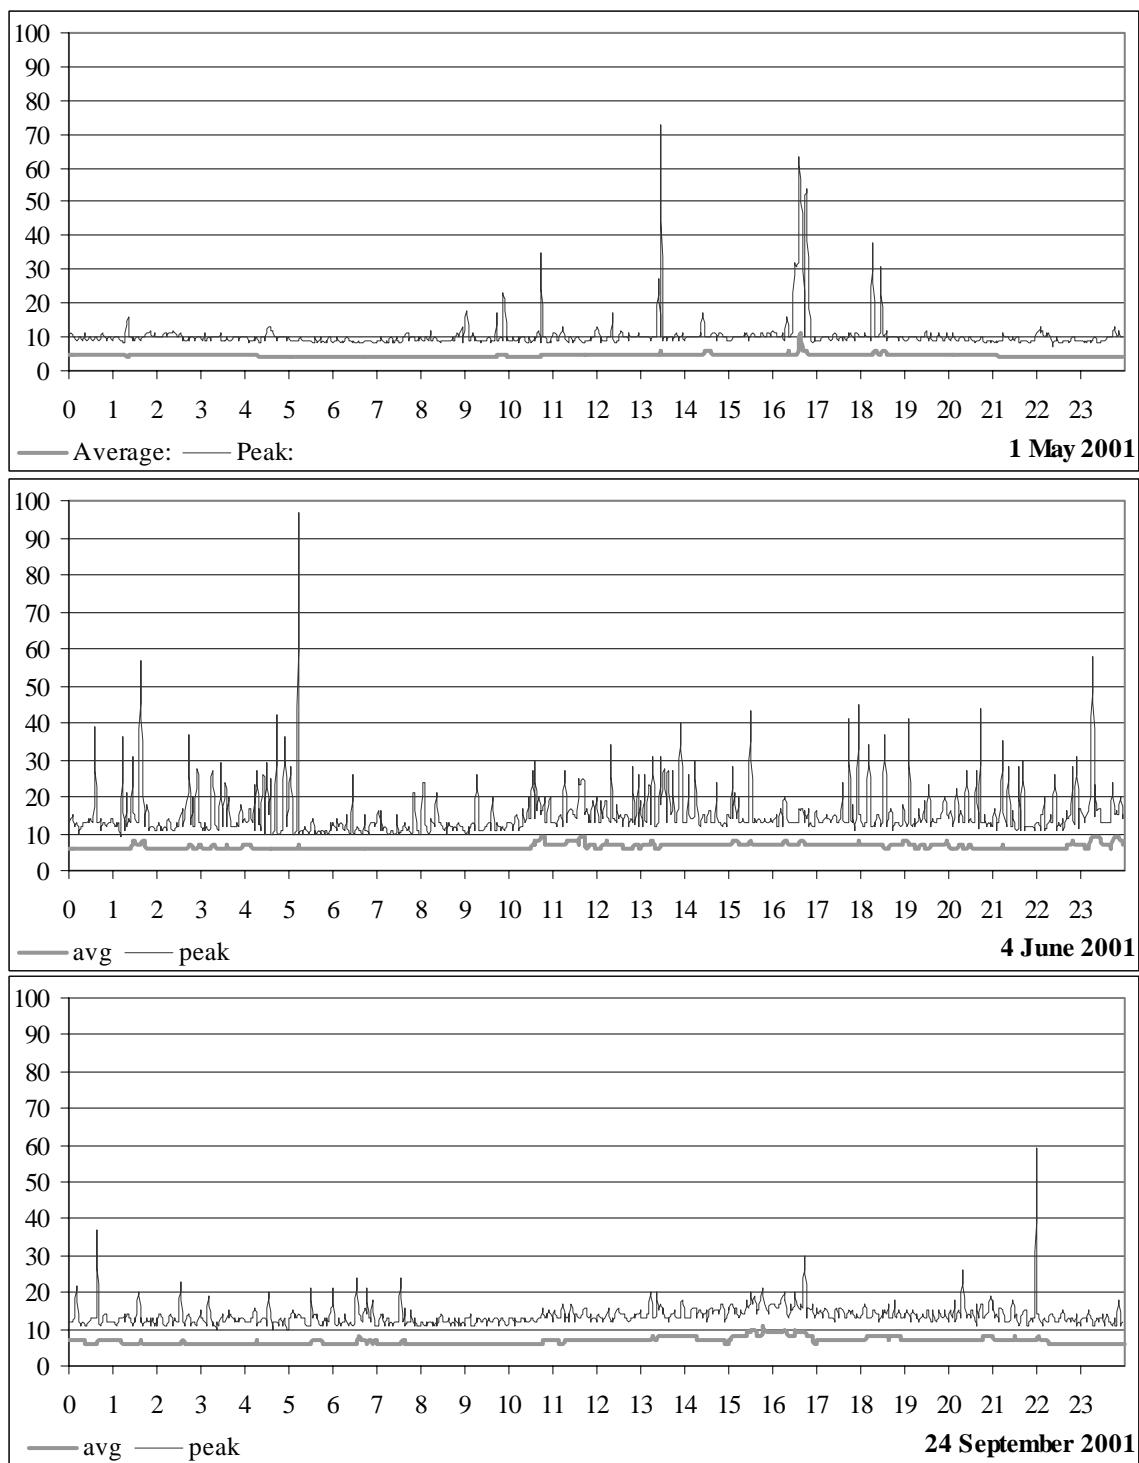
Figure 18. Daily graphs for 1 May (top), 4 June (middle), and 24 September 2001 (bottom) of the average and peak noise levels (percentages) for the orifice antenna located at Bonneville Cascades Island Ladder.

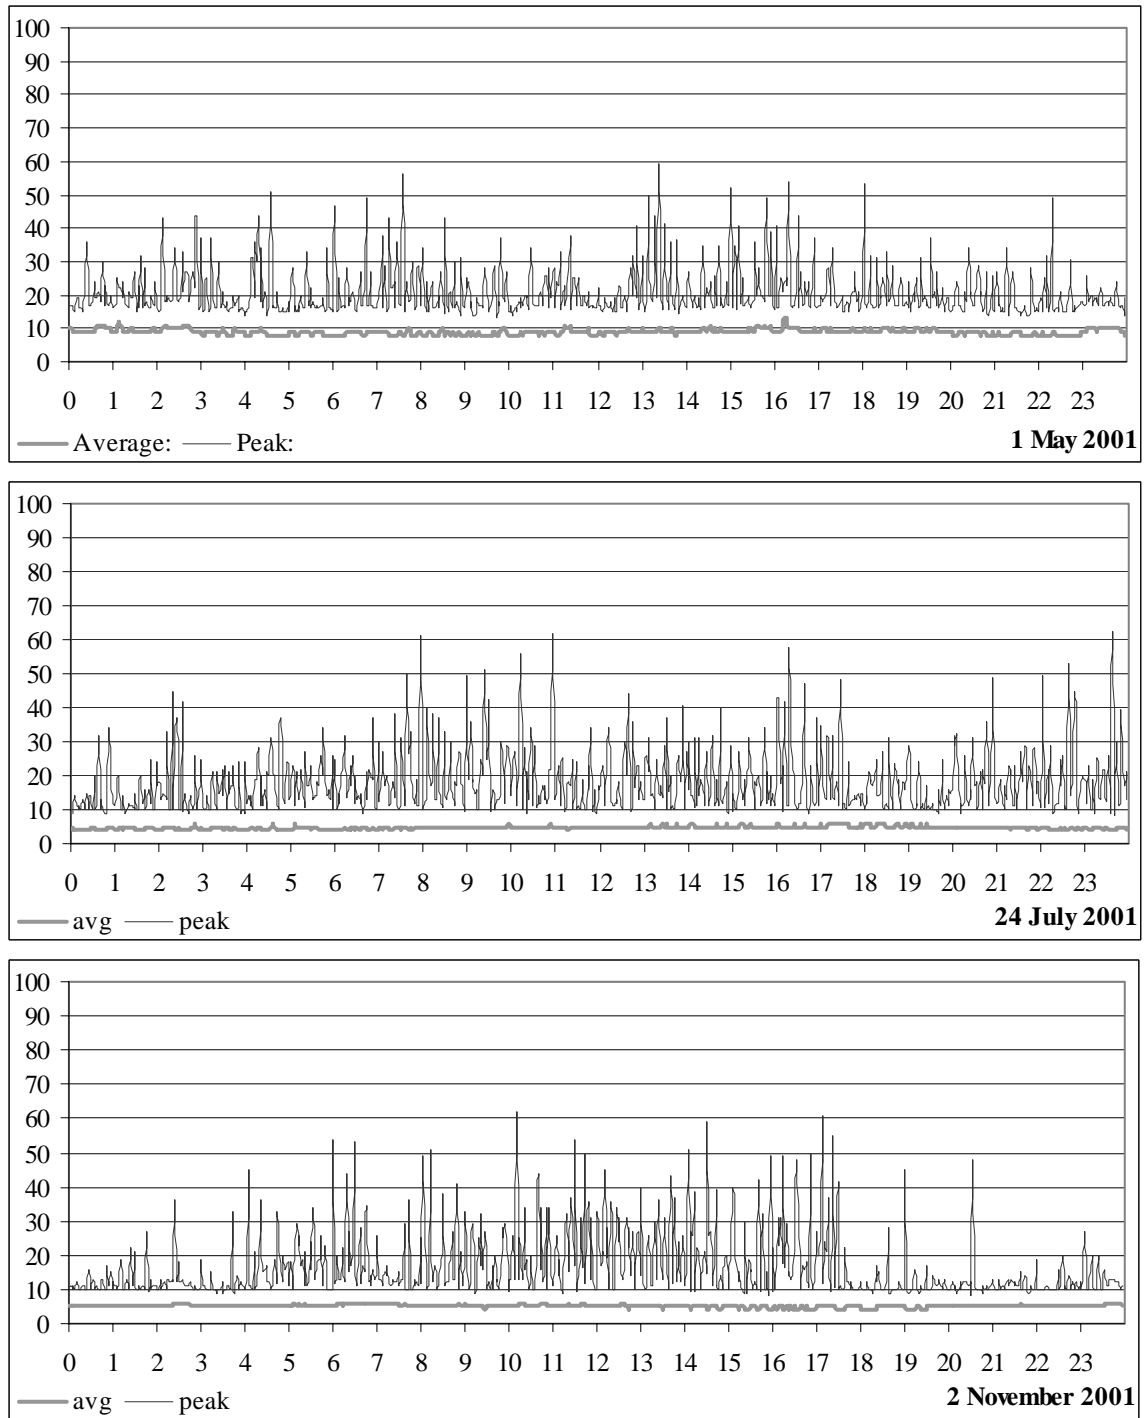
Figure 19. Daily graphs for 1 May (top), 24 July (middle), and 2 November 2001 (bottom) of the average and peak noise levels (percentages) for the orifice antenna with the continuous shield located at Bonneville Bradford A-Branch Ladder.

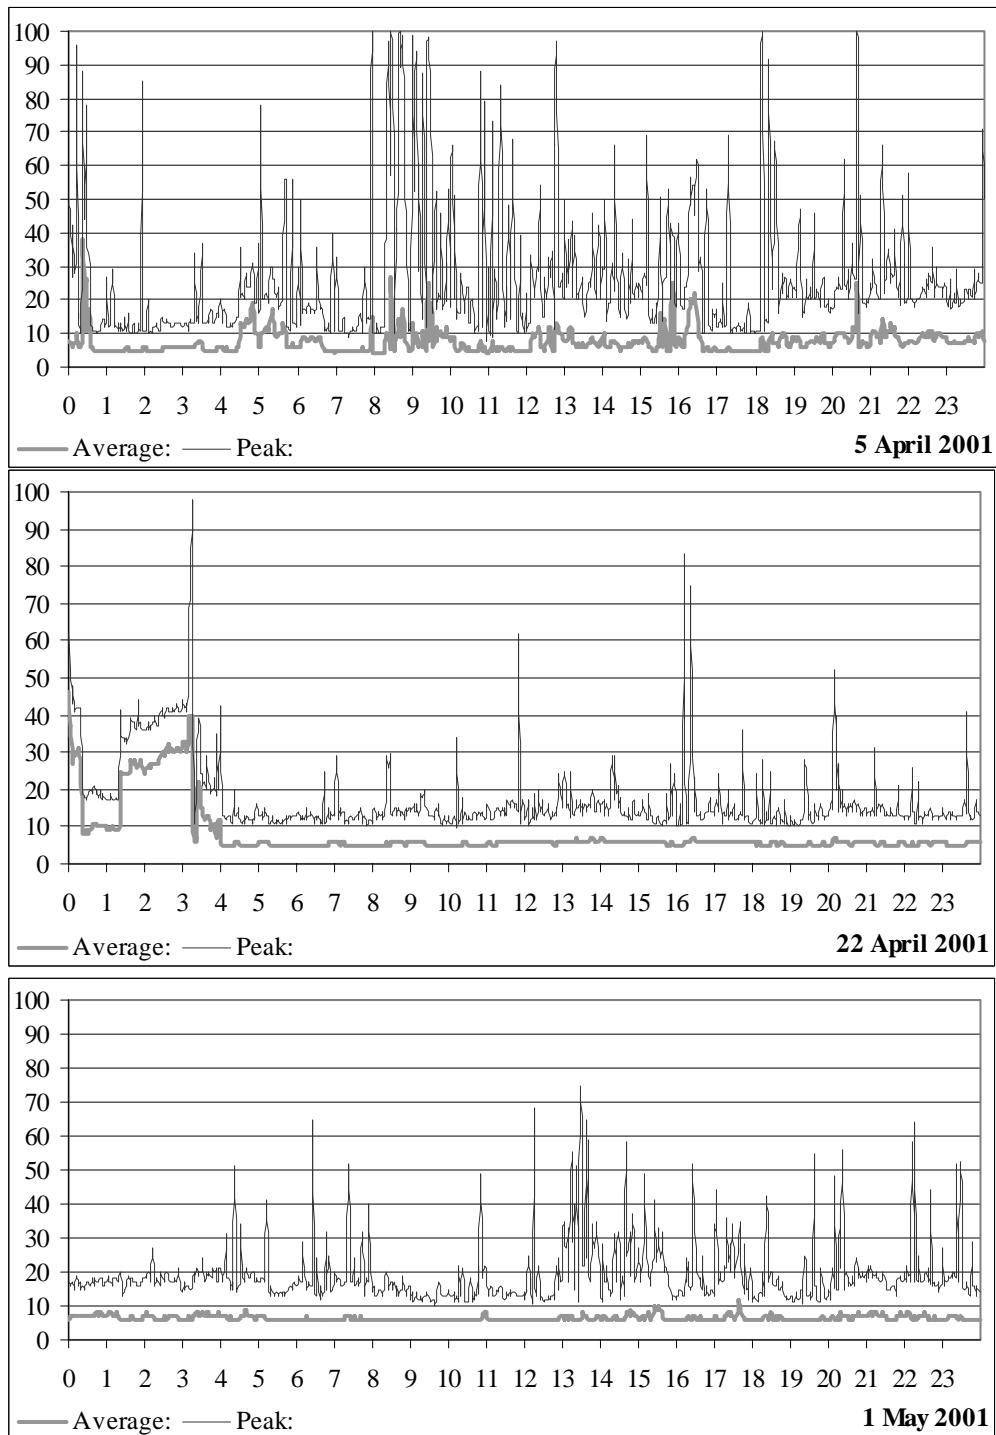
Figure 20. Daily graphs for 5 April (top), 22 April (middle), and 1 May 2001 (bottom) of the average and peak noise levels (percentages) for the orifice antenna with the continuous shield located at Bonneville Bradford B-Branch Ladder.

The conclusion was that loose screws allowed wind and rain to cause vibration in the transceiver box, and these vibrations caused internal noise. These changes eliminated the extreme conditions that had initiated on 12 May; however, because of the power source, this site continued to be noisier than any of the other sites. Typically, average noise levels would be high for several hours during 1-2 d and then return to a lower level (Figs. 22-23). We concluded that a cleaner power source would stabilize noise at this site; therefore, there was no reason not to proceed with installation of a production site.

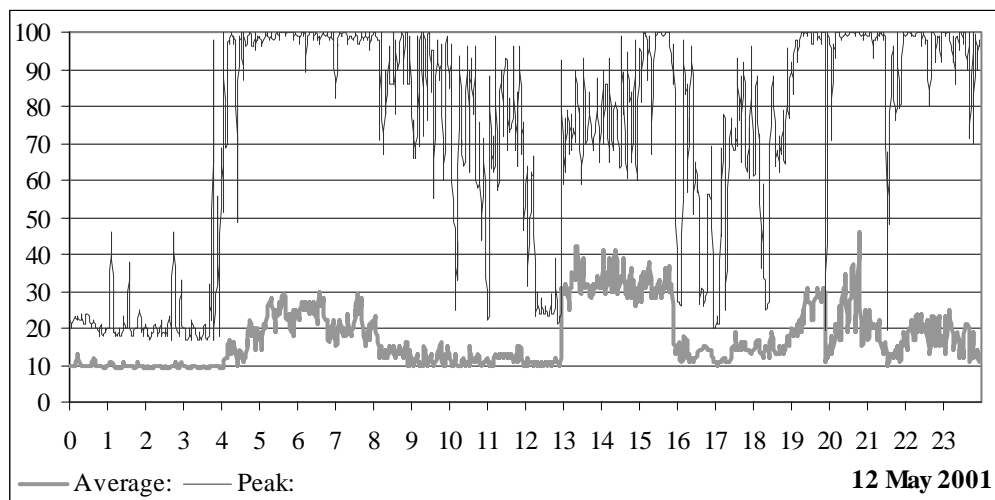
Figure 21. Daily graph for 12 May 2001 of the average and peak noise levels (percentages) for the antenna with the continuous shield located at Bonneville Bradford B-Branch Ladder.

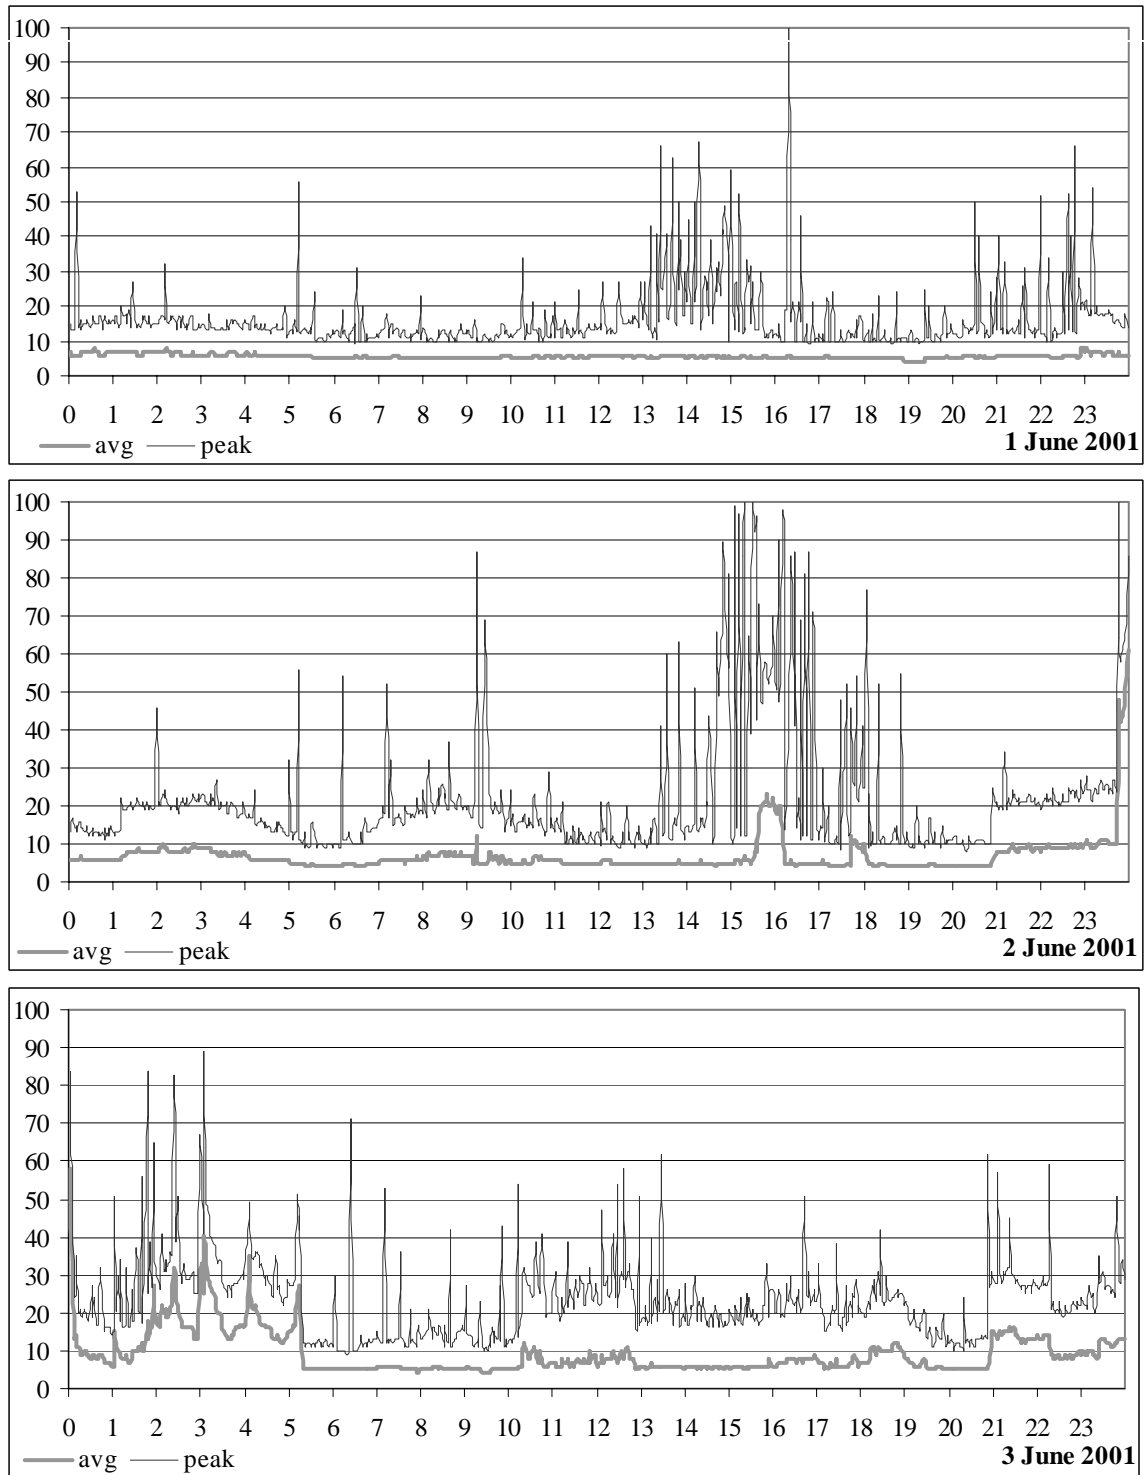
Figure 22. Daily graphs for 1 June (top), 2 June (middle), and 3 June 2001 (bottom) of the average and peak noise levels (percentages) for the antenna with the continuous shield located at Bonneville Bradford B-Branch Ladder.

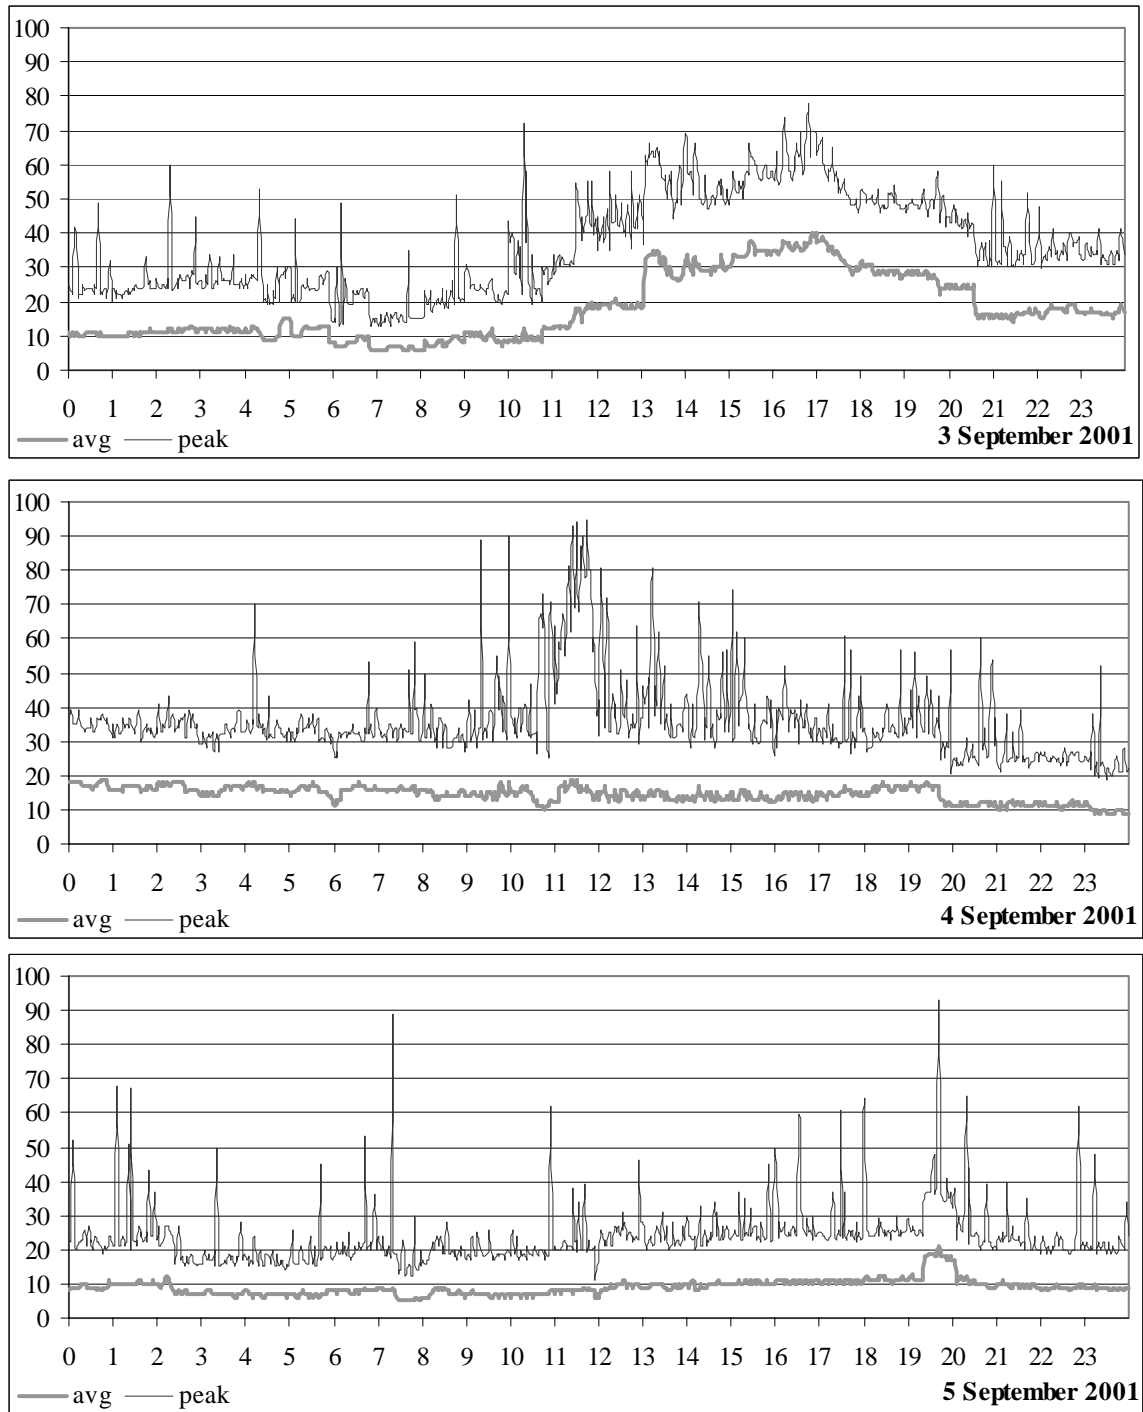
Figure 23. Daily graphs for 3 September (top), 4 September (middle), and 5 September 2001 (bottom) of the average and peak noise levels (percentages) for the antenna with the continuous shield located at Bonneville Bradford B-Branch Ladder.

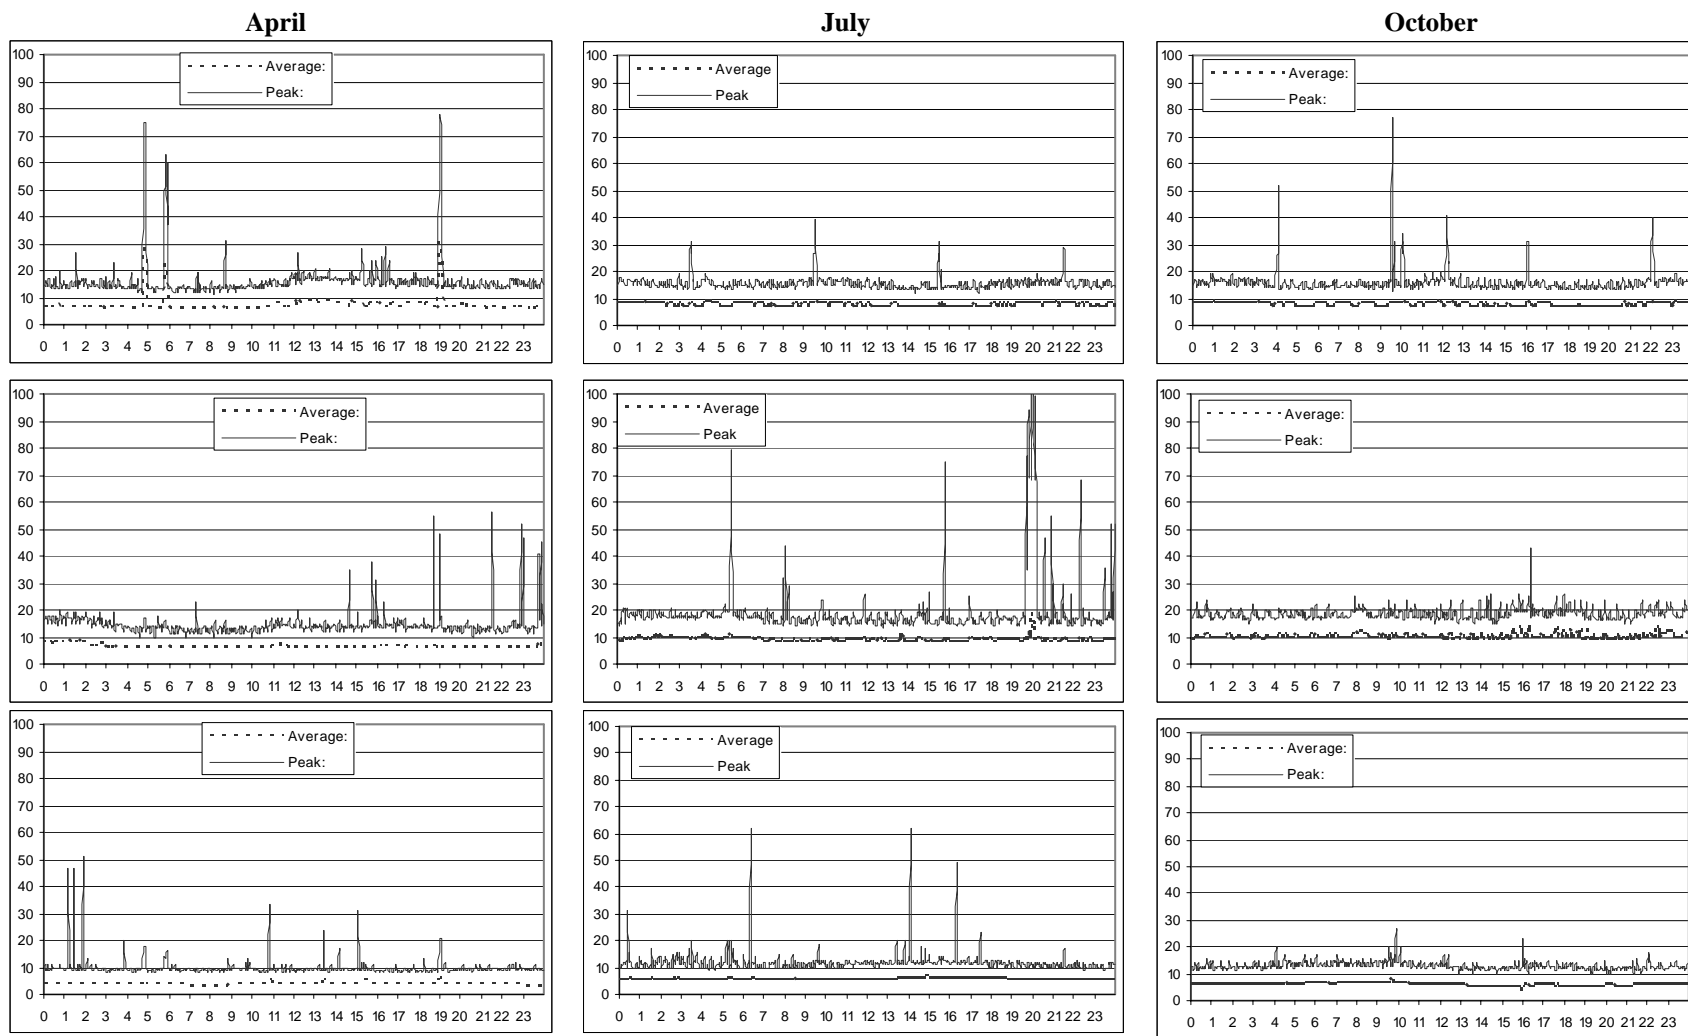
Figure 25. Daily noise graphs showing the average and peak levels (percentages) for Antennas 3B (top), 4A (middle), 4B (bottom) for 12 April, 29 July, and 1 October 2001.

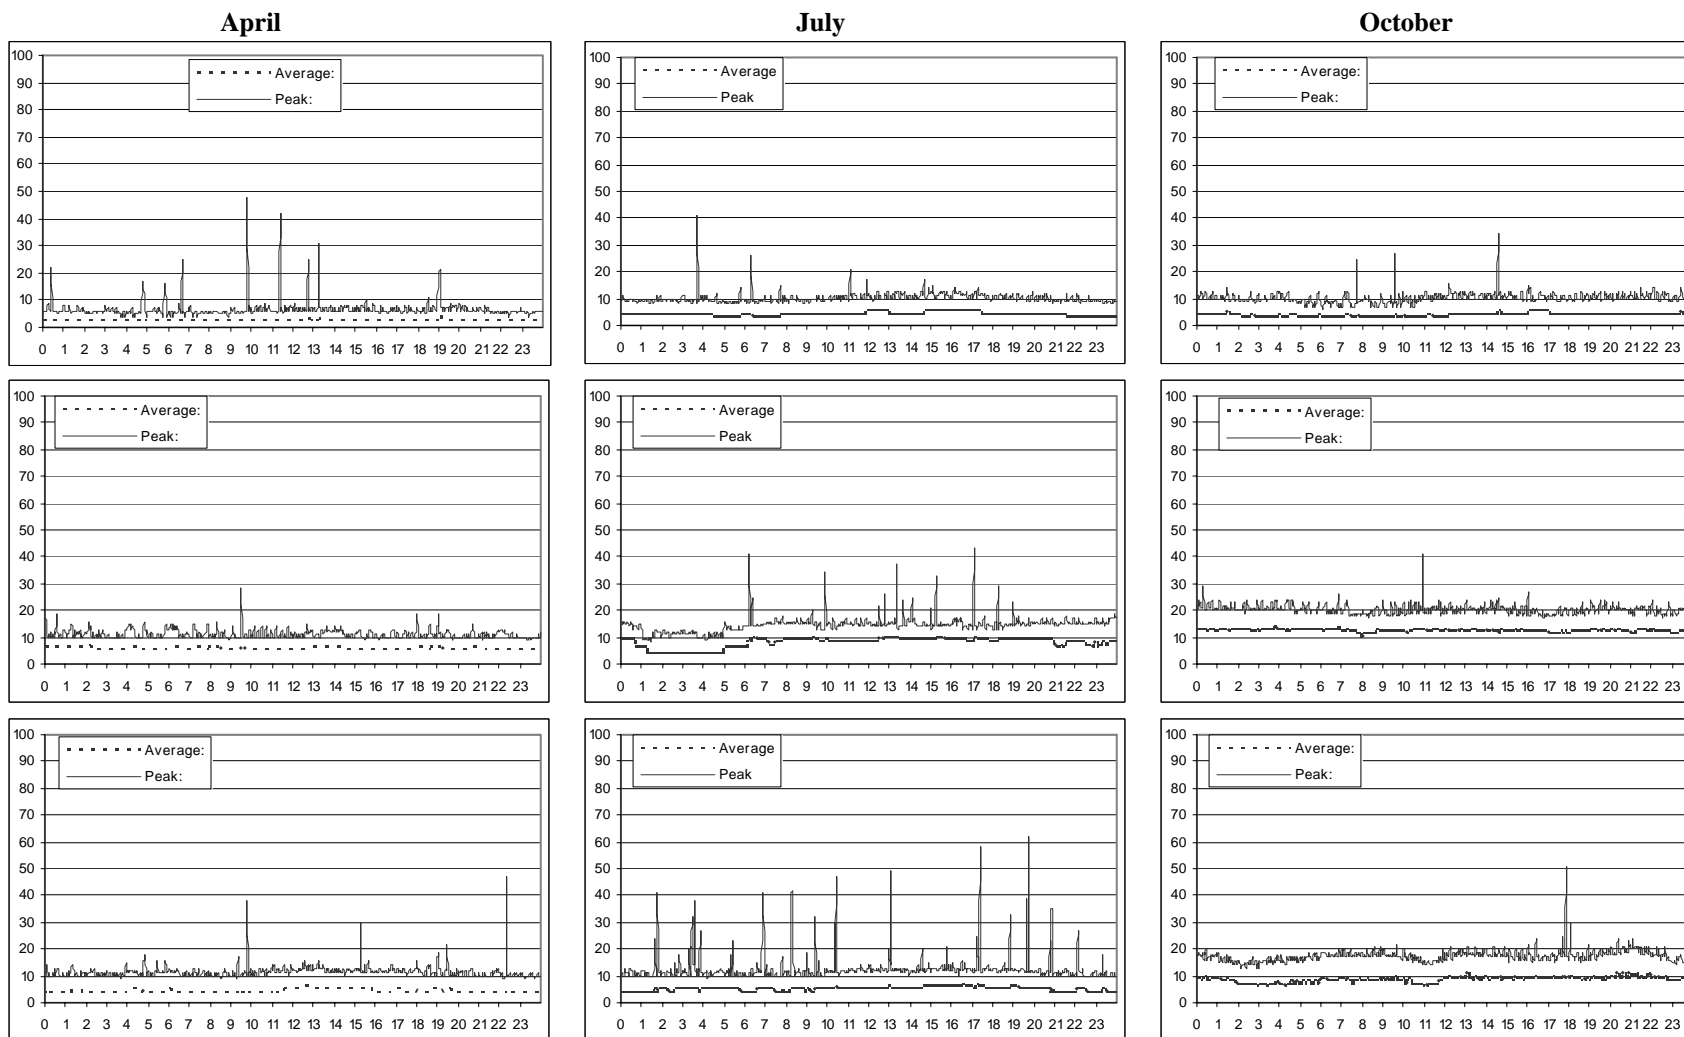
Figure 26. Daily noise graphs showing the average and peak levels (percentages) for Antennas 5A (top), 5B (middle), 6A (bottom) for 12 April, 29 July, and 1 October 2001.
