**Development and Evaluation of Passive Integrated
Transponder Tag Technology, 2000-2002**

Sandra L. Downing, Earl F. Prentice, Edmund P. Nunnallee, and Bruce F. Jonasson

April 2004

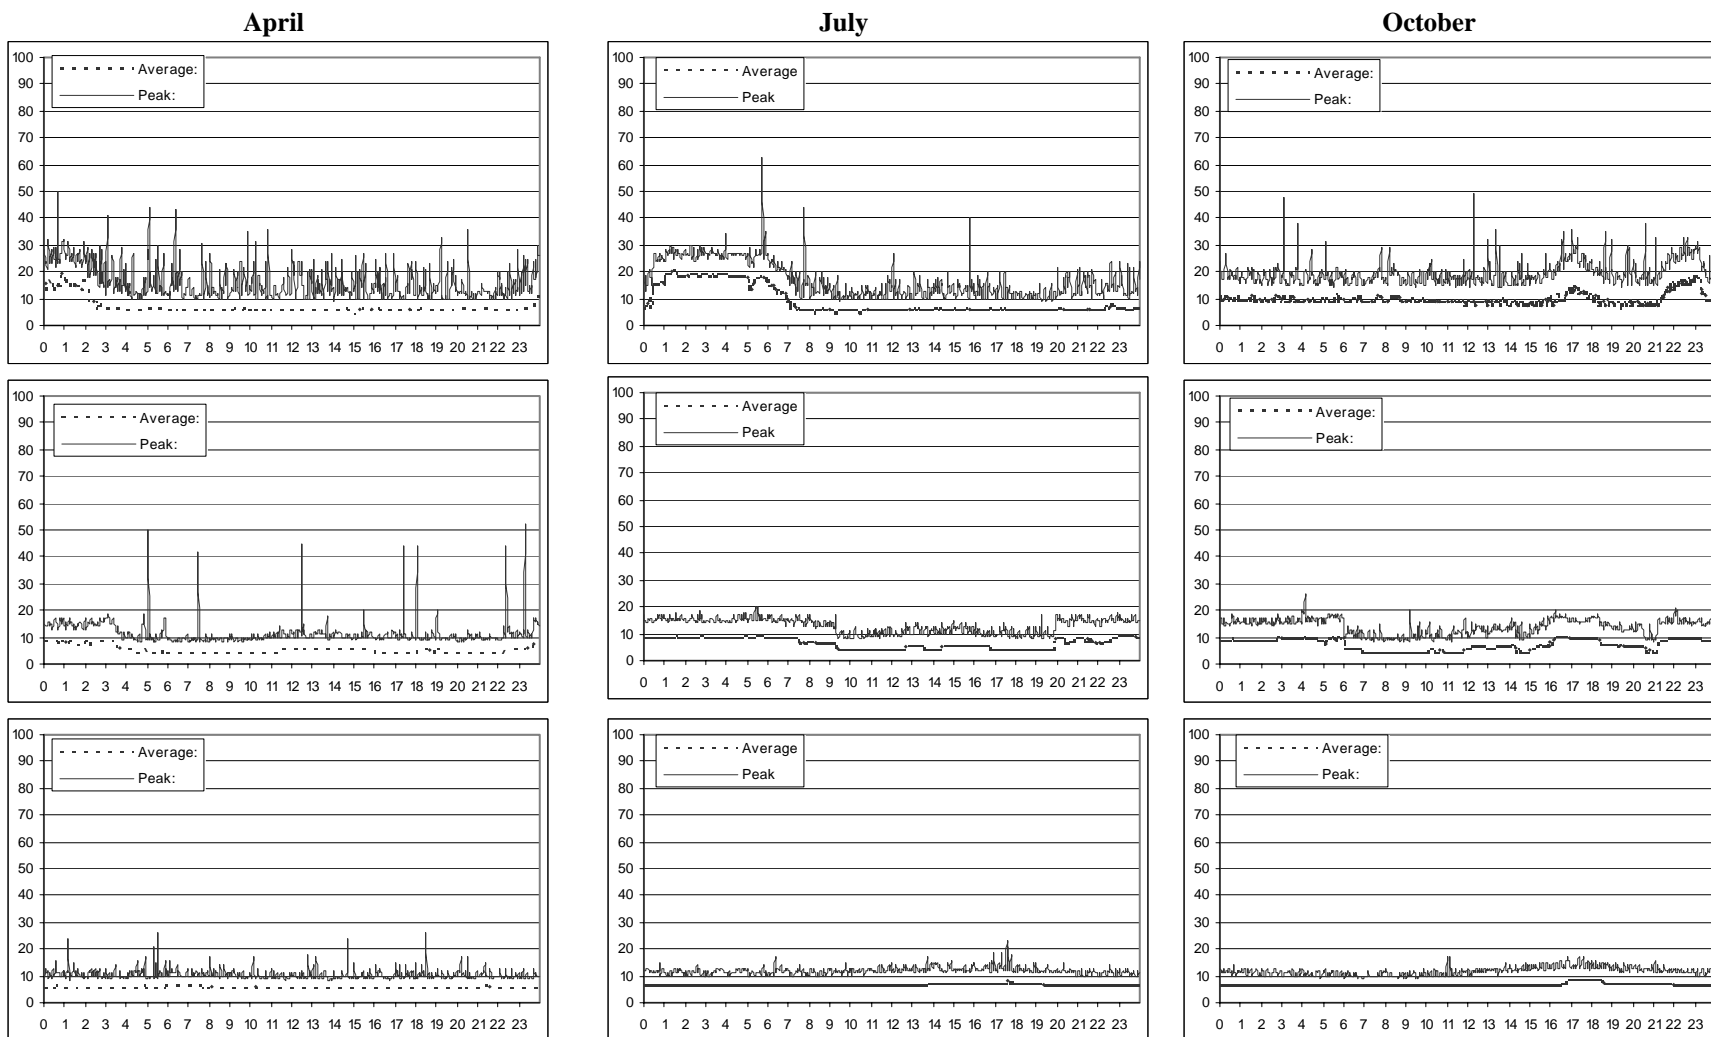
Figure 27. Daily noise graphs showing the average and peak levels (percentages) for Antennas 6B (top), 7A (middle), 7B (bottom) for 12 April, 29 July, and 1 October 2001.

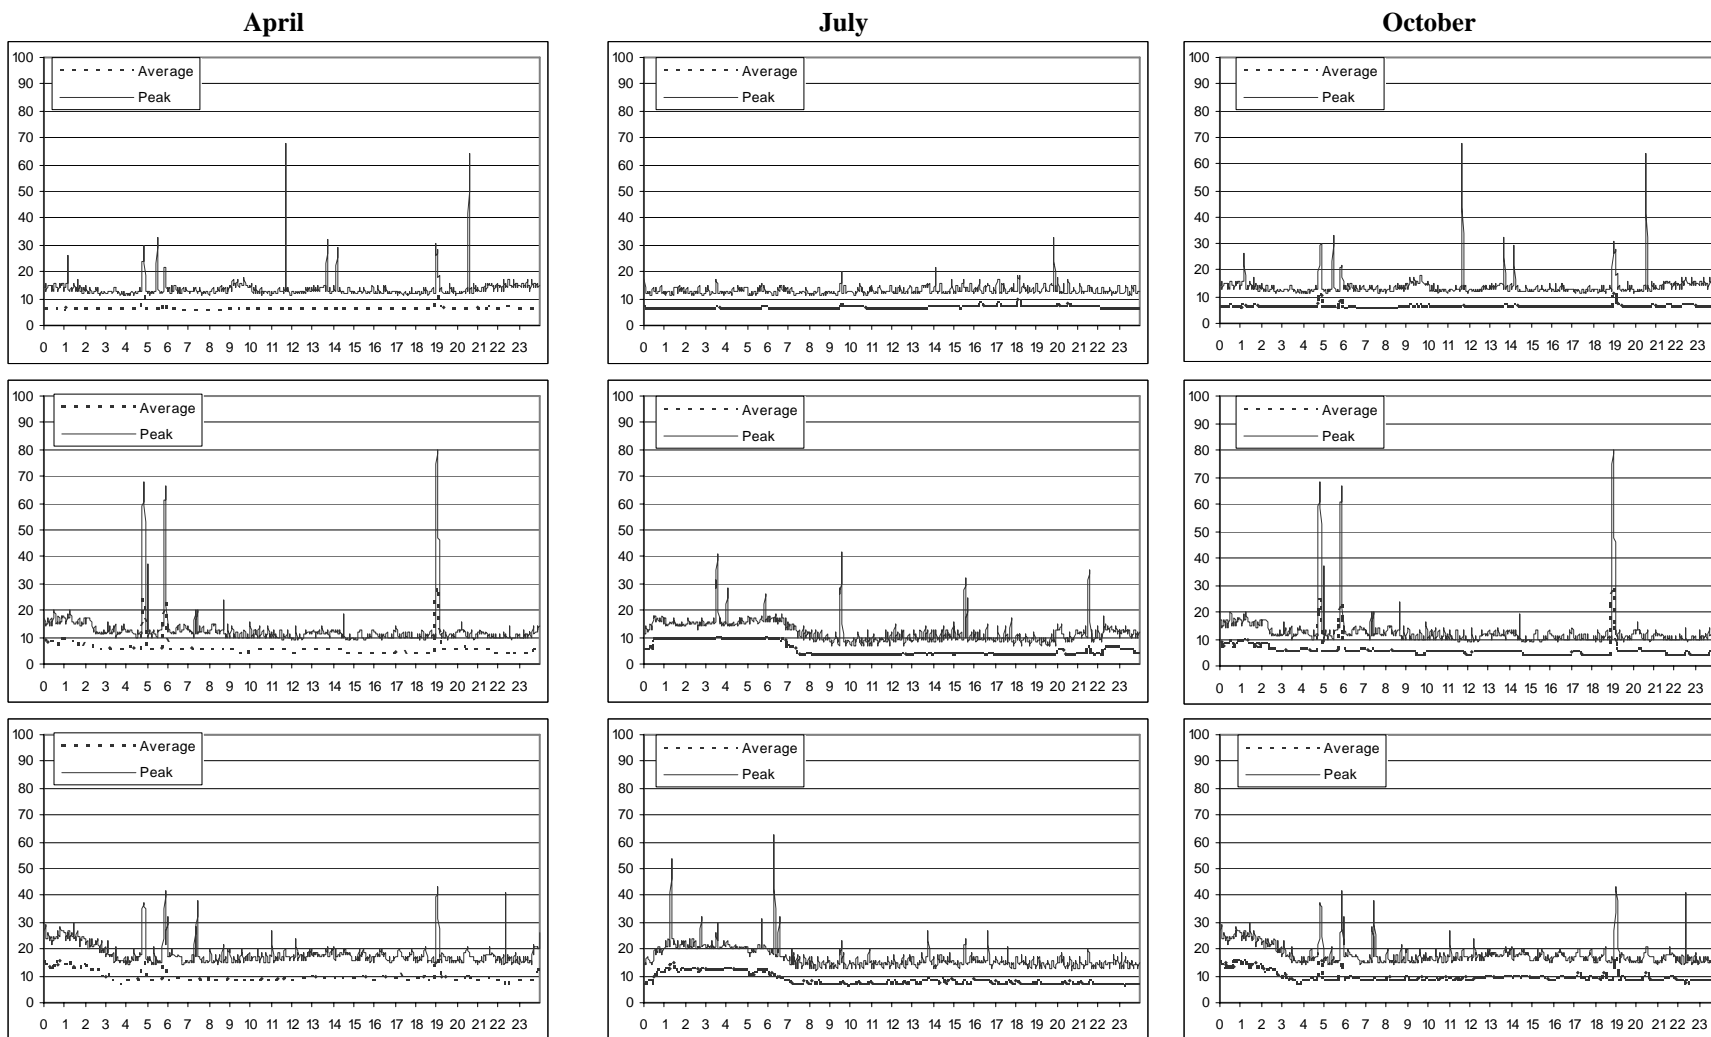
Figure 28. Daily noise graphs showing the average and peak levels (percentages) for Antennas 8A (top), 8B (middle), 9A (bottom) for 12 April, 29 July, and 1 October 2001.

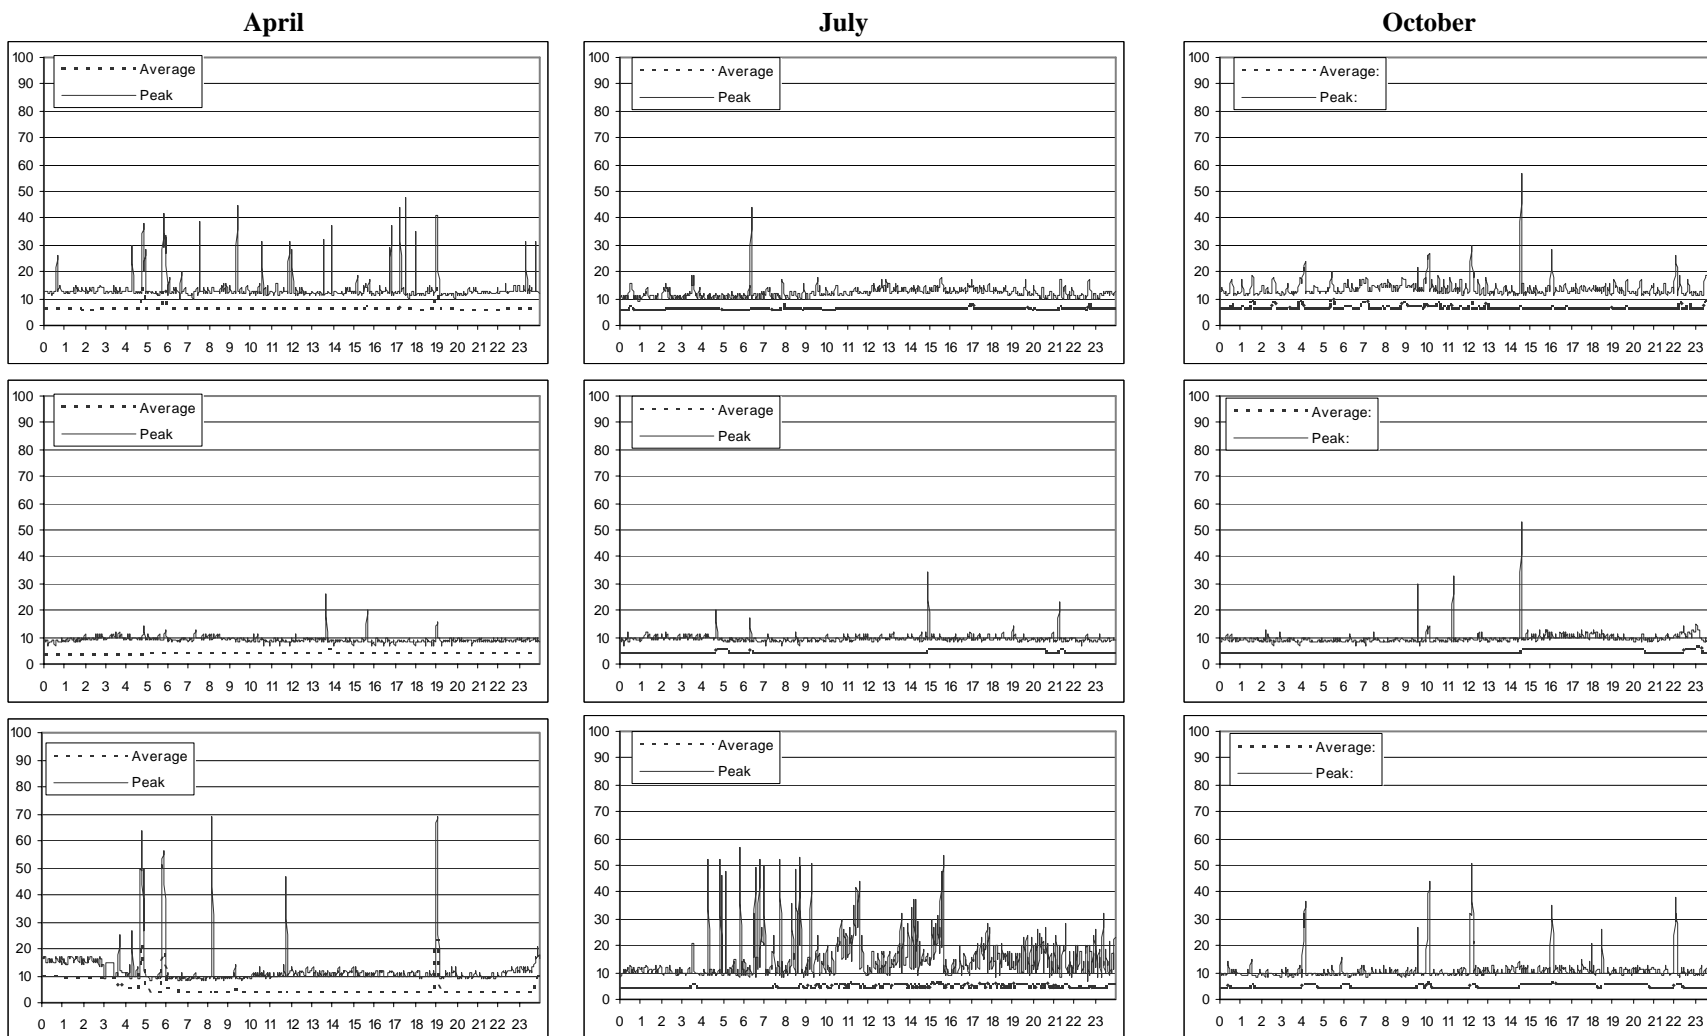
Figure 29. Daily noise graphs showing the average and peak levels (percentages) for Antennas 9B (top), DB (bottom) for 12 April, 29 July, and 1 October 2001.

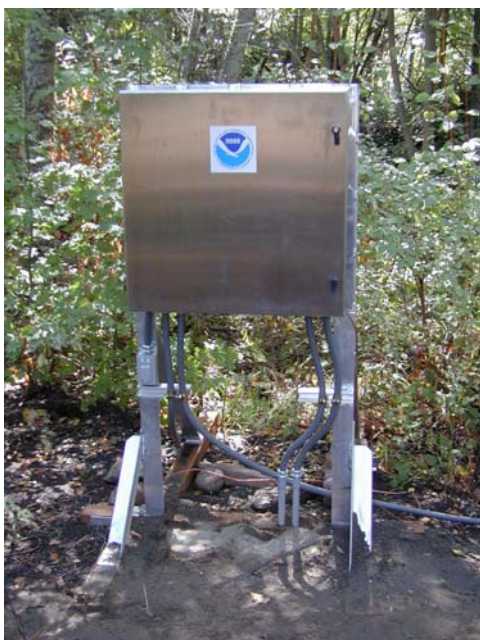
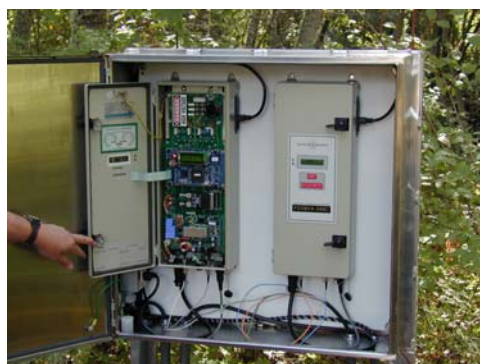
Figure 30. Enclosure box containing two transceivers that was installed streamside at Rattlesnake Creek.

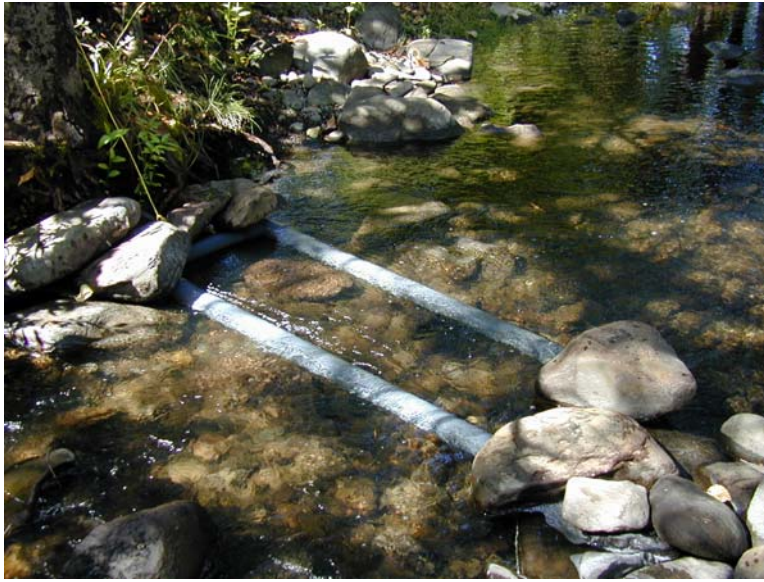
Figure 31. Photo of a pass-by antenna installed into Rattlesnake Creek.

6.2. Antenna Systems--To determine the direction of fish movement, two in-stream antennas were anchored 15 m apart during the installation in Rattlesnake Creek. This setup also permitted two different antenna designs to be evaluated under various stream flow conditions. In FY01, pass-through and pass-by designs were evaluated at Rattlesnake Creek.

In December 2001, debris during high-water conditions removed the pass-through antenna. The pass-by antenna housing design withstood the debris and bottom load impact during the high-water conditions. However, fish under these conditions may have avoided detection by passing too far above the antenna.

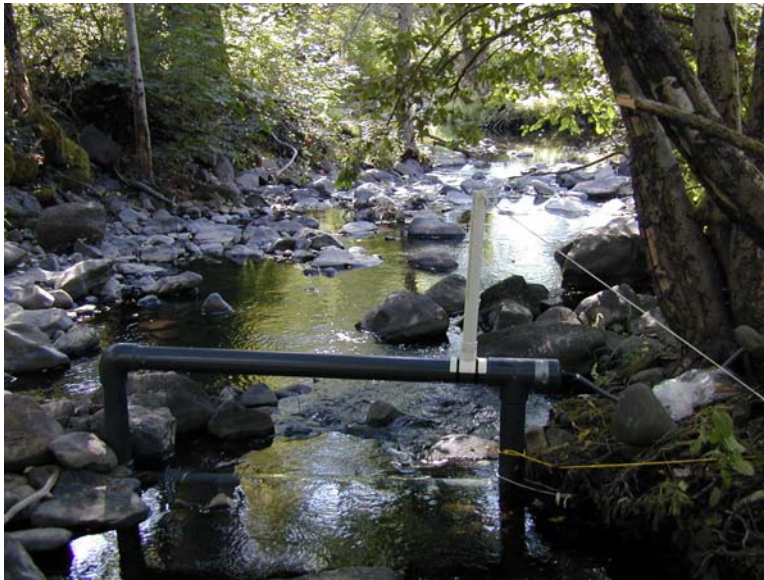
Figure 32. Photo of a pass-through PIT-tag antenna installed into Rattlesnake Creek.
Note the stanchion mounted at the top of the antenna that is designed to break when heavy debris hits the antenna and the salvage line designed to help retrieve the loose antenna.

The main advantage of the pass-through antenna design is that the fish swim through the antenna; therefore, the tagged fish are in optimal orientation for detection and they are swimming through the largest section of the tag-energizing field. Consequently, these antennas have large read windows. The disadvantage is that it is possible for debris to collect on the antenna and cause it to break from its moorage or cause stream channel alteration.

The main advantages of the pass-through antenna design are that tagged fish swim through the antenna in the optimal orientation for detection and they swim through the largest section of the tag-energizing field. Consequently, these antennas have large read windows. The disadvantage is that it is possible for debris to collect on the antenna and cause it to break from its moorage or cause stream channel alteration. To try to reduce the damage that would occur were the antenna to be hit by large debris or if water pressure increased significantly, the stanchion holding the pass-through antenna in its vertical position was designed to break under heavy debris load. When the stanchion broke, an attached salvage line would only allow the antenna to float downstream a short distance where it could then be retrieved. In addition, the plug connecting the antenna to its antenna cable was not securely attached in order to expedite its separation from the antenna when the antenna broke loose.

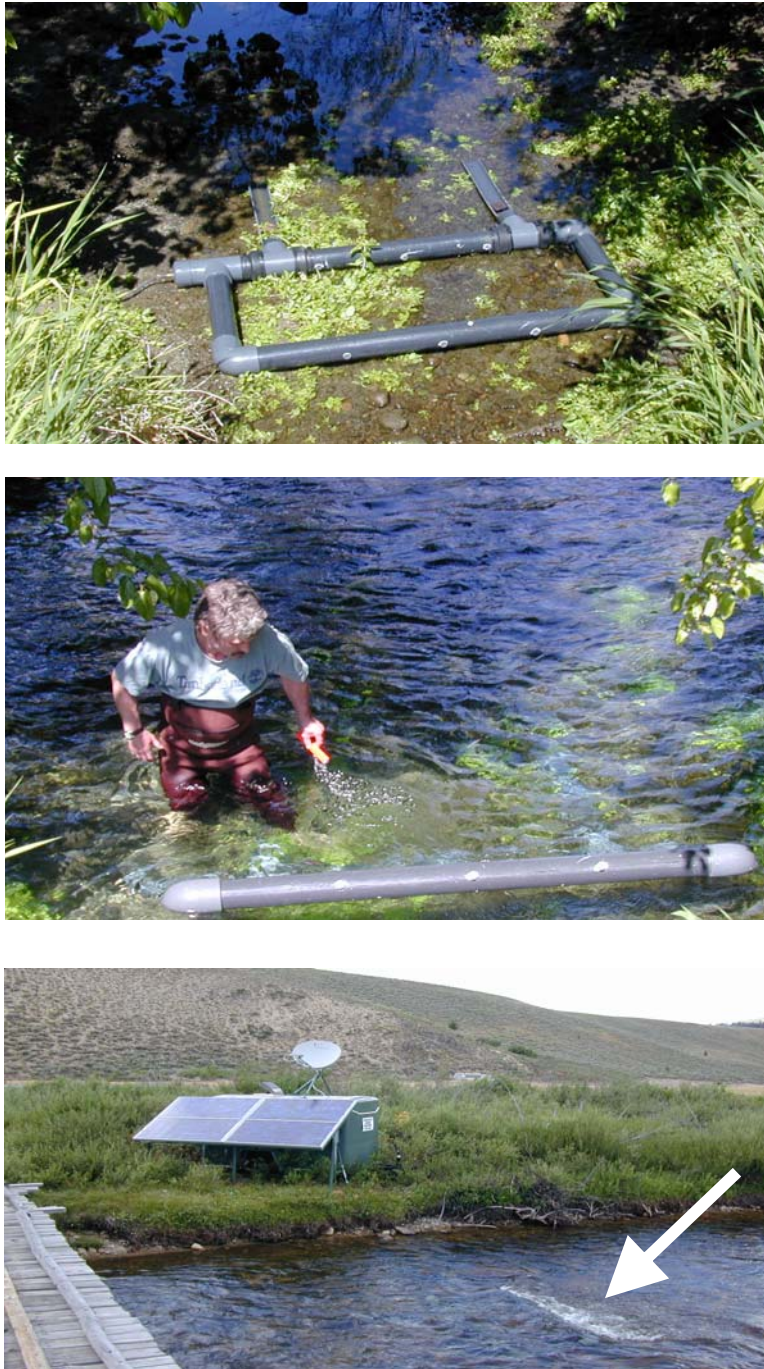
Figure 33. The hybrid PIT-tag antenna under low (top), medium (middle), and high (bottom) water conditions. Low and medium water photos were taken while the antenna was being developed in a stream near Pasco, WA; high water photo shows the antenna operating in Valley Creek, ID.

Therefore in FY02, we designed a pivoting "hybrid" antenna that incorporated both pass-by and pass-through features. In this design, only the upstream portion of the antenna is anchored to the stream substrate via pivots attached on each end of the antenna. This leaves the downstream end floating free, which enables the antenna to adjust to different stream flow conditions. At Rattlesnake Creek, this antenna functioned without problems during high flow and detected several PIT-tagged fish that the pass-by antenna did not detect. Similar hybrid antennas were installed at both interrogation sites in Valley Creek in 2002.

Therefore in FY02, we investigated a pivoting "hybrid" antenna design that incorporated both pass-by and pass-through features (Fig. 33). In this design, only the upstream portion of the antenna is anchored to the stream substrate via pivots attached on each end of the antenna. This leaves the downstream end floating free, which enables the antenna to adjust to different stream flow conditions. The buoyancy of the downstream end is adjusted so that it lies just underwater; this feature expedites the passage of surface debris past the antenna. The degree of submergence was adjusted by using a lead weight attached to the downstream member of the antenna. With the hybrid design, effective read distance varies with water depth because changes in depth alter the angle of the antenna and thus the orientation of fish passing through the antenna.

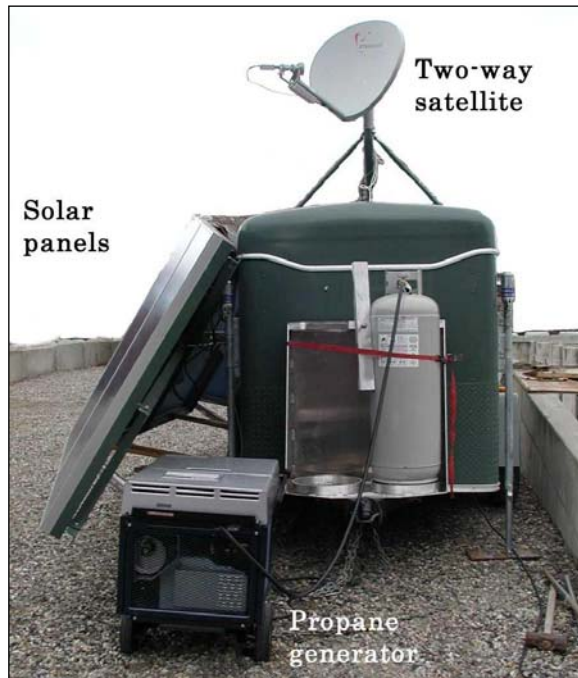
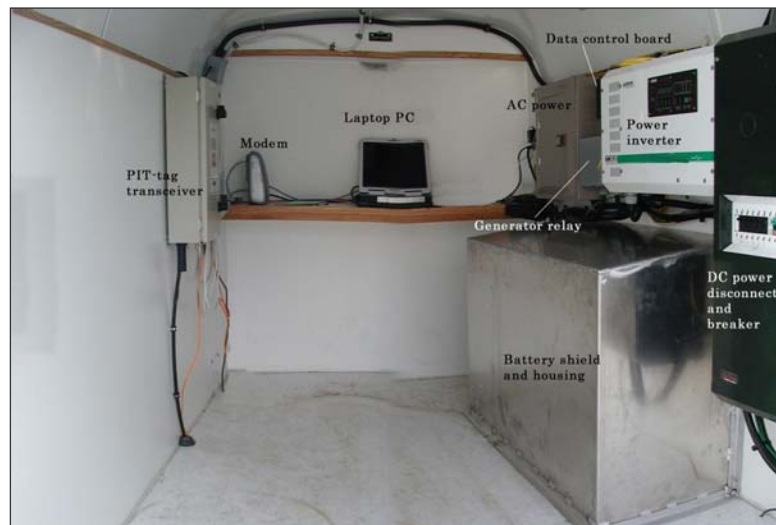
Figure 34. Outside and inside views of the PIT-tag equipment trailer that show the equipment for power management and communications.

Mounted on the outside of a trailer housing system components were four 150-watt solar panels, a satellite dish used to send data files and to monitor whether the system was operating, a 284-L propane tank, and a propane-operated generator (Fig. 34). Within the trailer the following electronics were housed: four 12V DC 110 amp-hour glass-mat storage batteries that were connected to provide 24V power (the batteries were placed in a shielded box to prevent them from interfering with the other electronics); one 24V DC-powered FS1000A transceiver; a notebook computer; a two-way satellite communication system; a power inverter; DC power disconnect and breaker panel; generator relay; and data control board.

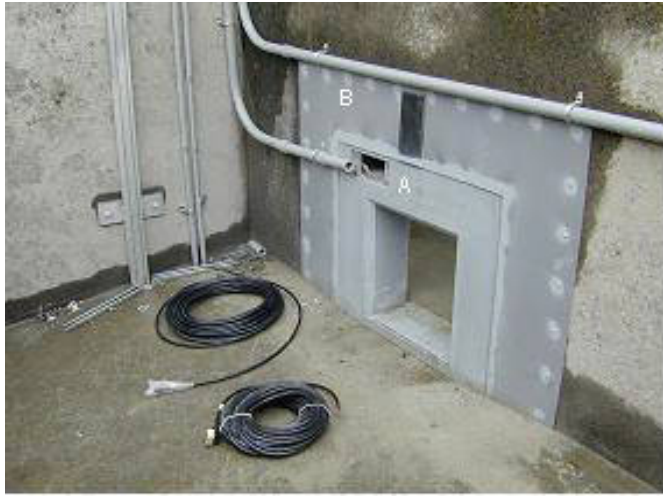
Appendix Figure A1. Photo taken during the installation of PIT-tag detection equipment into the Washington Shore Fish Ladder at Bonneville Dam. The antenna housing is labeled with the letter A at the approximate location of the connector inside the recessed access chamber. The aluminum shield is labeled with the letter B.

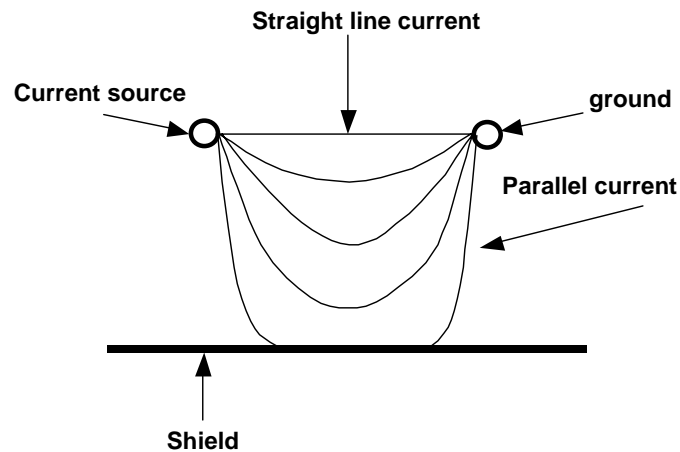
Appendix Figure A2. Schematic representation of parallel electrical current paths through water and the effect of the grounded aluminum shield. Note that the actual current paths will form a three-dimensional field, rather than two dimensions as depicted in the figure.

To better understand how electrical current flows between two points, it is necessary to visualize all possible current paths. Electrical current, as is the case with flowing water, always seeks the path of least resistance. Thus, the majority of the current will flow along a path near a straight-line distance between two points, but there will always be resistance to current flow and some current will also flow through longer, parallel paths (Appendix Figure A2). However, the quantity of current flow is inversely related to resistance; therefore, if path "B" is twice the length of path "A," the amount of current that will flow along path "B" will be half that flowing along path "A." Consequently, the voltage measured across a unit distance of path "B" will be half of that across the same distance along path "A."

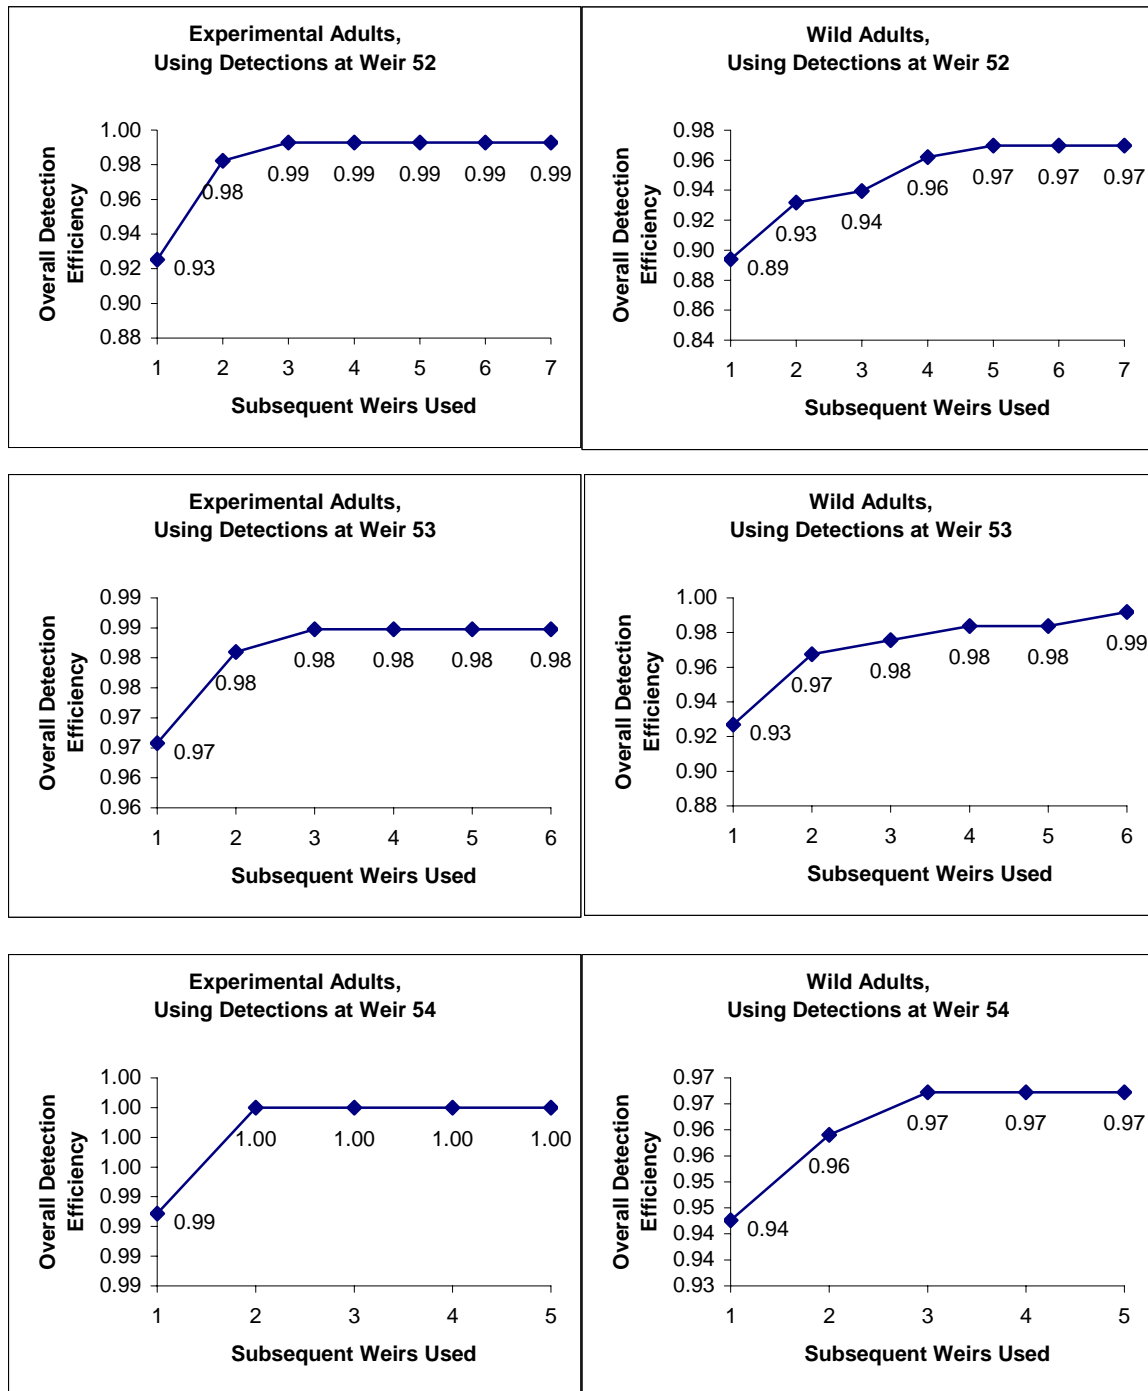
Appendix Figure C1. Analysis of Robust Estimator

These graphs indicate that the detection efficiency does not increase after including 5 or more subsequent weirs in all but one case; for the wild adult returns using weir 53, the final detection efficiency was reached in 6 weirs. The graphs suggest that this method of estimating is more consistent with the results in Section 1 above; the detection efficiency is less than 1.0 in all but one instance. The graphs also suggest that the minimum number of successive weirs that should have PIT-tag detectors is about 5; the benefit of having more than 5 sequential weirs with PIT-Tag detectors is minimal.
