## Rehabilitation and Retrofitting of Water Supply Systems in Western Part of Romania

To cite this article: Zsolt Marossy *et al* 2019 *IOP Conf. Ser.: Mater. Sci. Eng.* **471** 042032

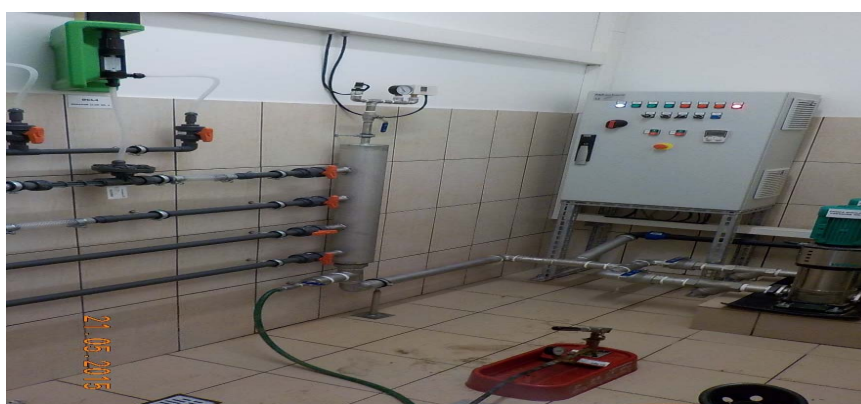
**Figure 1.** New chlorination station

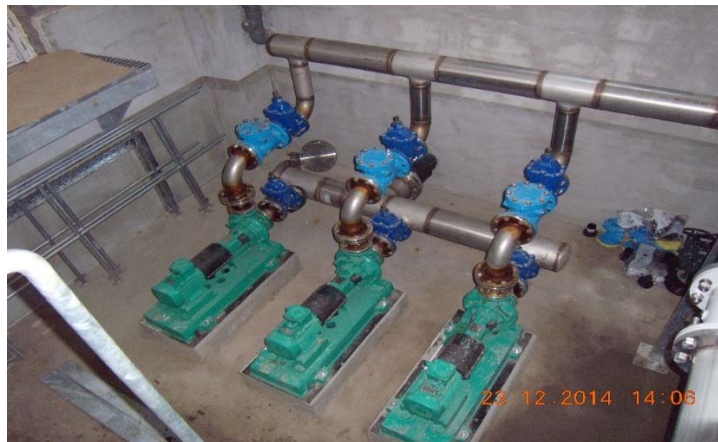
**Figure 2.** Influent pumps/wash filters

- testing and repairs of four boreholes;
- upgrading of adductions between boreholes, 591 m in length;
- water rehabilitation - reservoir rehabilitation, rehabilitation of water castle, rehabilitation and equipping station for pumping drinking water, figure 2;
- extension of the distribution network with 618 m;
- rehabilitation of the 2261 m long distribution network.

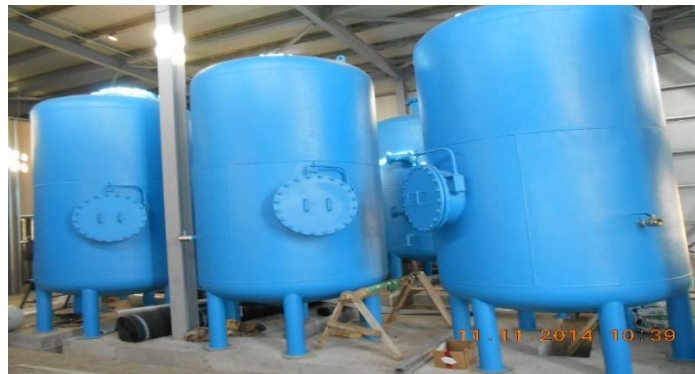
**Figure 3.** Sand filters + GAC filters

- The method of reducing the value below 0.05 mg / l is the oxidation of manganese in the first phase by aeration in the aeration basin, and in the second phase by oxidation and retention of manganese dioxide in the pre-sand filtering layer of the sand filters. The retention of manganese in the filter bed is also favoured by a higher value of crude water pH ranging from 7.4 to 7.6. To facilitate the filtration process, it is proposed to oxidize manganese in the second reaction chamber of the pre-treatment basin (aeration) by the injection of hyperchlorinated water over a period of time, (figure 1). During the treatment of raw water with hyperchlorinated water, active carbon filters (CAG) will be bypassed (figure 3).

- Suggested method of reduction below the value of 1 NTU to retain suspensions in pressure sand filters;
- The method of reducing the value below 0.05 mg / l is the pre-oxidation of manganese in the first stage by aeration and if necessary by treatment with  $\text{Cl}_2$  and precipitation thereof in the form of manganese dioxide and retaining in manganese sand filters, figure 3.
