Performance of pavement preservation with Ralumac Micro surfacing at LATAR highway

This study evaluates the performance of pavement preservation with Ralumac Micro surfacing for slow lane and fast lane from KM23.70 to KM24.10 Eastbound at LATAR highway after 36 months operational. The evaluation comprises of International Roughness Index (IRI), pavement rutting, texture depth and skid resistance.

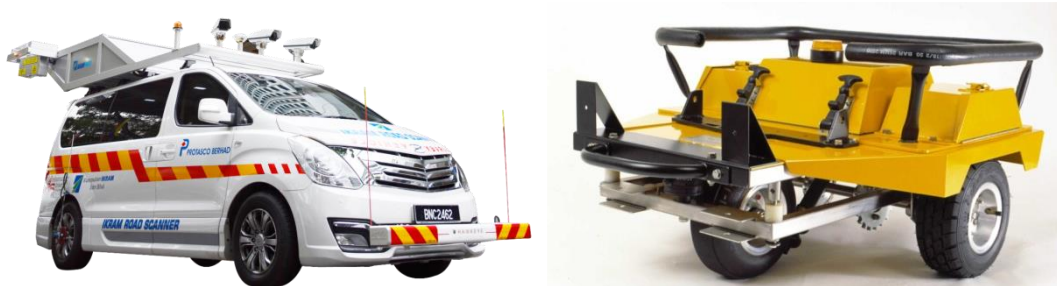
Figure 2. IKRAM Road Scanner (IRS) and Grip Tester (GT).

IKRAM Road Scanner (IRS) were used to capture pavement functional condition data, survey mapping information and roadside asset details whilst travelling at highway speed. This fully-featured vehicle contains a compact workstation capable of capturing and storing individual data elements for roughness, rutting, texture and surface condition, as well as providing high-detail video images of road and road side assets along the LATAR highway.

Meanwhile skid resistance was performed using the Grip Tester (GT) along the left wheel path of the road. The GT has one test wheel, fitted with apparatus containing transducers, instrumentation,

actuation controls, a water supply and automatic control system. It uses measurements representing the friction force on a test wheel operated at a constant load and longitudinal reference slip. During a test run, water was sprayed ahead of the measuring wheel by a self-watering system to produce 0.25 mm thick water film and the test wheel is brought to the road surface by means of the actuation system. The information was process and the Grip Number was converted to SCRIM (Sideway-force Coefficient Routine Investigation Machine) value by the following relationship:
