Shearography Technique on Inspection of Advanced Aircraft Composite Material

To cite this article: Mohd Yusnisyam Yusof *et al* 2019 *IOP Conf. Ser.: Mater. Sci. Eng.* **554** 012009

Abstract. The A320 aft fixed fairing is an advanced composite structure fabricated from laminate carbon woven and combines with honeycomb core which is externally mounted on the flap track fairing as a wing part of Airbus aircraft. These flaps are movable control surfaces to widen up the surface of the wing in order to increase the lifting. This paper discussed on the inspection of A320 aft fixed fairing by using shearography NDT technique. Shearography technique reveals the stress-affected zone due to additional loading that can be realized by the laser speckle correlation on the inspected composite panel. This A320 aft fixed fairing is identified as a scrap composite panel which having different sizes and orientations of defect. The results showed that the changes of shearing direction in laser shearography technique are an effective means to reveal the defects propagation in the composite component. The shearing at Y-axes direction is able to detect the cracks at horizontal orientation while shear

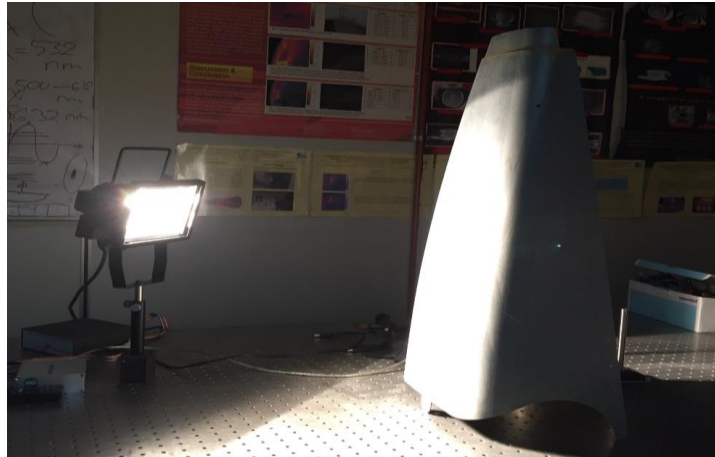
Figure 6. Arrangement of 500Watts infrared spotlight during heating of A320 Aft Fixed Fairing sample

Based on the investigation by shearography for inspection of A320 aft fixed fairing in an advanced composite sample, a 500 Watt spotlight was used as the stress mechanism applied at the front surface of A320 aft fixed fairing sample. The distance between the spotlight and the aft fixed fairing sample during the heating (5 and 20 second) of the sample was position at 300 mm; the distance and heating period where the whole surface of the sample can be optimally heated as shown in figure 6. In this inspection, shearography shows the effect of a local strain concentration due to stress loading if a crack present, on the visible surface of this sample. The A320 aft fixed fairing to be inspected is externally loaded by heating the A320 aft fixed fairing, this will produce the external stress of the A320 aft fixed fairing surface. In the areas of weakened surface caused by flaw, the rear surface of the sample is deformed more than the areas of without flaw. The phase change difference of a stress loaded and unloaded state provides information about the deformation of the rear surface of the A320 aft fixed fairing.

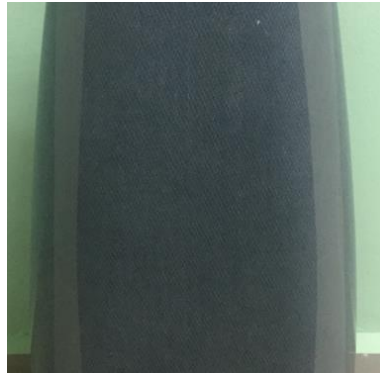
Figure 8. (a) front surface of A320 Aft Fixed Fairing sample

Figure 8. (b) back surface of A320 Aft Fixed Fairing sample

The A320 aft fixed fairing sample has the thickness of 30 mm lamination of carbon woven with honeycomb structure inside the sample, as shown in Figure 8. As it can be seen in Figure 8(a) front surface and Figure 8(b) back surface with multi direction cracks in honeycomb structure of A320 aft fixed fairing Sample. The presence of the crack is intended in the inspection as a reference defect of A320 aft fixed fairing location. The schematic illustration of cracks size measurement is shown in figure 9. The measurement indicates that the higher size of crack is 3.0 cm while the lowest size is 0.8 cm.
