To cite this article: Christina Ehlert *et al* 2019 *IOP Conf. Ser.: Earth Environ. Sci.* **225** 012003

## It's all about planning - pre-demolition audits to inform public calls for tender for enhanced resource management of building materials from deconstruction

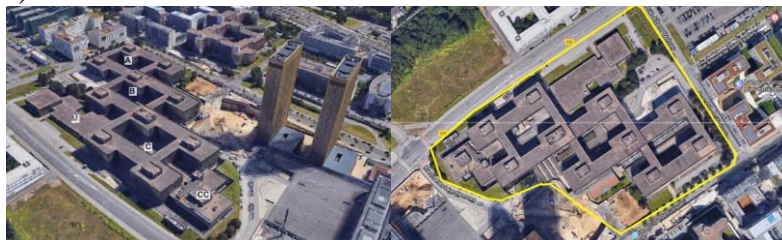
**Figure 1.** View of the Jean Monnet building. Google Earth 15/05/2017.

An extract of the results of the pre-demolition analyses is presented in the next paragraphs. The review of the plans, site visits and results from analysis of samples allowed to gain a good understanding of the building. The office building was built during the years 1975 to 1978, designed for 2000 employees and 500 visitors with a gross floor area of approximately 125,000m<sup>2</sup> spread over three main complexes (A, B, C) (see Figure 1).

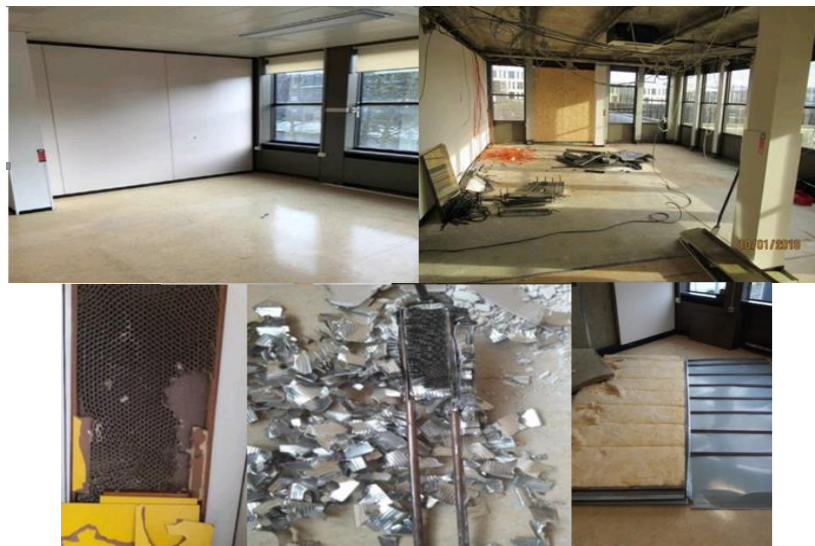
**Figure 2.** Test deconstruction of a representative unit in the building, from top left to below right corner: View of the office before and after the test. Office door composition. Radiator consisting of aluminium plates and copper bars. Interior wall.

The deconstruction tests delivered results on dismantling steps and material composition (Table 1).

Figure 2 illustrates the Mock-up office before and after the test deconstruction as well as the deconstruction of building components.
