# The hazard of change landscape and hydrogeology zone south karst mountain impact natural and human activity in Region Jember

**Abstract.** The purpose of this study was to determine the hazard of landscape change and hydrogeology in the karst region of the southern mountains of Jember Regency due to natural processes and human activities. The method used in this study used inductively on karst areas of the southern mountains. This method is used to determine the nature of diffuse, fissure, and conduit flow. In addition, hydrograph flow is used to determine the conditions of water release and karst squamous conditions with parameters related to natural changes and human activities. The hydrochemical properties and flow properties are used to characterize karst aquifer conditions in the southern mountains of Jember region. The results showed that landscape and hydrogeological changes in the karst area experienced rapid dissolution. Throughout the year the flow conditions of karst hydrology in the Jember area were dominated by diffuse and conduit types, so that fissure conditions never occurred. In addition, the hydrochemical conditions in the karst area did not experience sharp fl

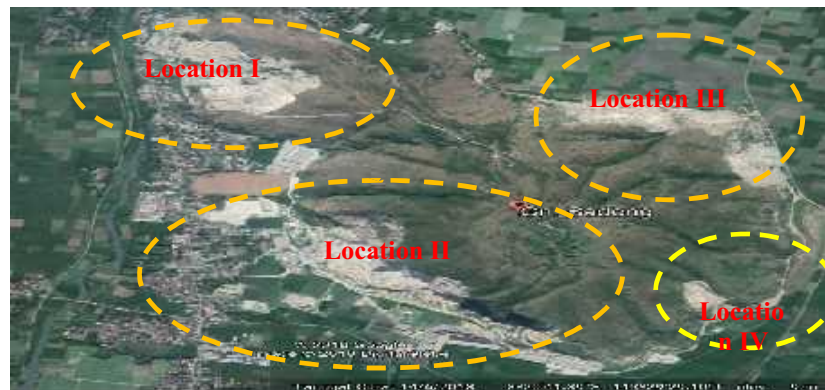
**Figure 1.** Location Changes Landscape Karst Mountain Sadeng

The heaviest damage in the field occurred in locations I and II. Both locations are industrial estates with large scale cement plants. While locations III and IV the damage level is still small. This condition is inseparable from traditional mining activities carried out by residents living in four villages including grenden, kasiyan, puger kulon, and puger wetan.

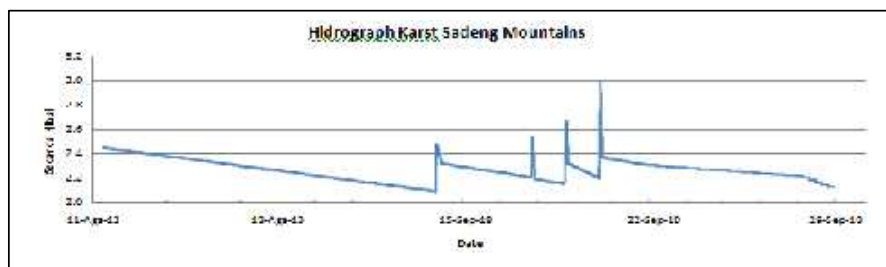
**Figure 3.** Speed of Under Water Discharge Mountains Sadeng Karst
