Geotechnical properties of gulying in Tomsk Oblast

Abstract. The article deals with causes, conditions and factors of gulying in Tomsk Oblast, the case of site Grodnenskaya. A nuclear-power station was planned to be constructed in Closed Administrative Territorial Unit Seversk, which led to geotechnical investigation of the area to study the geological processes developing there. The investigation included reconnaissance traverse of the area, geological and geomorphic descriptions, and sampling. The area and percentage of the territory affected by the geological processes were estimated. As a result, it was proved that the geological processes of the area are conditioned by surface water activity leading to gulying and river erosion, and by both ground water and surface water activity resulting in bog formation. It appears that gulying is caused not only by natural factors but also by technogenic ones.

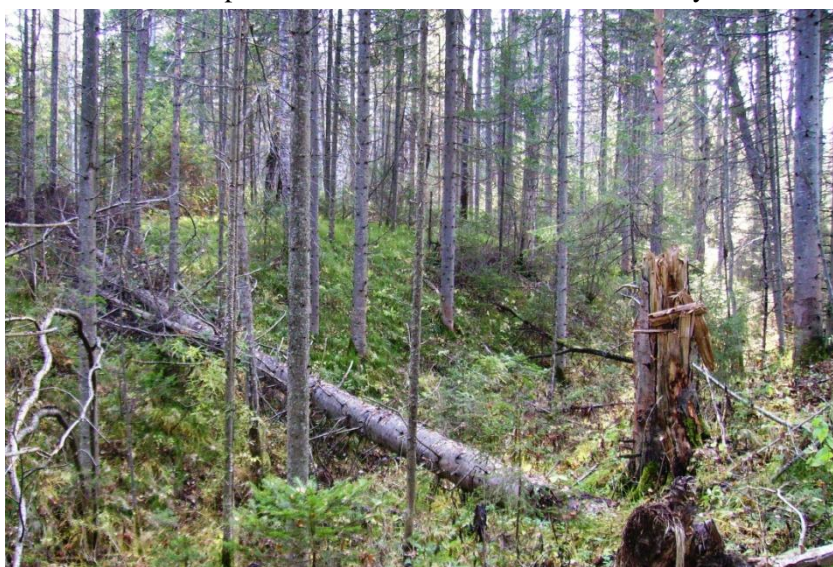
Figure 1. The gully on the studied site.

Gullying is the most developed geological process on Grodnenskaya site, which occupies almost 40% of the site [2] making the areas unsuitable for construction (fig.1).

The gully network can be classified as highly eroded [3]. A developed gully network with both dry and wet gullies spreads from the top of the site down toward the river valleys. Most of the gullies are grass-covered and forested; however, there are rare cracks and failures of the sides, which means that the erosion still continues.

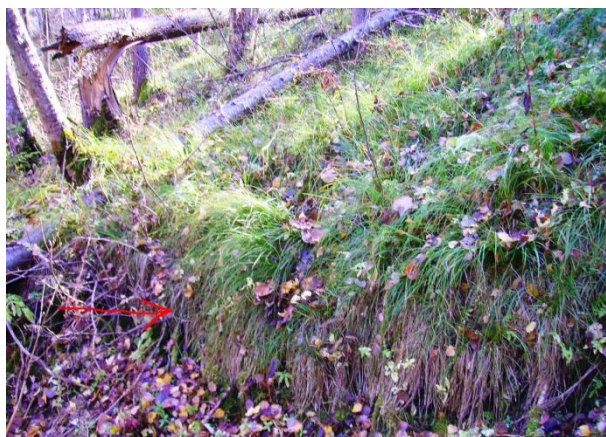
Figure 2. Slumping.

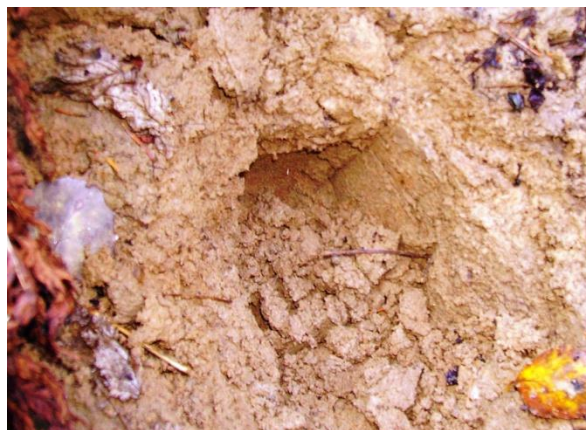
Figure 3. Sand clay in the gully side.

The gullies of the studied area are of different size: from 2 to 43 m wide, with 0.5-7.0 m deep. They are at different stages of development: from water galls and developing gullies to grass-covered and forested ravines. The length of the gully network is 1.5 km and more. The side slopes are usually covered with grass and subdued. The longitudinal section has the form of a smooth curve. The cross-section is of U-type. The slopes of gullies and ravines are covered with birch, aspen, abies, and small spruce (up to 40 cm high). There are a lot of windthrown trees. The sides are covered with thick grass: sedge, horsetail, fern, and etc. There occur small hills of sedge 7 cm high and of a diameter up to 25 cm, they are covered with moss. The side slopes are prone to slumping, cracks and paps (fig. 2). As a rule, a temporal flow cuts the gully bottom. The observed fresh cut, 40-105 cm wide and 15-30 cm deep, continues to develop the gully. Sand and sand clay are exposed in the cut (fig. 3).
