Impact of defectiveness on the parameters of the acoustoelectric transformations in heterogeneous non-metallic materials

Abstract.

The article studies acoustoelectric transformations of concrete with a crack. The research presents three-dimensional modeling and 3D visualization of wave processes in a concrete sample with a surface crack. The parameters of the electrical response are found to reflect the processes of interaction between the acoustic wave front and the defect and boundaries of the sample.

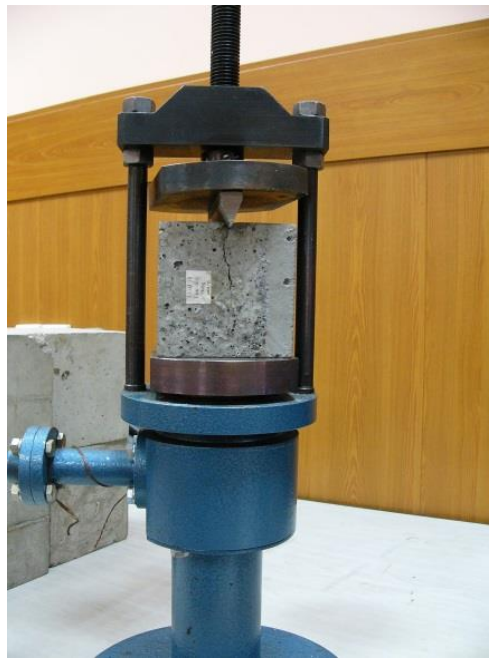
Figure 1. Photograph of the loading system.

The natural crack was made in the following way. The sample was cut 5 mm deep to the center. Then a metal wedge was inserted into the cut. The system sample-wedge was loaded with a hand press. Figure 1 shows a photograph illustrating the process of crack growing in the sample of 100×100×100 mm. The sample was made from the mixture of cement, sand and gravel in the ratio 1:2:4 with the maximum fraction size of 20 mm.

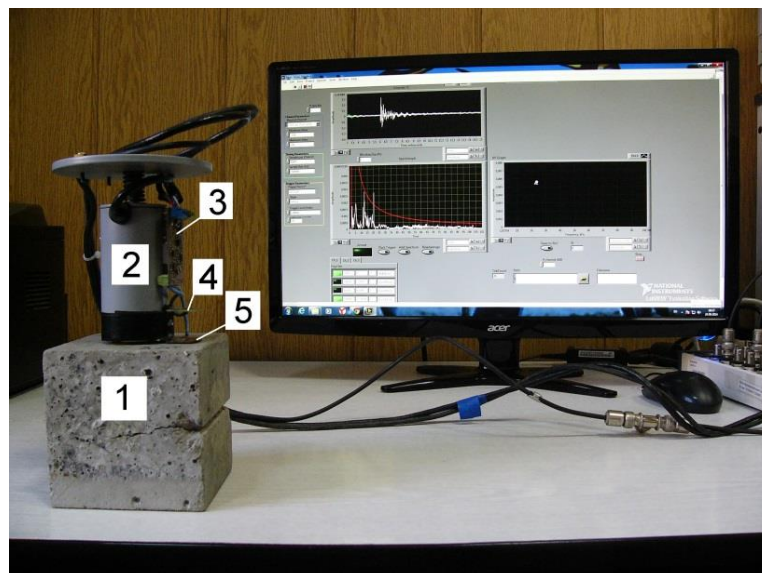
Figure 2. Photograph of the measurement system.

Figure 2 shows a photograph illustrating the process of measuring the electrical response from the concrete sample with a crack located perpendicularly to the direction of the shock and in parallel to the plane of the electrical receiver.

Pulsed mechanical excitation of the sample (1) is performed with the help of electromechanical impact devices with standardized impact force (2). To record the electrical response, a differential electrical sensor is used. Electrical measuring receiver (5) is located at the distance of 2 mm from the surface. Thus, the conditions for the noncontact reception are created. Compensation receiver (4) is

located at the height of 30 mm from the measuring receiver. After that these signals are sent to the input of the differential amplifier (3), subtracted and amplified. This measurement design enables to improve significantly the signal-to-noise ratio. The signals from the electrical sensor are recorded with Multi-I/O-card “NI PCI-6251”, combined with the computer, allowing the digitization of time realization of an electrical signal.

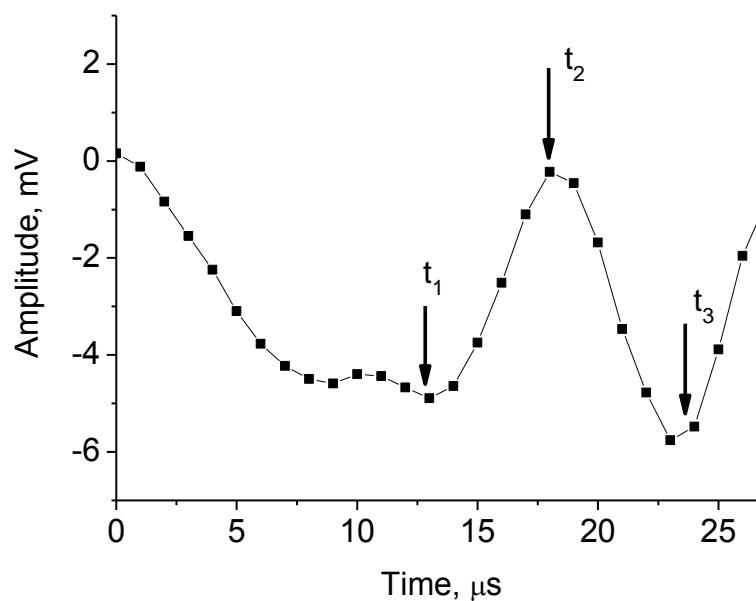
Figure 3. The initial section of the electrical response from the concrete sample with a crack.

Figure 3 shows the electrical response from the concrete sample with a crack. The crack passes through the center of the side surface of the sample in parallel to the upper surface. The crack depth is 50 mm, length is 100 mm.

Figure 3 shows significant deformation of the electrical response at 13 μs – (t_1), 18 μs – (t_2), and 24 μs (t_3).

At 8 μs , the wave overcomes the level of the crack. In other words, it goes over it, undergoing the maximum distortion in comparison with the previous stage (Figure 4C). The change in the shape of the wavefront affects the level of the electrical response (point t_2 , Figure 3).

At 24 μs (Figure 4D), the wave front is reflected from the opposite face. In Figure 3, this point is marked as t_3 . The reflection from the opposite face causes signal increase.

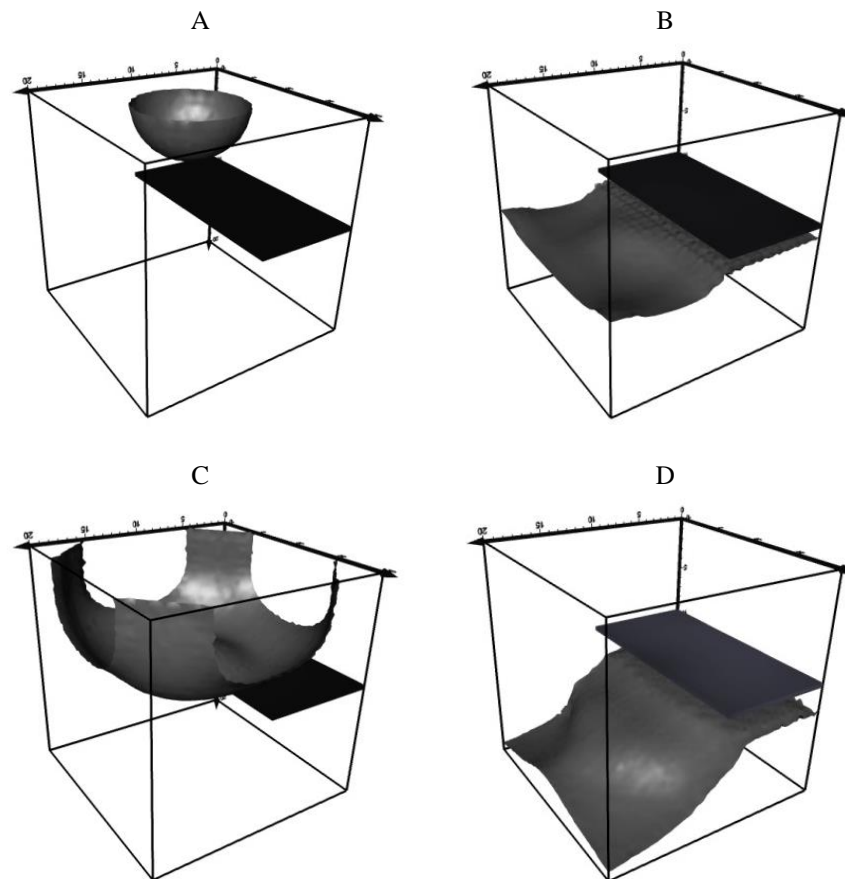
Figure 4. Longitudinal displacement fields in the concrete sample over the time intervals equal to: A is 5 μs ; B is 13 μs ; C is 18 μs ; D is 24 μs after loading.

3D modeling of wave processes was used to form the fields of longitudinal displacement in the sample. For calculation, the following concrete values were used: density was $2.3 \times 10^3 \text{ kg/m}^3$; elasticity modulus was $3.3 \times 10^{10} \text{ H/m}^2$; Poisson's ratio was 0.2; longitudinal wave velocity was $4 \times 10^3 \text{ m/s}$. The calculation was carried out for the case when the shock was made towards the sample center. Figure 4 shows 3D visualization of the longitudinal displacements fields carried out with Voxler 3 program.

At the initial stage (see Figure 4A) we can see wave propagation without distortion by defects and boundaries of the sample. The crack is shown in dark in Figure 4. Within this time interval it can be seen that the shape is spherical which corresponds to the wave theory.

In Figure 4A the wave reaches the side boundaries of the sample. After 13 μs , when the wave reaches the side boundaries of the sample, the acoustic wavefront is distorted due to the reflection of the wave from the boundary. This instant time is characterized by the distortion of electrical response which corresponds to t_1 in Figure 3. The increase of the electrical response magnitude in the time interval from 13 to 18 μs occurs due to the contribution of the reflected waves. In papers [7, 8], it is shown that in heavy concrete, the main contribution to the electrical response is made by piezoelectric sources of acoustoelectric transformations. The sources are distributed throughout the sample volume. The electrical signal occurs due to the appearance of charges on the faces of the piezoelectric quartz contained in fine and coarse aggregate (river sand and gravel) under its deformation by the acoustic wave, and due to the shift of these charges relatively to the electrical receiver. Consequently, the increase in the magnitude of the electrical response in the time interval from 13 to 18 μs is connected with the contribution of the acoustoelectric transformations reflected from the side surfaces of the waves.
