# Change in the microstructure and mechanical properties of drawn pearlitic steel with low-temperature aging

**Abstract.** Hydrogen embrittlement is a serious problem in high-strength steels. Drawn pearlitic steel shows excellent resistance to hydrogen embrittlement despite its high strength, and aging treatment at a low temperature can simultaneously improve its strength and hydrogen-embrittlement resistance. To clarify the mechanism for this we have used thermal desorption analysis (TDA) and the newly developed precession electron diffraction analysis method in the transmission electron microscope. After aging at 100 °C for 10 min, the amount of hydrogen seen amount on the TDA curve reduced at around 100 °C. In contrast, when aging was performed at 300 °C, the hydrogen amount further reduced at around 100 °C and the unevenly deformed lamellar ferrite zone was locally recovered. For the samples that were aged at the low temperature, we confirmed that their yield strength and relaxation stress ratios increased simultaneously with improvement in the hydrogen-embrittlement property. We infer that segregation of carbon or formation of very fine carbide in dislocations during aging is

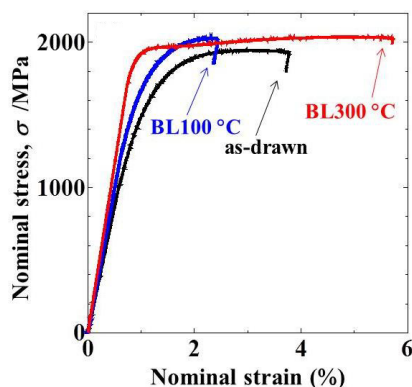
Figure 1 shows the results of the tensile test. The 0.2% yield stress increased with the aging temperature up to  $300^\circ\text{C}$ . Furthermore, the largest total elongation was recorded for the specimen with an aging temperature of  $300^\circ\text{C}$  (BL300  $^\circ\text{C}$ ).

**Figure 1.** Stress–strain curves of the as-drawn, BL100 °C, and BL300 °C specimens.

The yield strength increased upon the application of the aging treatment, more significantly at 300 °C than at 100 °C. Dislocations during the relaxation test were also stabilized by the aging treatment in a similar manner to that observed in the tensile test, where again, the aging treatment at 300 °C had a stronger effect than that at 100 °C. During the drawing process for pearlitic steel at room temperature, lamellar cementite is expected to be partly dissolved as solute carbon in the ferrite matrix together with an introduction of dislocations. These dislocations are supposed to be locked or pinned by segregated carbon or by very fine carbides formed during the aging treatment. Taking into account the fact that recovery simultaneously occurs during aging at 300 °C, the increment in the pinning force for dislocation movement by segregated carbon or very fine carbides is inferred to be much larger than the softening effect of recovery.

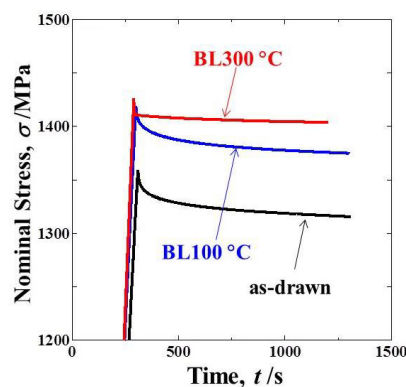
Figure 2 shows the results of the stress-relaxation test. The ratios of stress relaxation were 3.4% for the as-drawn material, 3.2% for the specimen aged at  $100^\circ\text{C}$  (BL100  $^\circ\text{C}$ ), and 1.6% for the BL300  $^\circ\text{C}$  sample. These results suggest that the dislocations were stabilized by the aging treatment.

**Figure 2.** Stress-relaxation curves of the as-drawn, BL100 °C, and BL300 °C specimens.

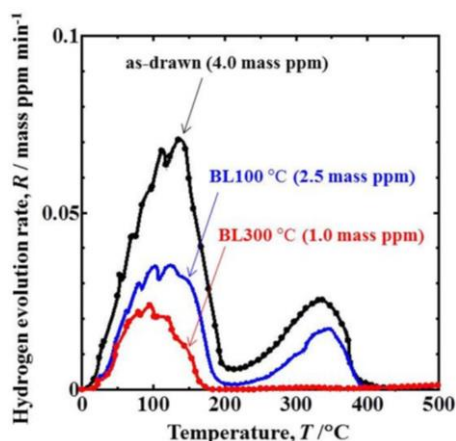
Figure 3 shows the TDA profiles of the specimens subjected to hydrogen charging for 144 h. The hydrogen concentration is expected to reach an equilibrium value up to the sample center. Two desorption peaks at 100 °C and 300 °C were observed, where the first peak, near 100 °C, corresponds to the hydrogen trapped in the stress field of dislocations, the second peak, near 300 °C, corresponds to hydrogen trapped in dislocation cores [12]. As the aging temperature increased, the height of both peaks decreased, indicating a decrease in trapper hydrogen content.

**Figure 3.** Thermal desorption profiles of the as-drawn, BL100 °C, and BL300 °C specimens charged with hydrogen for 144 h.

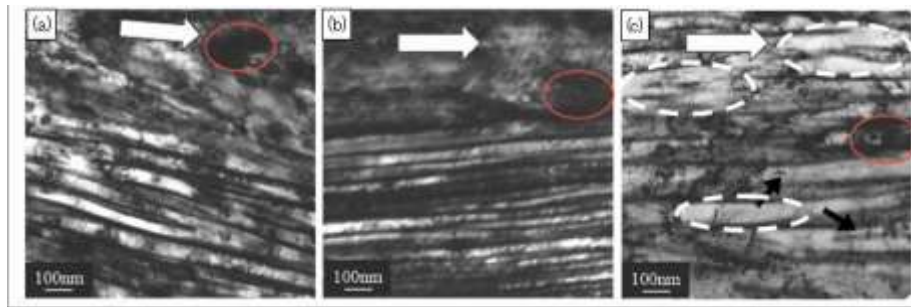
Figure 4 shows bright-field TEM images of the as-drawn specimen as well as of specimens subsequently aged at 100 °C and 300 °C. The drawing direction is indicated by white arrows. Dislocations were observed in the lamellar ferrite in each specimen. The width of the lamellar ferrite was 50–100 nm in each specimen. No clear changes were observed either in the ferrite-phase width or the cementite structure as a result of the aging treatments. The specimens aged at 300 °C, however, yielded images suggesting some dislocation rearrangement in lamellar ferrite, as indicated by the dashed-line circles in Fig. 4(c). A contrast suggesting the precipitation of carbides was also observed, as indicated by black arrows in Fig. 4(c). Strain contrast arising from the localized presence of high-density dislocations was also observed, as indicated by red circles in Figs. 4(a)–(c).

**Figure 4.** TEM images showing the dislocation structure in (a) the as-drawn specimen and in the specimens subsequently aged at (b) 100 °C and (c) 300 °C.

4(c) and the circles in the lower part of figure 9(b)). Despite the softening effect induced by recovery, the yield strength increased. This significant increase in the yield strength with aging at 300 °C is expected to be caused by the very strong pinning force exerted by fine carbides. As for hydrogen-embrittlement susceptibility, it should be essentially high after wire drawing, as pointed out by Doshida and Takai [4], owing to the presence of hydrogen segregation at dislocations, and due to the deterioration of toughness associated with the work-hardened structure, particularly in high-strained regions where dislocations are tangled in a complex manner (see figure 4 and the upper part of figure 9(b)). However, aging at 300 °C improved hydrogen-embrittlement resistance. This presumably occurred because dislocations are strongly pinned by the very fine carbides and the toughness is improved by the recovery.

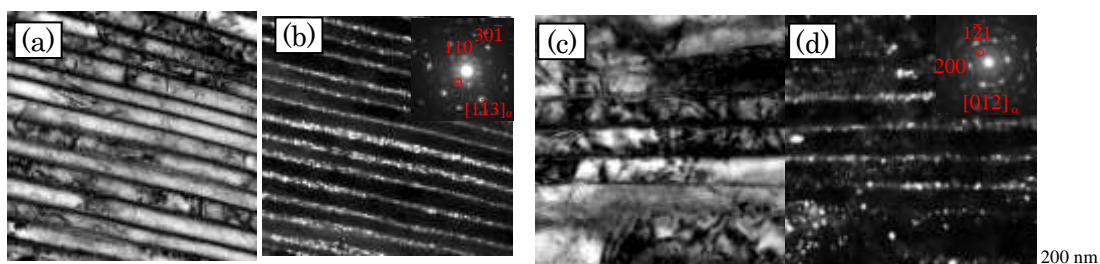
Figure 5 shows the detailed information of cementite in the as-drawn specimen and in the specimen subsequently aged at 300 °C. The dark-field image in Fig. 5(d) indicates the commencement of spheroidization of very fine carbides at an aging temperature of 300 °C.

**Figure 5.** TEM images showing the lamellar cementite structure (a) the bright field image of the as-drawn specimen, (b) dark field image of the as-drawn specimen, (c) bright field image of the specimen aged at 300 °C, and (d) dark field image of specimen aged at 300 °C.

Microstructural changes during the aging treatment are considered to have a positive effect against hydrogen embrittlement. The TEM grain-orientation maps of the minute regions of the as-drawn specimen and those of the specimen subsequently aged at 300 °C (figures. 7(a) and (c), respectively) not only revealed the grains elongated in the drawing direction but also indicated the occurrence of dislocation rearrangement more prominently during aging at 300 °C. Furthermore, the TEM grain orientation maps revealed for the first time the formation of a fine microstructure with high-angle grain boundaries wherein recovery progressed and subgrain formation apparently proceeded. This microstructural change is expected to soften the material. A slight hardening actually occurred, however, during aging at 300 °C. This is presumably caused by the further strengthening resulting from the segregation of carbon or the precipitation of very fine carbides, as shown in figures. 5(a) and (b).

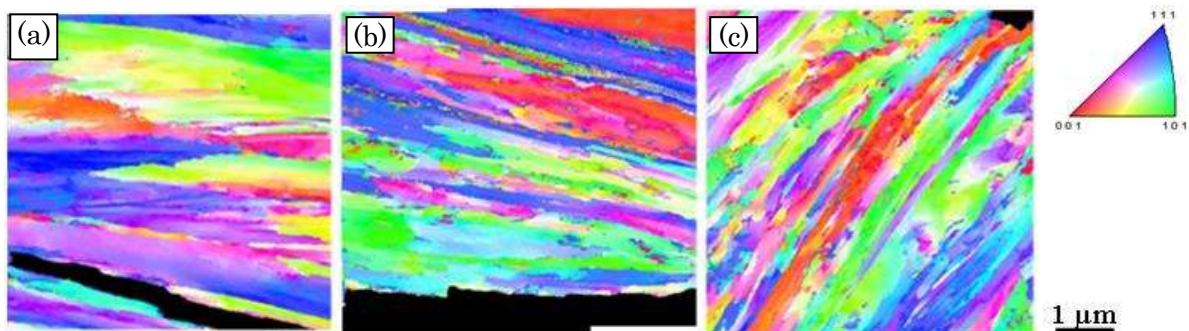
Figure 6 shows ferrite-phase orientation maps obtained by subjecting the as-drawn specimen and the specimens subsequently aged at 100 °C and 300 °C to precession electron diffraction. In the grain-orientation map of each specimen, grains of the same color are elongated in the drawing direction. A region with the same color is inferred to be an initial block with a width of approximately 1–2  $\mu\text{m}$ . The gradation in the grain orientation in a block is inferred to reflect a packet. In this way, the inhomogeneity of the microstructure of the drawn pearlitic steel is related to the grain orientations of the blocks before the drawing operation. It is worthwhile to note that the specimen aged at 300 °C revealed a region with a fine microstructure having high-angle grain boundaries (Fig. 6(c)). This suggests that the aging treatment at 300 °C locally decreased the dislocation density through rearrangement of dislocation, resulting in subgrain formation. The magnified TEM orientation maps shown in Fig. 7 evidently imply that dislocation rearrangement proceeds during aging at 300 °C.

**Figure 6.** TEM grain-orientation maps of specimens: (a) as-drawn, (b) subsequently aged at 100 °C, and (c) subsequently aged at 300 °C.

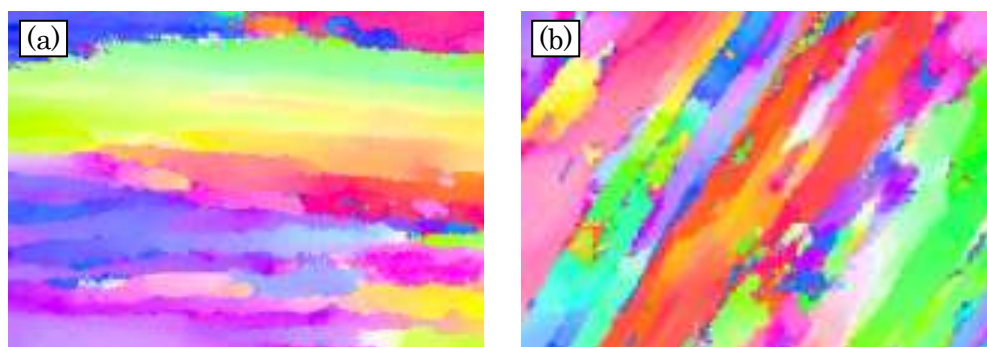
**Figure 7.** Magnified TEM grain-orientation maps of specimens: (a) as-drawn and (b) subsequently aged at 300 °C.

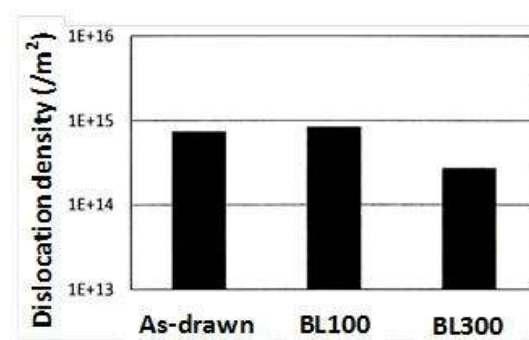
**Figure 8.** Dislocation density of the following specimens: as-drawn and subsequently aged at 100 °C (BL100) and 300 °C (BL300).

Figure 8 shows the results of the dislocation-density measurements performed using X-ray diffraction to indirectly evaluate the aging-induced recovery behavior. The dislocation density hardly changed with aging at 100 °C for 10 min, suggesting the occurrence of only the decoration of dislocations with carbon. Meanwhile, aging at 300 °C for 10 min slightly decreased the dislocation density. The results obtained via X-ray diffraction are considered to be in good agreement with the TEM grain-orientation maps.

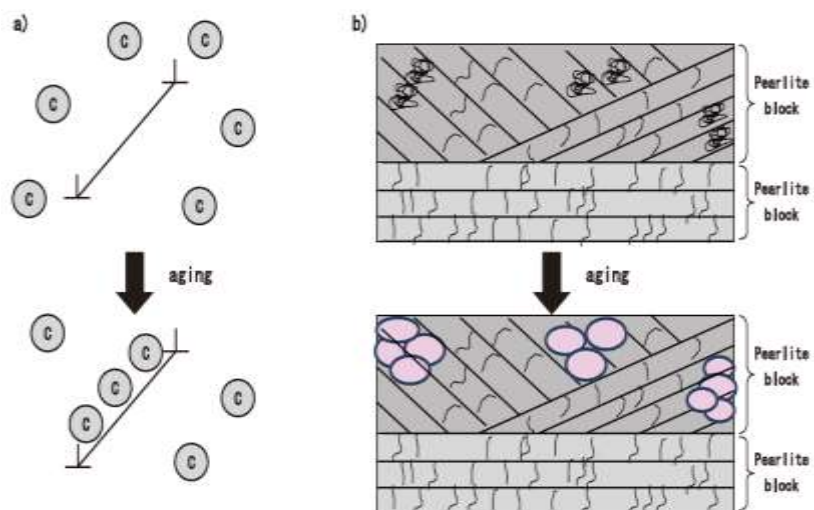
The change in microstructure of drawn pearlitic steel during low-temperature aging is schematically illustrated in figure 9. Pearlitic steel in the as-drawn stage consists of an elongated lamellar structure consisting of ferrite and cementite. Since cementite is considered to be partly dissolved as solute carbon during the drawing process, solute carbon is expected to exist in dislocated lamellar ferrite. When drawn pearlitic steel is aged at 100 °C for 10 min, the solute carbon segregates to the dislocations (figure 9 (a)). Therefore, the yield stress is considered to increase as a result of the Cottrell atmosphere. Moreover, hydrogen-embrittlement susceptibility is expected to decrease, because the amount of harmful hydrogen segregated to the dislocations decreases owing to the preferential segregation of carbon to the dislocations. Moreover, the mobility of dislocation, which was initially promoted by the HELP theory owing to the segregated hydrogen, is inferred to be reduced by the presence of segregated carbon in the dislocations.

When drawn pearlitic steel is aged at 300 °C for 10 min, carbon further segregates to the dislocations and very fine carbide precipitation may occur (figure 9 (b)). On the other hand, aging at 300 °C induces local recovery or subgrain formation (see the regions enclosed with white broken circles in figure

**Figure 9.** Schematic illustrations showing the change in microstructure and the mechanism of the improvement in mechanical properties upon aging the as-drawn specimen at a) 100 °C and b) 300 °C.
