Comprehensive characterisation of groundwater quality in and around a landfill area for agricultural suitability

V Hariharan, L Chilambarasan , G Nandhakumar and P Porchelvan

School of Civil and Chemical Engineering, VIT University, Vellore, Tamil Nadu 632014

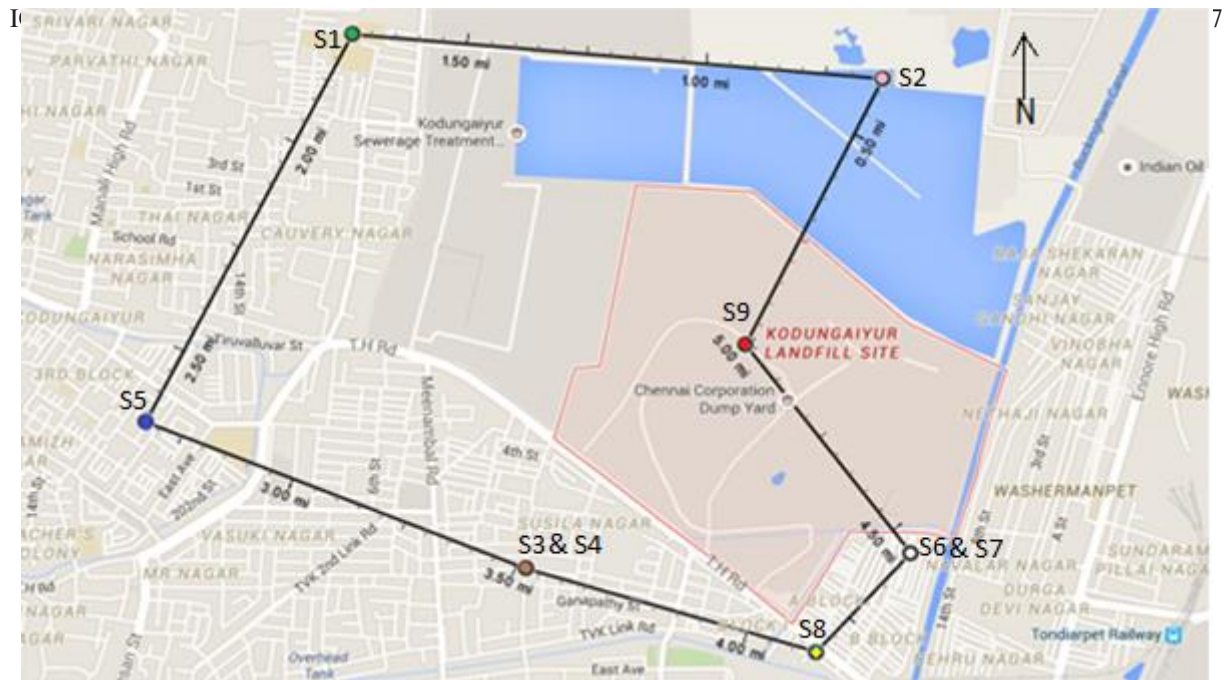
Fig.2. Sampling locations in and around the site

Fig.2 depicts the sampling locations in and around the landfill site. Five bore well samples (including one sample inside the site) from the surrounding residential units situated within a distance of 2 km and four samples from observatory wells (nine samples in total) were collected radially. The wells other than observatory wells are currently used for domestic utilization (except for drinking) by the residents.

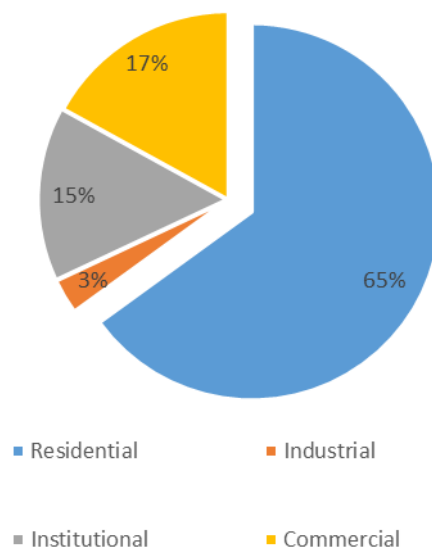
Fig.3. Solid wastes from different sources

The extent of the landfill area is about 200 acres. This site has been in use for the past 30 years receiving 2100 to 2300 metric tons of solid waste every day^[6]. Fig.3 shows the average distribution of wastes being brought to the landfill.
