Abstract Spacecraft are complex systems operating in challenging environments that require customized testing procedures designed to mitigate the unique hazards of a space launch environment. As an example of those testing procedures, we describe the test methodology and recommendations developed to mitigate electrostatic discharges that could have triggered an explosion of the Space Shuttle during launch, return to launch site, abort after one orbit, or during normal landing.

ELECTROSTATIC EVALUATION OF THE SPACE SHUTTLE THERMAL CONTROL SYSTEM
MULTILAYER INSULATION BLANKETS

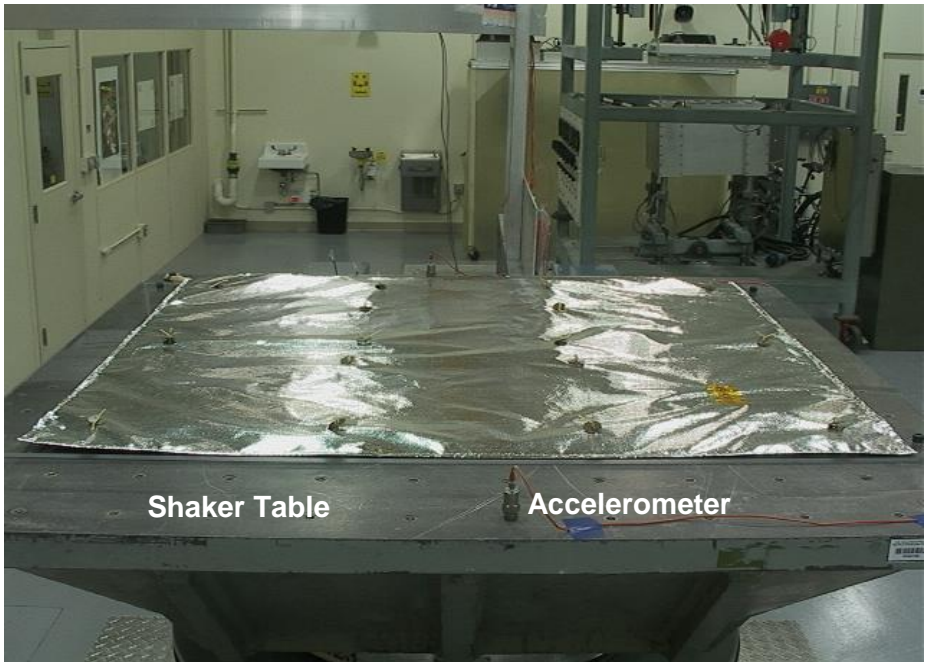
Figure 2. Shaker table experiment with aluminized MLI blanket.

To produce a charging scenario that would approach what the MLI blankets might encounter during flight, shaker table experiments (Unholtz Dickie Vibrating Test System) were performed that simulated the amplitude, the frequency of vibrations, and the changing accelerations experienced by payloads in the payload bay (Fig. 2). An aluminized TCS (no Beta cloth) MLI blanket that measured 41.5 by 36 inches was custom-built to represent one of the largest blankets used in the Shuttle payload bay. After cutting one side of the blanket to expose the inner layers, resistance measurements between each inner layer and the outer layers were conducted using a PRS-812 meter. The first three inner layers had a resistance between them on the order of a few kilohms, the same as inner layers 4 through 8. However, inner layers 1 through 3 were not connected to inner layers 4 through 8, even though they were stapled together and bound with the Beta glass cloth tape. None of the inner layers were connected to the outer layers of the MLI blanket.
