## QUARTERLY REPORT

January-March 2001  
1st Quarter, Issue #4

### Windward Engineering Profile

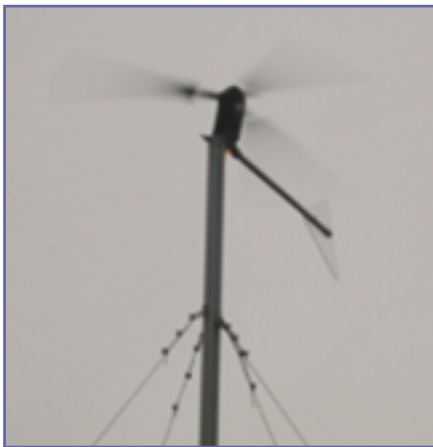
**Figure 1.** Furling Whisper H40 in Spanish Fork, Utah.

Last quarter, Windward Engineering added some data processing capabilities to their LabView data acquisition system (DAS) to determine extreme loading events on the Whisper H40 furling wind turbine (Figure 1). The new data processing includes six new calculated outputs: maximum instantaneous rotor speed, maximum instantaneous wind speed, maximum yaw rate, time of maximum yaw rate event, maximum furl rate, and time of maximum furl rate event. This quarter, ending March 31, 2001, was the first full quarter where these values were monitored.

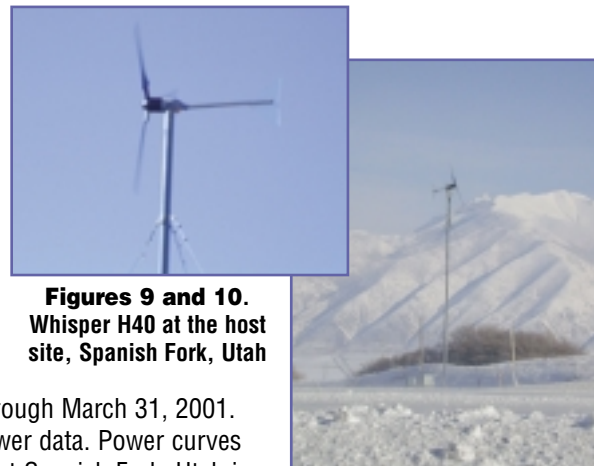
**Figures 9 and 10.**  
Whisper H40 at the host site, Spanish Fork, Utah

Windward Engineering staff are testing a grid-connected Whisper H40 at an existing wind energy test site (Figures 9 and 10) in Spanish Fork, Utah. Since the turbine was commissioned in February 2000, it has produced a total of 1,543 kWh, and 77% of the energy produced has been sold to the grid. Another Whisper H40 has been tested at the NWTC since February 2000.

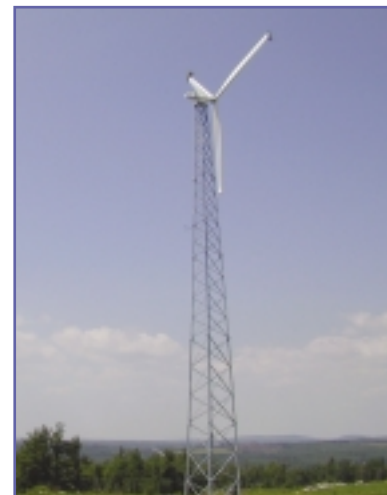
**Figure 14.** AOC 15/50 wind turbine at the Allen Blueberry Plant in Orland, Maine.

The issues addressed this quarter focused on connecting the system to the grid. Previously it was agreed that two protective relay units would be added to address Central Maine Power's (CMP) concern about the level of grid-monitoring, relay-protection equipment. Before the turbine (Figure 14) could be connected to the grid, utility staff needed EEC to simulate a fault, without disturbing relay wiring, to verify the protective relays would disconnect the turbine from the grid and the protective relay operation would translate through the program logic controller to the instrumentation relays and to the main contactor. EEC added a three-pole, double-throw switch to the control circuitry to prepare to simulate a fault. EEC scheduled the fault simulation and turbine commissioning at the same time. Staff from Atlantic Orient Corporation, EEC, G.M. Allen & Son, and CMP were present. During the fault simulation, the turbine successfully disconnected from the grid when the protective relay inputs were switched. The utility representative gave verbal authorization to connect to the grid and left before the commissioning. Later that day, January 15, 2001, the utility representative provided written authorization after returning to his office. During the commissioning, a wiring problem was discovered with one of the factory-wired connectors on the rotary transformer cable connection to the blade tip brakes. Commissioning was halted, but within a week a corrective patch cable was assembled at the factory and delivered to the site.

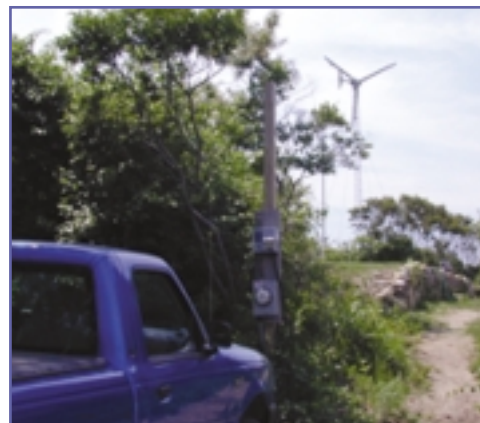
**Figure 15. A Bergey 7.5 kW/R wind turbine charges the site's electric Ford Ranger pickup.**

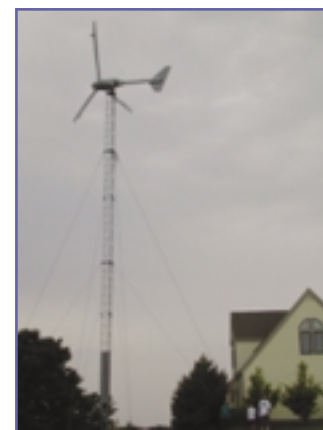
**Figure 18. A guy wire failed on the Evans Residence Bergey Excel-S/E 10 kW.**

In Issue #2, Offshore reported that the power transducer equipment was producing noise. Staff thought that perhaps it was due to electromagnetic interference from the proximity of the Trace inverter. Staff moved the Ohio Semitronics (OSI) current transformer and transducer away from the inverter. The noise was only lessened, rather than eliminated. Staff will try an alternate OSI and/or a Second Wind "Nomad" Data Logger. In addition, last quarter, the turbine's guy wire to the tower failed and the turbine fell (Figures 18 and 19). The guy wire was repaired this quarter. Before the turbine could be reraised, a neighbor appealed the repair permit and put a temporary stop on the work. (Note: In the Field Verification Program Quarterly Report, Issue #2, Offshore reported problems the Block Island community was having with wind turbine installations. Block Island was in the process of adding new zoning and noise ordinances, which would allow neighbor input before permitting. To date, there is a wind turbine building moratorium in effect until May 28, 2001, in order for the Town to reexamine the provisions in the present wind turbine ordinance.) The town held a public hearing on February 26, 2001. The host site owner and the town building official testified that the repair permit was issued in accordance with the town ordinances. The Zoning Board decided that the building official was correct and the appeal was denied. The turbine would have been immediately erected except, in the interim, the insurance carrier that paid for the turbine's repair declined to provide coverage in the future. A new insurance carrier is being sought. The turbine did not operate this quarter and no operating data are provided.

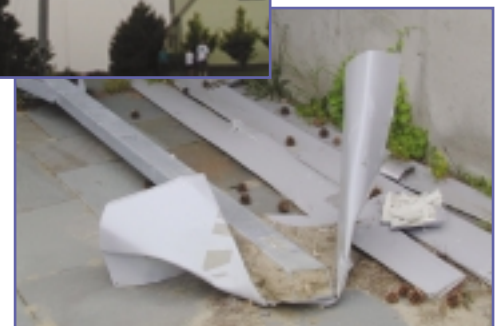
**Figure 19. The Evans Residence turbine fell after a guy wire failed. Here you see the tail crushed with embedded rocks and soil. Next to it lay the blades.**
