# Treatment of Acid Mine Drainage Using Fishbone Apatite II™

**2006 National Association of  
Abandoned Mine Land Programs 28<sup>th</sup>  
Annual Conference**

## TREATMENT OF ACID MINE DRAINAGE USING FISHBONE APATITE II<sup>TM</sup><sub>1</sub>

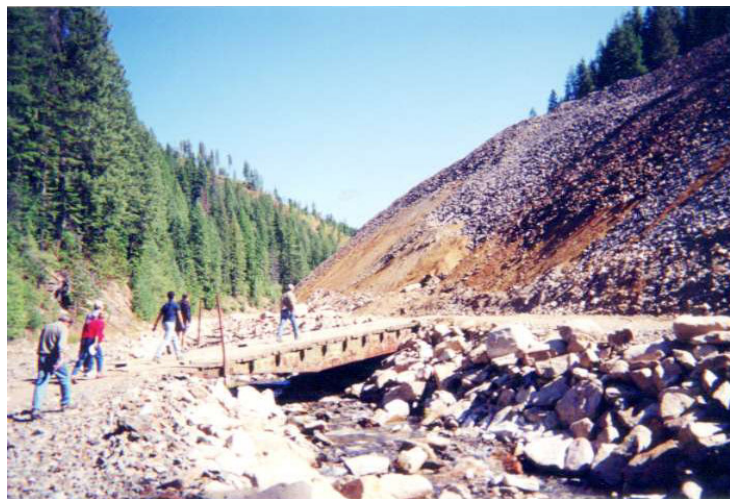
Figure 1.0 Ground and Surface Water Passing through Mine Tailings

Groundwater flows from the adjacent hillsides and comes up in various locations in the canyon floor. Portions of this water comes up through the tailings pile and flows down gradient until it enters the creek, again carrying with it increased levels of dissolved and suspended metals with a lowered pH level.

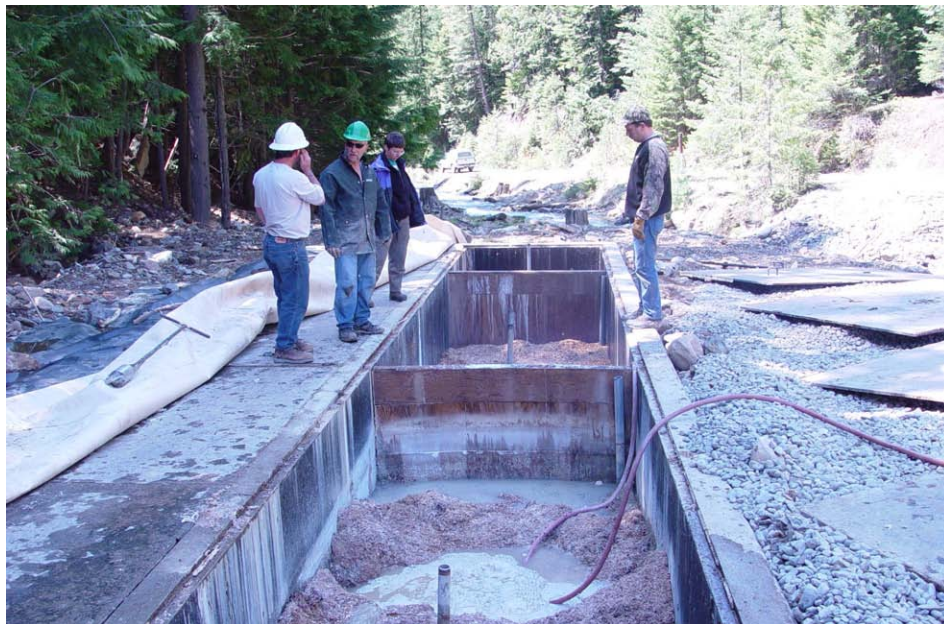
In 2000, a 45 foot long 12 foot deep reactive barrier was constructed to treat acid mine drainage resulting from surface and groundwater passing through mine and mill tailings at the Success Mine on the East fork of Ninemile Creek near Wallace, Idaho. The reactive barrier was constructed having two separate sides, each 6 foot wide, 12 feet deep, and 45 feet long (See Figure 2). On each side of the reactive barrier, water flows over and under alternating baffles to

create as much contact between the media and contaminated water as possible. Each side of the reactive barrier has 5 cells separated by these alternating baffles (Figure 2).

Figure 2.0. Construction of the Reactive Barriers at the Success Mine Site.

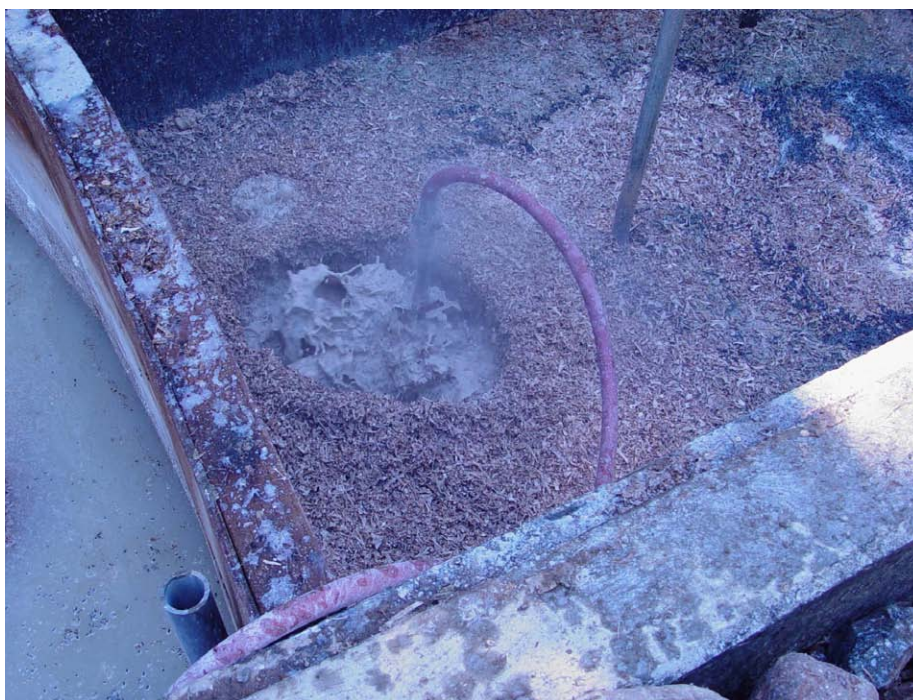
The covers to the reactive barriers were removed to provide access to the media. A 10 foot galvanized hollow wand was fabricated to inject compressed air deep into the media. Compressed air was injected in at least two locations in each of the 5 cells for both the East and West side of the reactive barrier (See Figure 3).

Figure 3. Injecting Compressed Air in the Apatite II<sup>TM</sup> Media.

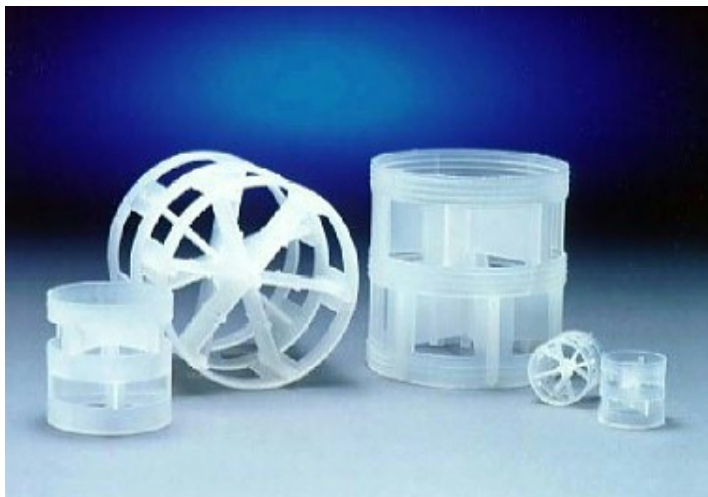
surface area for microbial attachment and increase the reactive area of the media. They are also used to increase the void space in the media (Figure 4).

Figure 4. Plastic Packing Rings.

In November of 2005, the media in the East side of the reactive barrier was replaced with new Apatite II™ mixed with plastic packing rings at a ratio of 30 volume % plastic packing rings. Two inch Jaeger plastic packing rings were used to provide an increase in void volume in the reactive barrier. The increase in void volume was desired to provide more area for water to flow through in the Apatite II™ media and to provide more volume for sediments and precipitates to form without impacting the flow. Figure 4 is a picture of the packing rings used in the reactive barrier. By themselves, the plastic rings have a void volume of 92%. Information on the void space of Apatite II™ was not available, but had noticeably less void volume than the plastic rings alone.

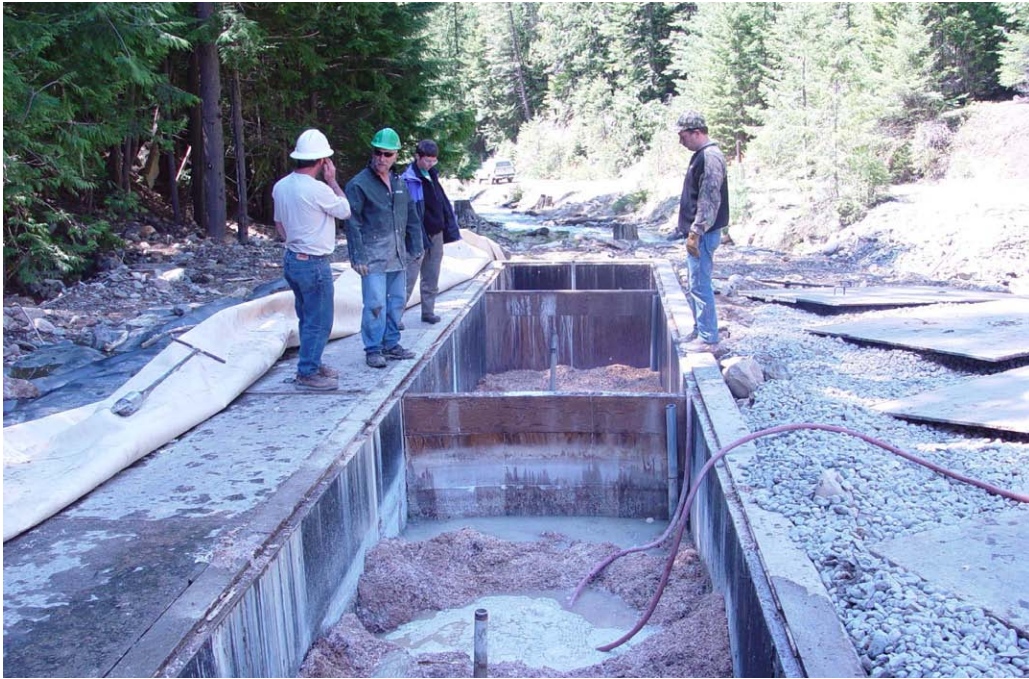
Another similar site in the Coeur d'Alene basin is using Apatite II™ to treat acid mine drainage at the Nevada Stewart Mine. At this location, compressed air is injected into the media combat the effects of plugging on the reactive barrier. This results in temporarily increased flow in the media at the Nevada Stewart Mine site. For the reactive barrier at Success, a ten-foot hollow wand was constructed to inject air deep into the media at the Success Mine reactive barrier. Figure 10 shows the workers injecting air into the media at the Success Mine.

Figure 10. Injection of Compressed Air into the Reactive Media.

The result of the injection of compressed air into the media was an immediate increase in flow through the reactive barrier, primarily on the West side. The presence of the gravel on the East side made it difficult to get the metal wand into the media to successfully inject the air into the media. This resulted in only limited success on the East side of the reactive barrier.
