**INTERNAL/EXTERNAL CORROSION ANALYSIS
OF THE SAFKEG 3940A PACKAGE IN KAMS (U)**

Savannah River Technology Center
Strategic Materials Technology Department
Materials Technology Section
Materials Consultation Group

Publication Date: June 2003

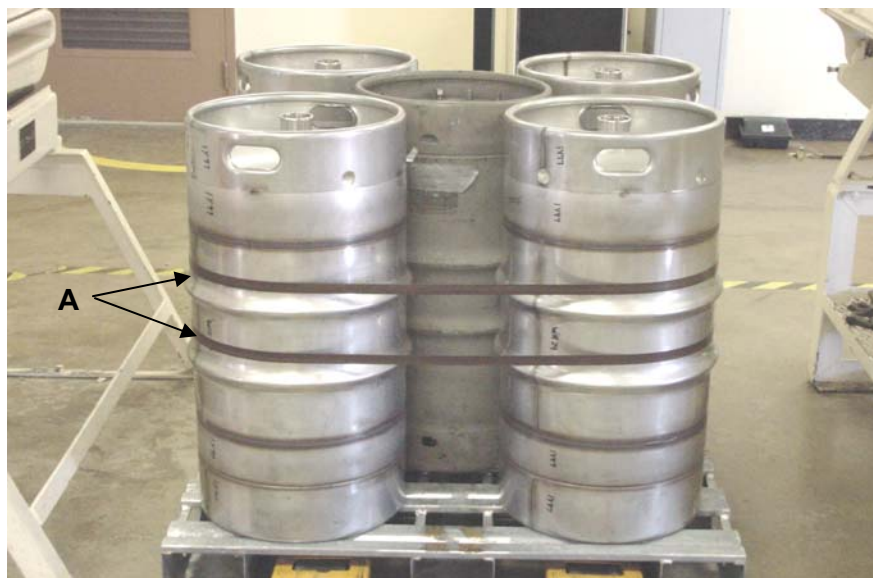
Figure 5. Digital photo of five SAFKEG drums on a galvanized steel pallet. Note strapping (A) securing drums to pallet. Pallet size is 4 feet by 4 feet. Drums will be stored 3 pallets high.

Galvanized carbon steel pallets are normally expected to last a long time, even in exterior applications. However, corrosion of zinc will increase with increasing moisture levels (primarily acid rain). Reference 44 discusses interior applications of hot dip galvanized steel and states that it can be used in wet (high humidity) interior applications for up to 20 years before any maintenance is required. A typical application in this environment is structural steel. One caveat is that this assumes that no penetrations have been through the zinc coating. Exposed carbon steel due to small pin hole in the zinc coating will not corrode due to cathodic protection. When large through coating penetrations are made such as a scratch from a drum being scrapped against the coating, the exposed area of the carbon steel may be too large to be cathodically protected. This produces surface corrosion that will be a visual defect. This will not cause significant degradation to the carbon steel pallet over the 12-year period.

Galvanized and painted carbon steel strapping is subject to corrosion during service to bind drums on a pallet. Rust stains have been observed (by the author) on D₂O drums (stainless steel) due to corrosion of the galvanized strapping. The drums were stored in the crane maintenance area of 105-K. Condensate will cause corrosion on existing breaks in the galvanized coating and will drip on the stainless steel drum. It is difficult for a coating to survive the tension, twisting, rubbing, and bending of strapping installation without a coating break. The eventual rust becomes a visual appearance problem. SS strapping should behave the same as mentioned above on the 304 SS outer container in the SAFKEG 3940A shipping assembly. Stainless steel strapping is the recommended material for strapping in this application.
