Massive Sternal Osteophyte Compressing Aortic Arch Branch Graft

Aorta (Stamford) 2021;9:231–232.

We present a dramatic computed tomography scan demonstrating compression of a brachiocephalic graft by a massive sternal osteophyte, coming to light many years after aortic arch replacement surgery.

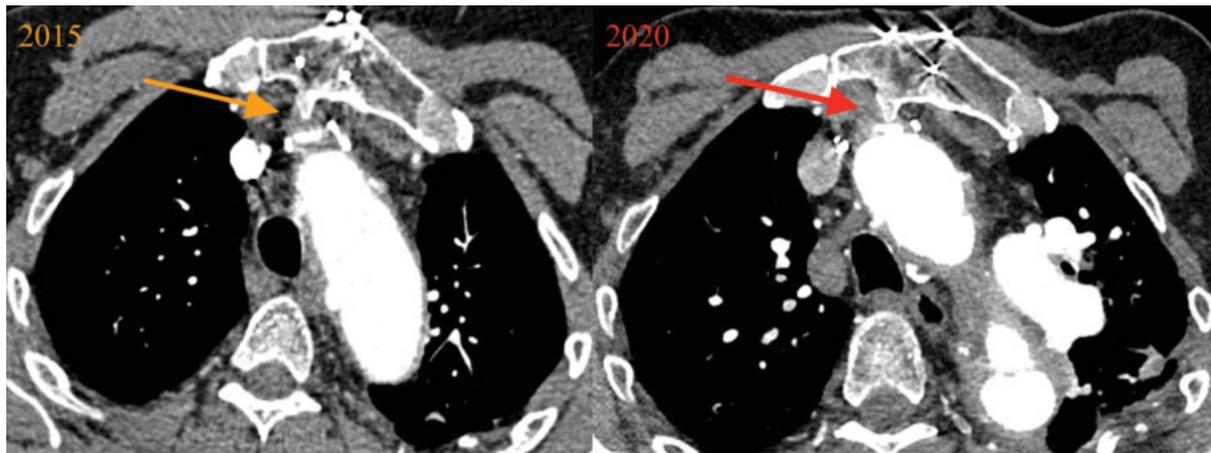
Fig. 1 Axial thoracic computed tomography scan images illustrating brachiocephalic artery compression by a sternal osteophyte that formed following open aortic surgery.

encompassing both the right and left carotids (as well as the right vertebral). Upon further review of the CT scan, an astute observer (J.C.) looked beyond the luminal dye shadow, noticing a dramatic posterior sternal osteophyte, which had formed after the previous redo open aortic surgery, compressing the brachiocephalic artery (▶ **Figs. 1** and **2**; ▶ **Video 1**). Although incidents of osteophyte causing native vessel compression were previously reported,^{1–4} we were not aware of a prior such osteophyte-related graft compression.

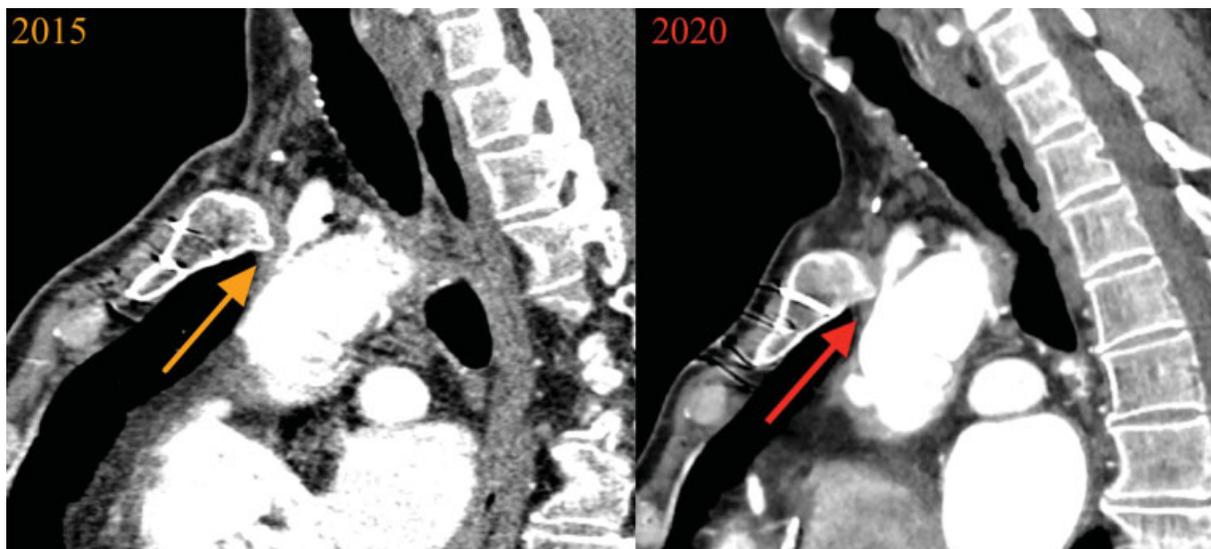
Fig. 2 Sagittal thoracic computed tomography scan images illustrating brachiocephalic artery compression by a sternal osteophyte that formed following open aortic surgery.
