Molten salt facilities, lessons learnt at pilot plant scale to guarantee commercial plants; heat losses evaluation and correction

This paper presents the importance of the thermal losses in the performance evaluation of thermal storage systems. In order to reinforce this statement, an evaluation of a pilot plant whose size is sufficiently representative for the extrapolation of results at larger scales has been carried out. The evaluation of the heat losses of a molten salt pilot plant with 8.1 MWh_{th} built in Spain by Abengoa is presented. While the storage materials development has attracted a lot of attention from the researchers, the performance of a two-tank storage system has not been evaluated in detail. The relevance of the design of conventional systems such as insulation, mechanical assembly or foundation, are found to be the key for the feasibility of a TES system. Different performance scenarios were performed and based on experimental results, decisions for reengineering of the pilot plant could be taken to improve commercial storage plants.

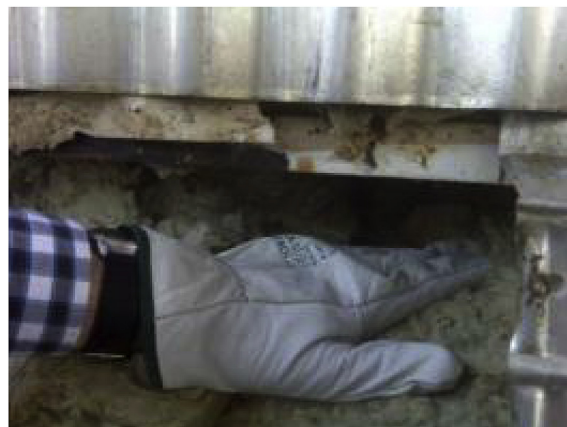
**Fig. 3.** Lack of insulation material in the storage tanks.

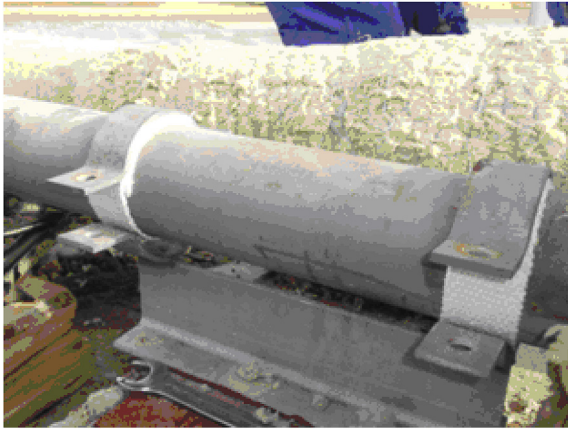
The oil circuit piping also had important heat losses, mainly in the clamp shoes. A ceramic fibre coating was installed in all the shoes (Fig. 8) and a more rigid insulation material in the contact

Fig. 8. Shoes clamps with ceramic fibre.
