Emergency responder and public health considerations for plastic sewer lining chemical waste exposures in indoor environments

## Emergency responder and public health considerations for plastic sewer lining chemical waste exposures in indoor environments

### Abstract

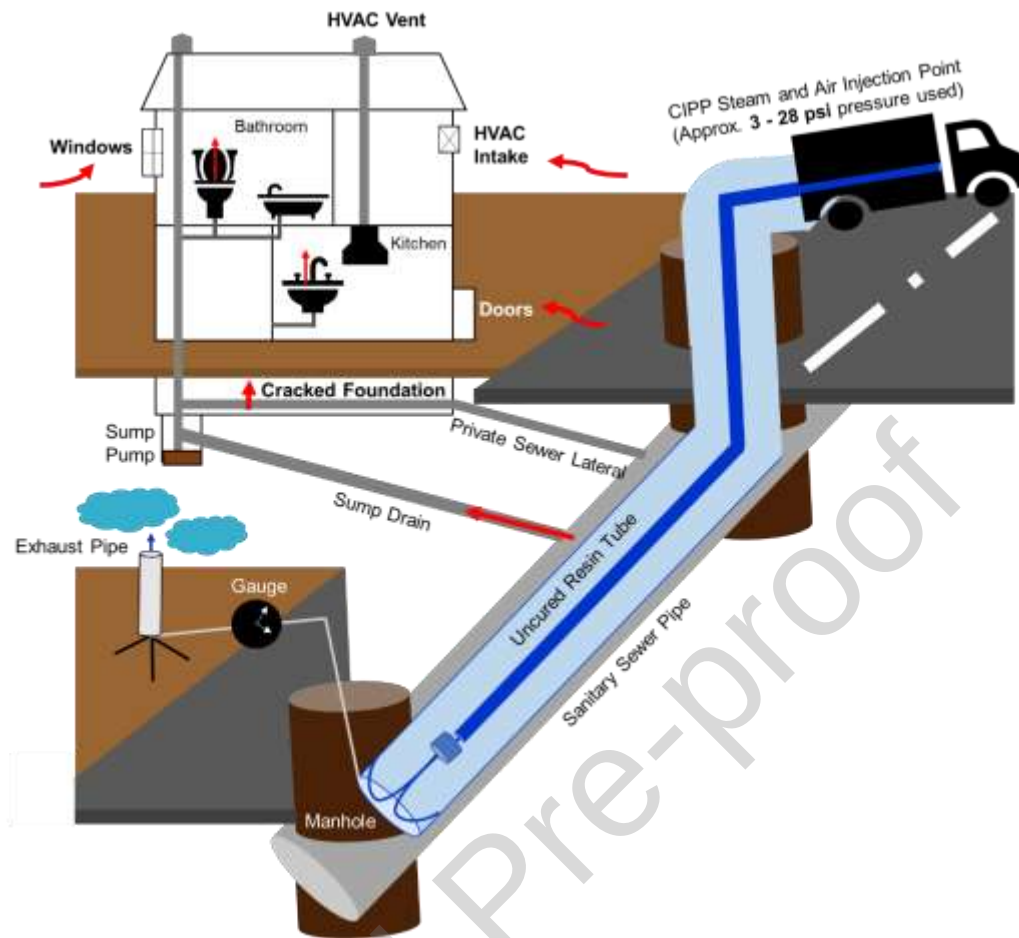
**Figure 1.** Schematic of building intrusion pathways for CIPP waste products from a sewer liner manufacturing worksite. The CIPP worksite includes a pressure source at the truck, uncured resin tube, exhaust pipe, and the escape of exhaust and fugitive emissions into the air.

CIPP waste can enter buildings through multiple pathways (Figure 1). Waste material can be discharged into the air during the uncured resin tube insertion, curing, and cool-down processes. Waste can travel through sewer pipes directly to buildings, enter the building through foundation cracks, and exit the buried pipes through manholes and vents aboveground. Water seal blowback incidents for sinks and toilets have been reported, and sometimes buildings next to one another did not have the same indoor air contamination problems. This may be because of differences in sewer pipe characteristics (i.e., size, cracks,

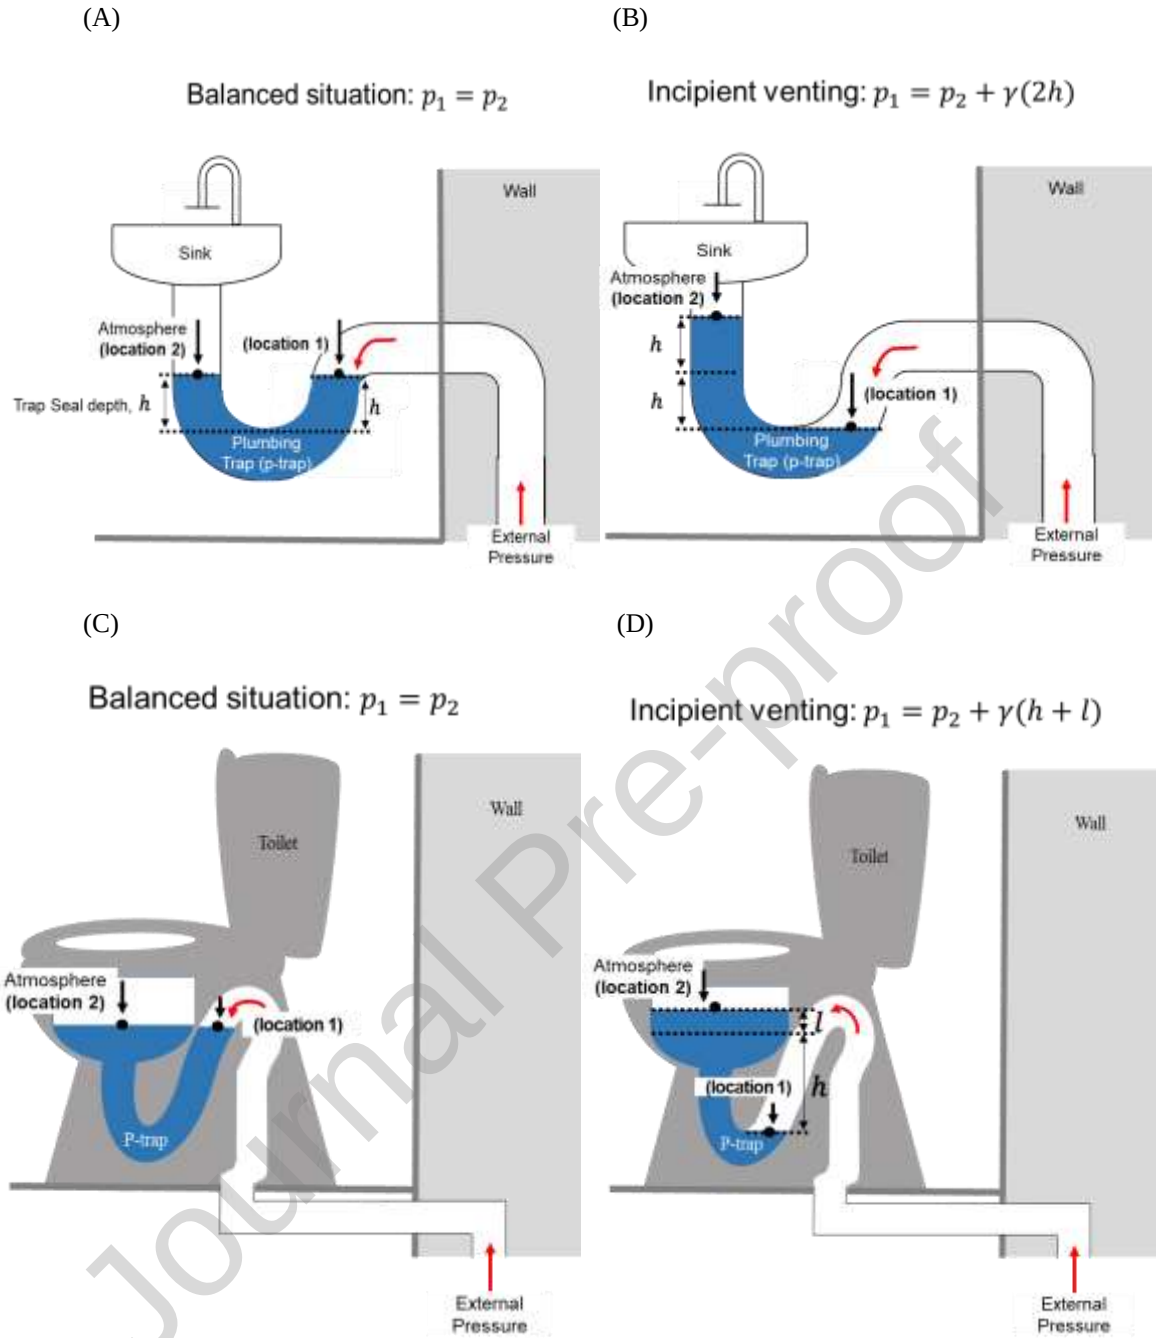
**Figure 2.** A sectional view of the sink (A, B) and toilet (C, D) in a typical bathroom.

To estimate the air pressure needed for water seal displacement, the dimensions of a standard sink p-trap in the U.S. were applied (Ripka, 1997). The sink drain is connected to a p-trap and then runs to the wall (Figure 2A, 2B). The trap depth is considered to range between  $h = 5.08$  and  $10.16$  cm (about 2 and 4 in) (International Code Council, 2019; International association of Plumbing and mechanical officials, 2018). The relative (gauge) pressure needed to displace the water seal was calculated by assuming a hydrostatic pressure distribution in the water at the point of incipient venting and equating the volume of water between the balanced case and the moment of incipient venting, which will occur at the point shown in Figure 2B (this was verified with a simple laboratory experiment):

The air pressure required to cause displacement of the toilet trap water seal was estimated in a similar manner to the sink (Figure 2C, 2D). As the excess sewer gas pressure pushes the trap water down, the water will rise slightly in the toilet, with the volume of water rising in the toilet balancing the water displaced from the trap seal. The authors assumed that

the point shown in Figure 2D is the point of incipient venting and that the water has a hydrostatic pressure distribution at this point. The toilet trap seal depth is usually used as  $h = 10.16$  cm (about 4 in) (International Code Council, 2019; International association of Plumbing and mechanical officials, 2018), and the p-trap pipe inner area estimated at  $45.58$  cm<sup>2</sup> (about 3 in diameter) (Ripka, 1997; USEPA, 2015a). Equating the water volume displaced from the trap to the toilet bowl, and assuming a water surface area of  $360$  cm<sup>2</sup> (determined by inspection of several toilet bowls in the U.S.), the bowl water deflection is estimated as  $l = \left(\frac{360}{45.58}\right)h$ . With these assumptions, the necessary sewer gas back pressure (gauge) for toilet venting becomes:

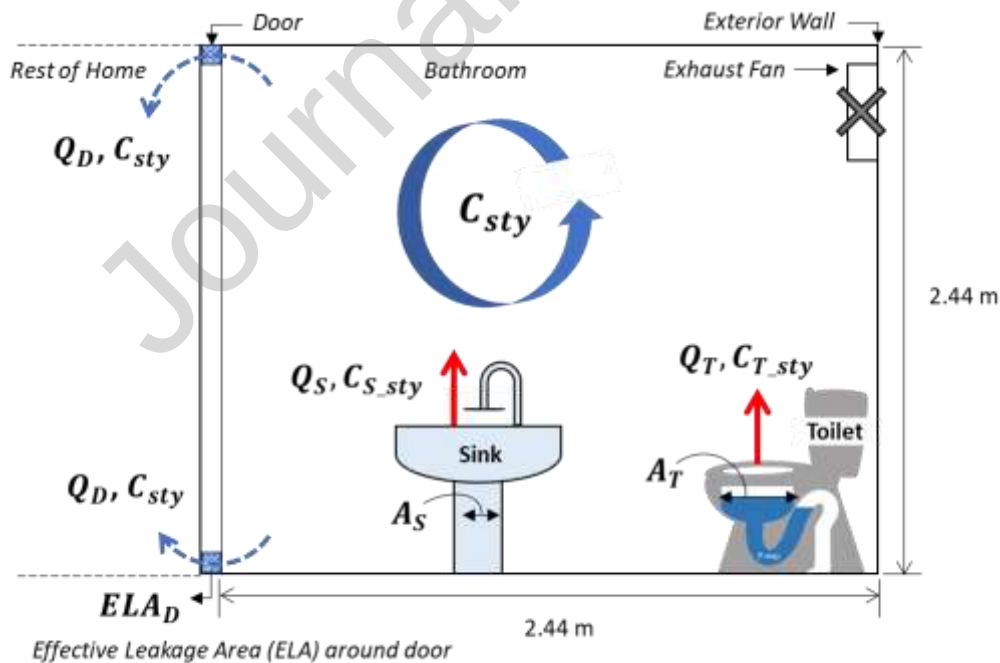
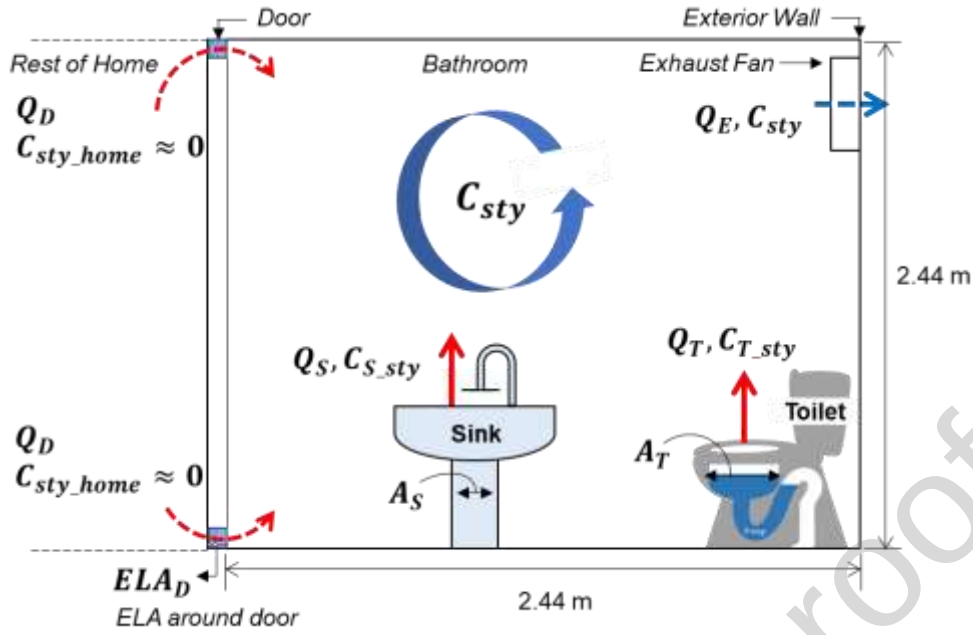
**Figure 3.** Schematic of bathroom model with the location of the sink, toilet, and bathroom exhaust fan noted: (A) non-ventilation condition (exhaust fan off) and (B) ventilation condition (exhaust fan on). The diagram is a single-cell CSTR model; the arrows represent the airflow pathways. Supply and return vents for a home mechanical HVAC system are not considered.

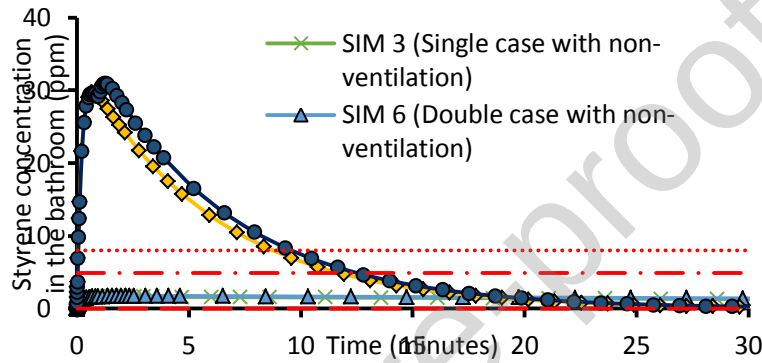
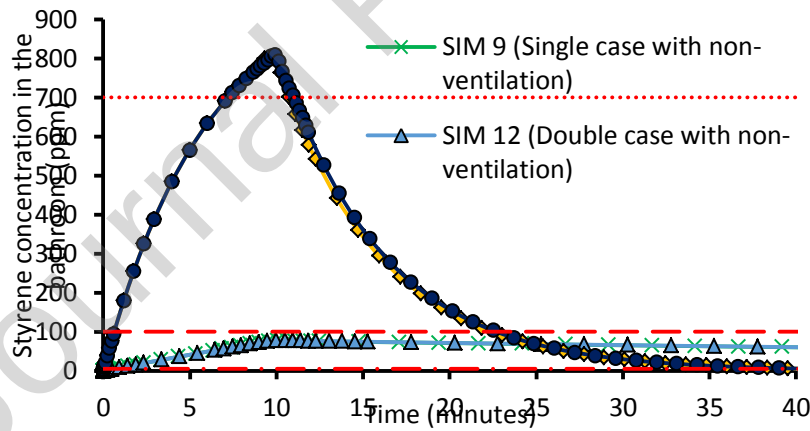
**Figure 4.** Time-series of the estimated indoor styrene vapor concentration after inflow ( $C_{T/S\_sty} = 1,000$  ppm) into the bathroom for the: (A) instantaneous inflow cases and (B) constant inflow cases. The ventilation level was simulated for a perfectly sealed door. For information on the type of styrene influx and its intrusion condition, see Table S4 and Table 1, respectively.

The predicted bathroom air styrene concentration was influenced by bathroom exhaust fan operation and certain conditions prompted exceedance of the styrene IDLH concentration. Figure 4 shows the time-dependent change in indoor styrene concentration according to the  $C_c$  emission scenario ( $C_{T/S\_sty} = 1,000$  ppm) from the sink and/or toilet under

perfectly sealed door condition. For both the instantaneous inflow (Figure 4A) and the 10 min constant inflow conditions (Figure 4B), the greatest styrene concentrations were found when the exhaust fan was on (AER 10 h<sup>-1</sup>), followed by the non-ventilation condition (AER 0.5 h<sup>-1</sup> with a perfectly sealed door). This was due to the bathroom exhaust fan entraining more contaminated styrene-laden air through the p-trap of the sink and toilet during its operation.

When the exhaust fan was operated at a constant toilet/sink emission, styrene concentrations of 802 ppm and 806 ppm were reached in under 10 min (Figure 4B). These levels far exceeded a variety of worker exposure limits, including the OSHA ceiling limit (200 ppm) (OSHA, 2020) and NIOSH IDLH concentration (700 ppm) (NIOSH, 2020). NIOSH recommends that workers should wear an organic vapor cartridge respirator when 500 ppm styrene concentrations or higher are possible, and a self-contained breathing apparatus (SCBA) with a full face piece when levels are 700 ppm or higher (NIOSH, 2020). Once the emission ceased, the exhaust fan on scenario showed 45 min was needed for styrene levels to decrease below the AREL, and 85 min was needed to reach the odor threshold concentration. When the exhaust fan was off under the high discharge case, the maximum styrene concentration was 77 ppm. The levels also exceeded recommended occupational short-term exposure limit (STEL; 15-min); 40 ppm of ACGIH (40 ppm) (ACGIH, 1999). During a 60 min period, the total amount of styrene that passed through the bathroom, under the double discharge condition, was 625 kg (with ventilation) and 300 kg (for non-ventilation case) (Figure S4).

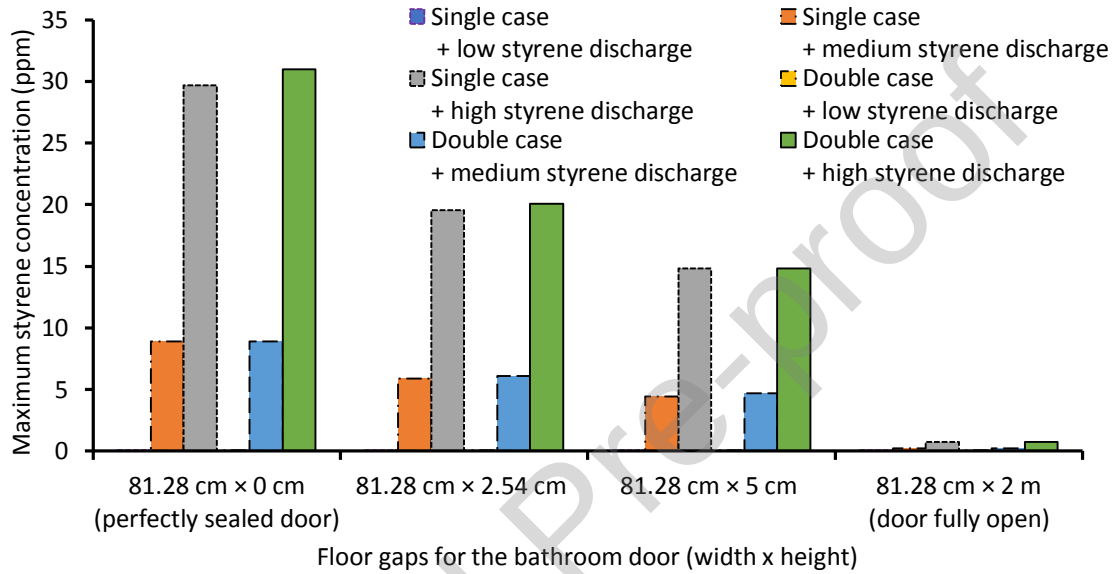
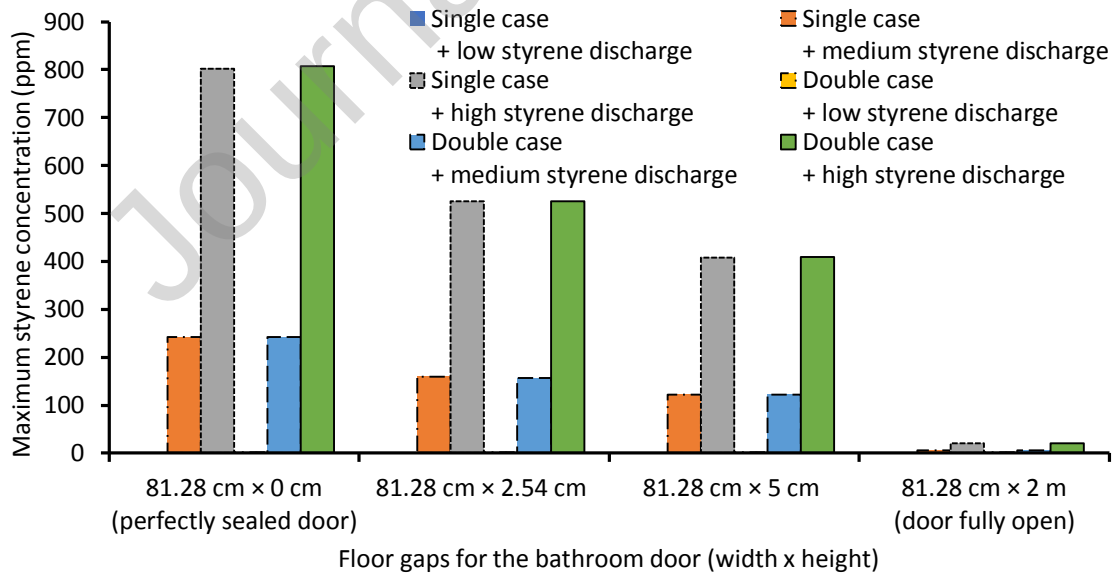
**Figure 5.** Maximum styrene concentrations for each bathroom door ELA condition for the: (A) instantaneous emission cases and (B) constant emission cases.
