# **Examination of the 1970 National Bureau of Standards Underground Corrosion Test Welded Stainless Steel Coupons from Site D**

January 2008

**Idaho National Laboratory  
Environmental Management Science Program  
Idaho Falls, Idaho 83415**

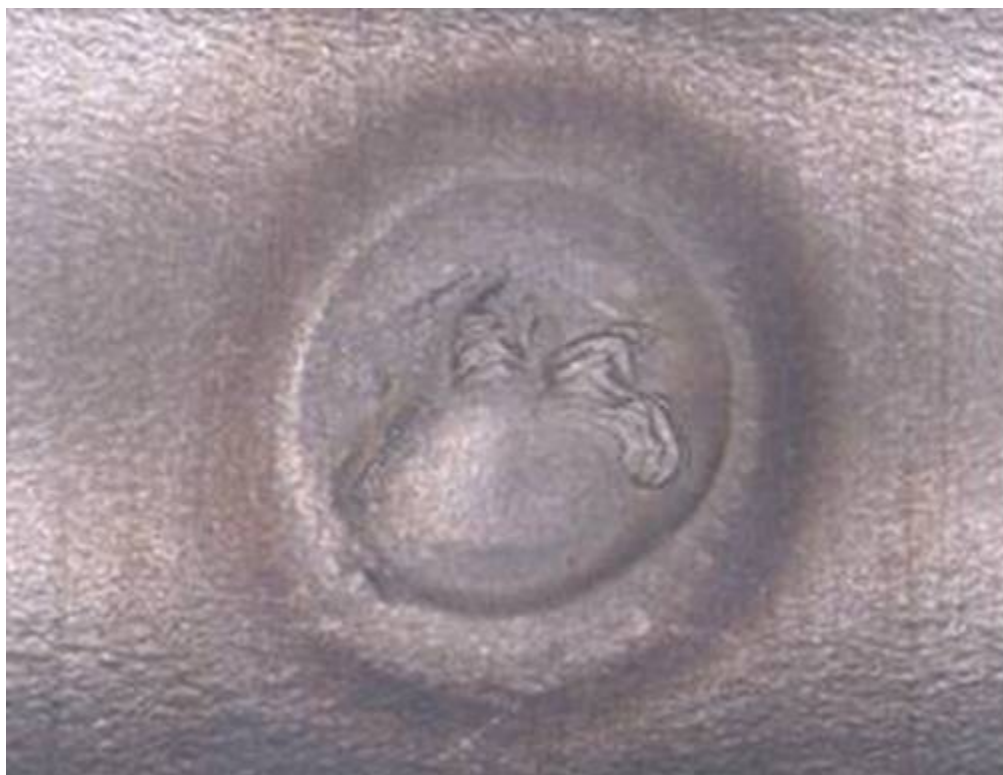
Figure 32. System 68, this optical photograph shows the basic size of the melted spot weld in relationship to the expulsions. This photograph shows the actual spot weld size or “nugget” better than the ESEM photograph.

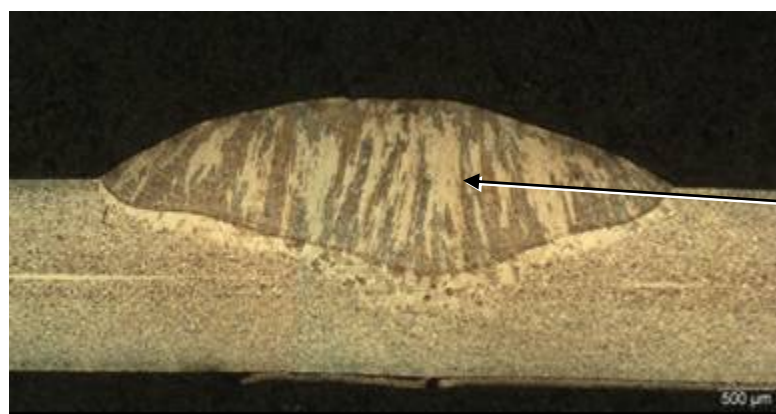
The following sketch, Figure 48, shows the locations on the plates where sections of both cross bead plates were removed for metallurgical analysis. These were also the locations of the pitting on the plates as illustrated in the metallographic cross sections of the welds, Figures 49-51.

The plate is 0.06-in thick and the weld is about 0.2-in wide. (Lippold et al., 2007).

Figure 49. End view of cross sectioned weld about 1-in from the edge of the plate, sample 54D19.
